## Site Report

### **GEOTECHNICAL INSPECTION PROPOSED STABILISATION OF ROCK OVERHANG 189 RIVERVIEW ROAD, AVALON BEACH, NSW**

As requested, our Associate Geotechnical Engineer, Mr Matthew Pearce, visited the above site on 15 October 2020 to complete a detailed inspection of a previously identified potentially unstable block of overhanging rock on the boundary between the subject site and No 191 Riverview Road. This site report confirms and expands upon our discussions on site with Mr Jamie Durie.

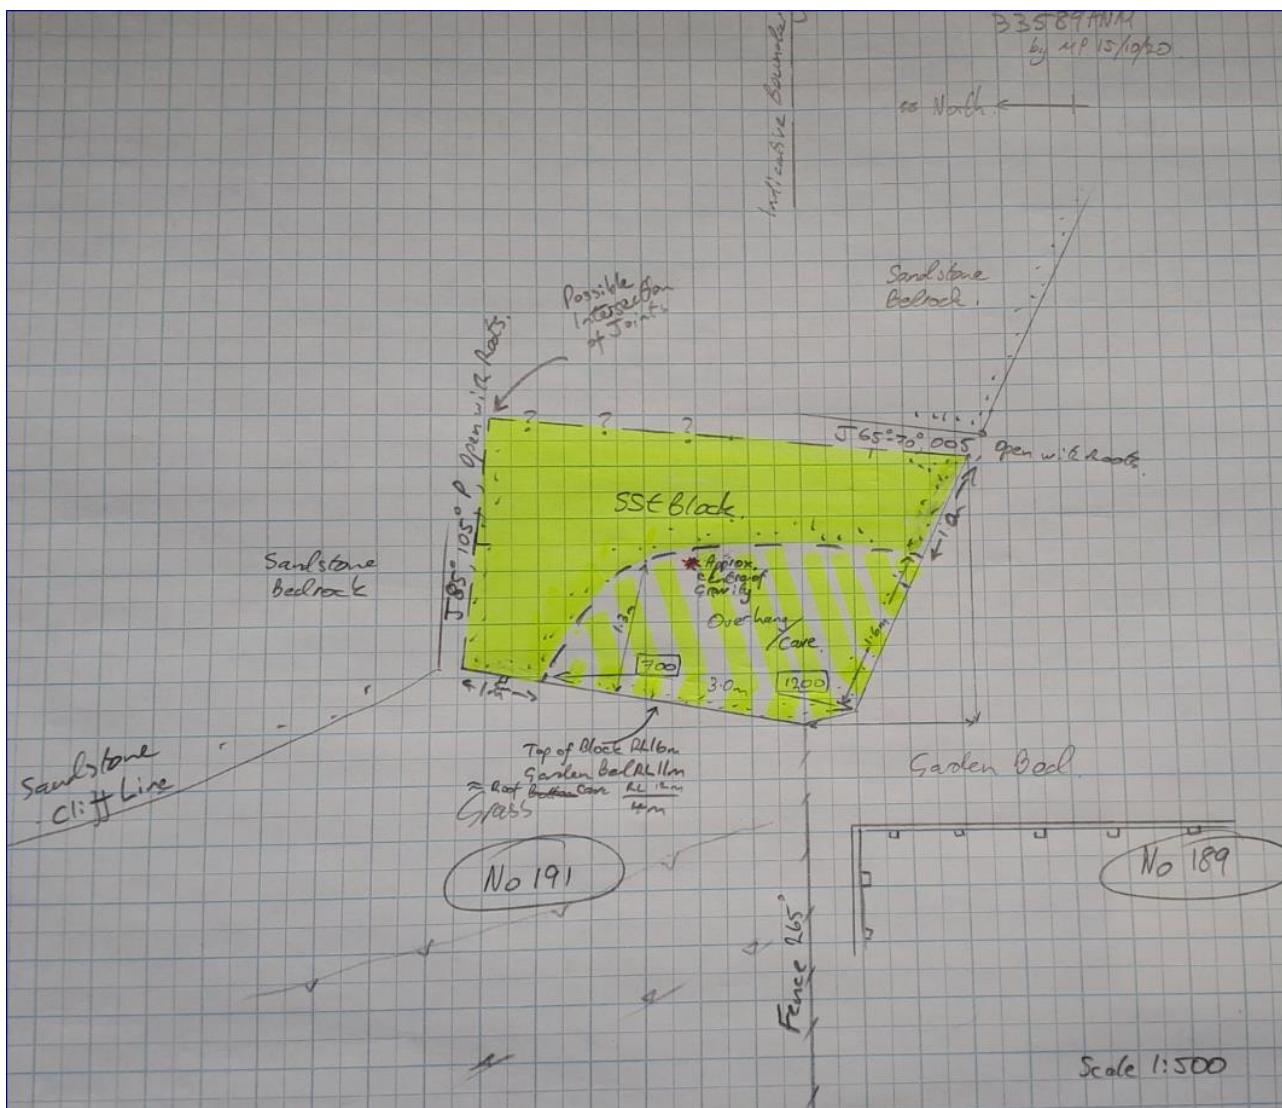
**Sketch Plan**

- The block is formed by open joints, at the rear (east) and side (north).
- The plan dimensions of the block are about 3.5m to 4.5m wide (north-south) by 2.5m to 2.7m deep (east-west)

- The block is a maximum of approximately 5m high, but at its western edge it is about 4m high over an undercut at the base.
- At the base of the block is an undercut, or 'cave', which measures about 2.5m to 3m wide (north-south) by 1.3m to 1.8m deep (east-west), and is 0.7m to 1.2m high.

- From our measurements, the centre of gravity of the block is approximately just at the rear face of the cave.

- We estimate the mass of overhanging rock to be about 40 tonnes.

It appears that the block is only marginally stable, and as such, we recommend that additional support be provided without delay.

We recommend the block be stabilised by underpinning with blade walls founded on sandstone bedrock of at least medium strength below the base of the cave. We strongly recommend an investigation be completed to confirm the depth to such bedrock within the extent of the base of the cave at an early stage, as alternate solutions may be required if such bedrock is not present. At least two blade walls are recommended at one third points from each end.

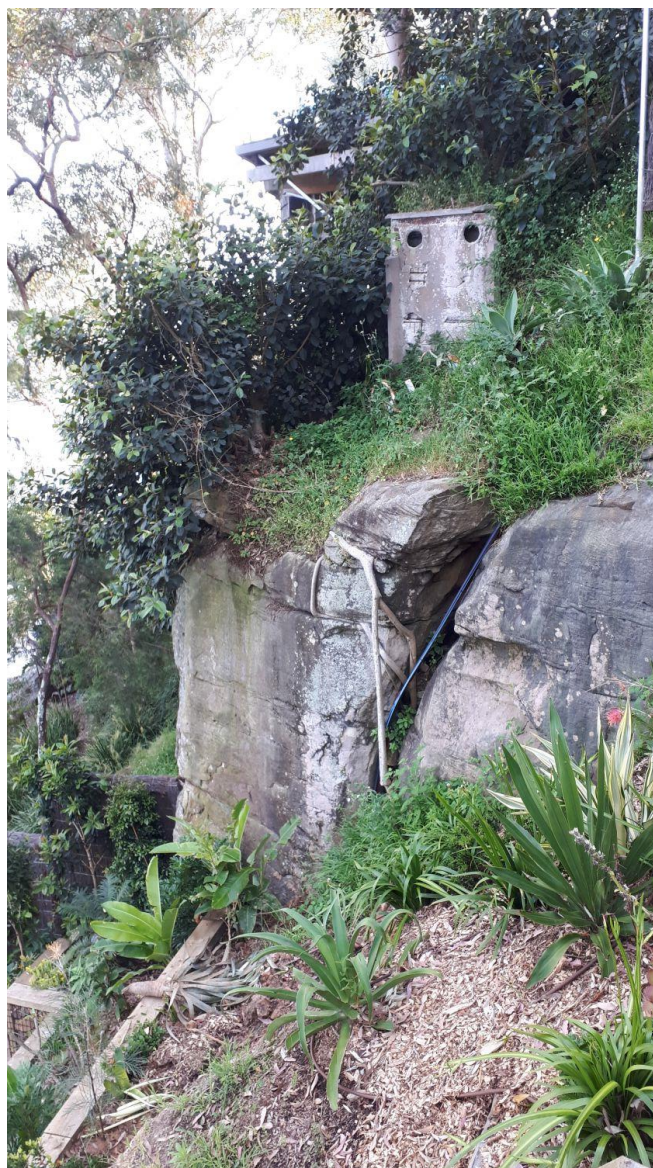
**Looking northwards**

- A fig tree is growing at the top of the block, with its roots extending into the joints at the rear and side of the block.
- The external face of the block was assessed to be of medium to high strength, and the material at the rear of the cave was of low to medium strength.

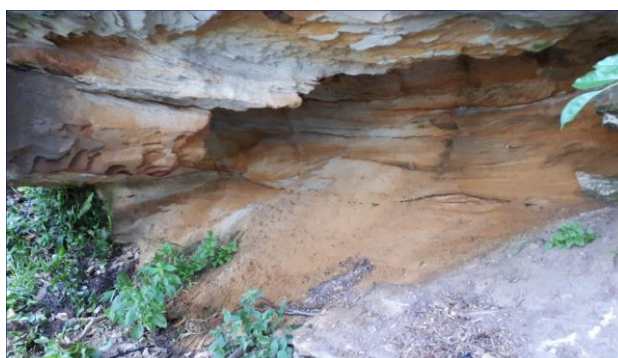
**Looking North-eastwards**

- At the base of the cave sandstone bedrock is exposed within the rear and central portions, however, the surface of the bedrock slopes or steps down to the west and is covered with sandy fill.
