**DETAILED SITE INVESTIGATION
&
REMEDIAL ACTION PLAN**

**LOTS 2 & 3 IN DP1115877 AND PART LOT 3 IN DP942319
53A, 53B & 53 WARRIEWOOD ROAD, WARRIEWOOD**

REPORT NO 20223/3-AA 14 MARCH 2024

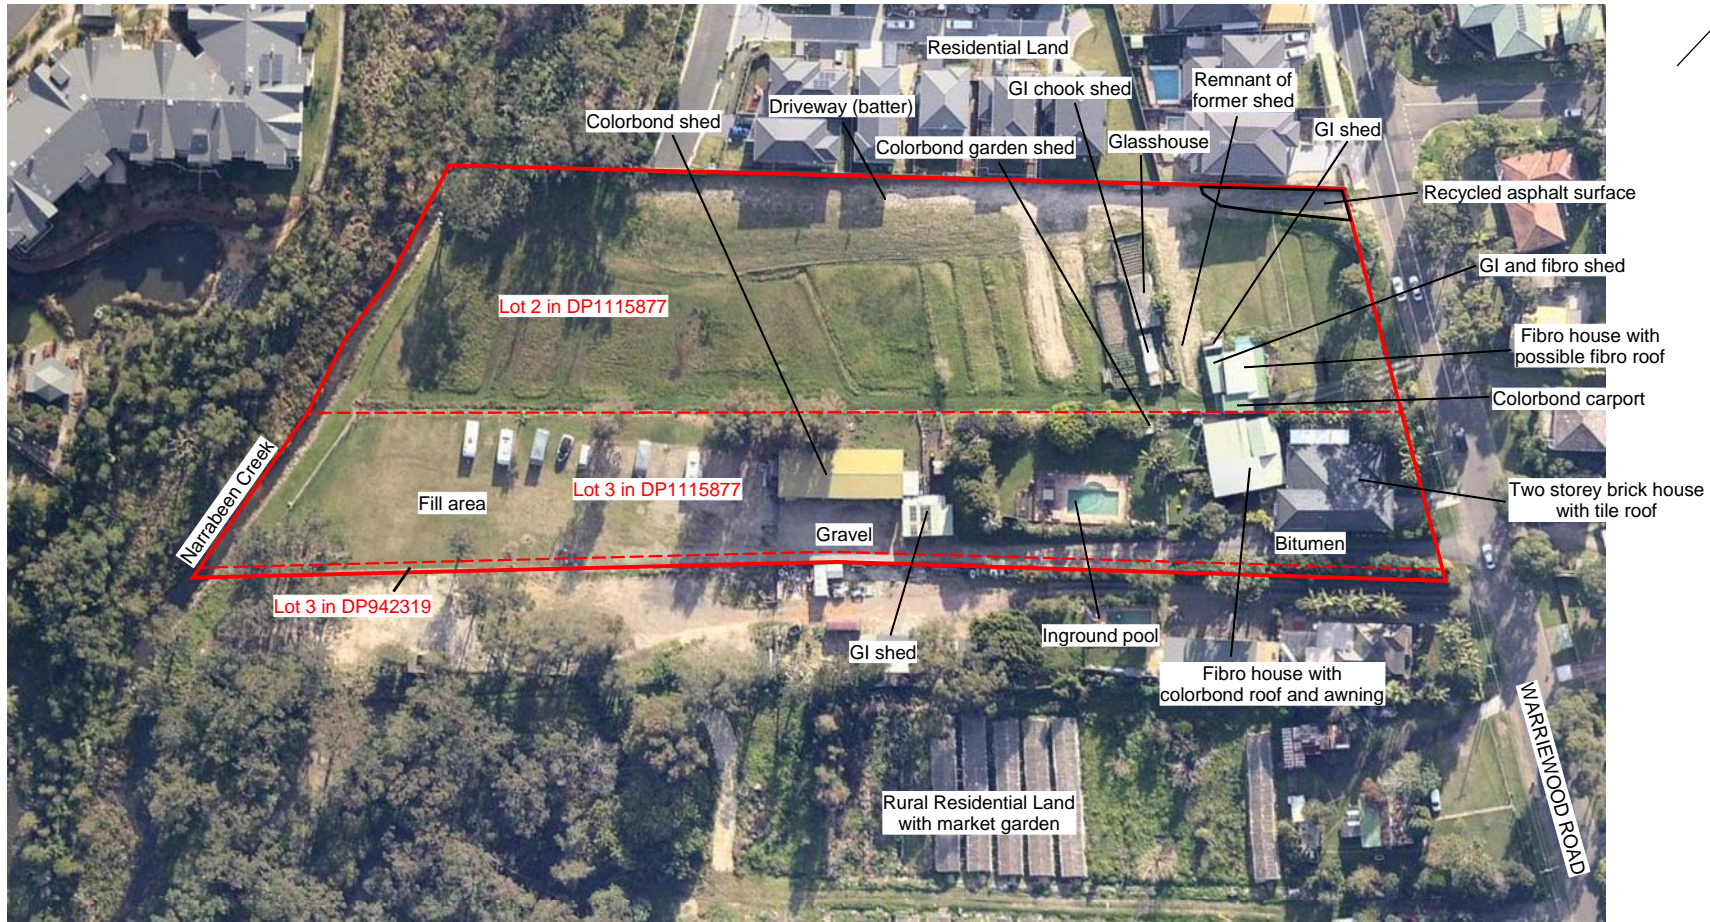
Drawing No: 13234/2-AA1
 Job No: 13234/2
 Drawn By: MH
 Date: 25 August 2014
 Checked By: AN/AB

At the time of inspection and field sampling on 30 May 2016 by a Field Engineer from Geotechnique as a part of the Phase 2 CA, the site comprised two individual rural residential properties, facing Warriewood Road. During the inspection for the phase 2 CA, the site remained unchanged as observed during phase PCA in July 2014, as shown on Drawing No 13234/2-AA1.

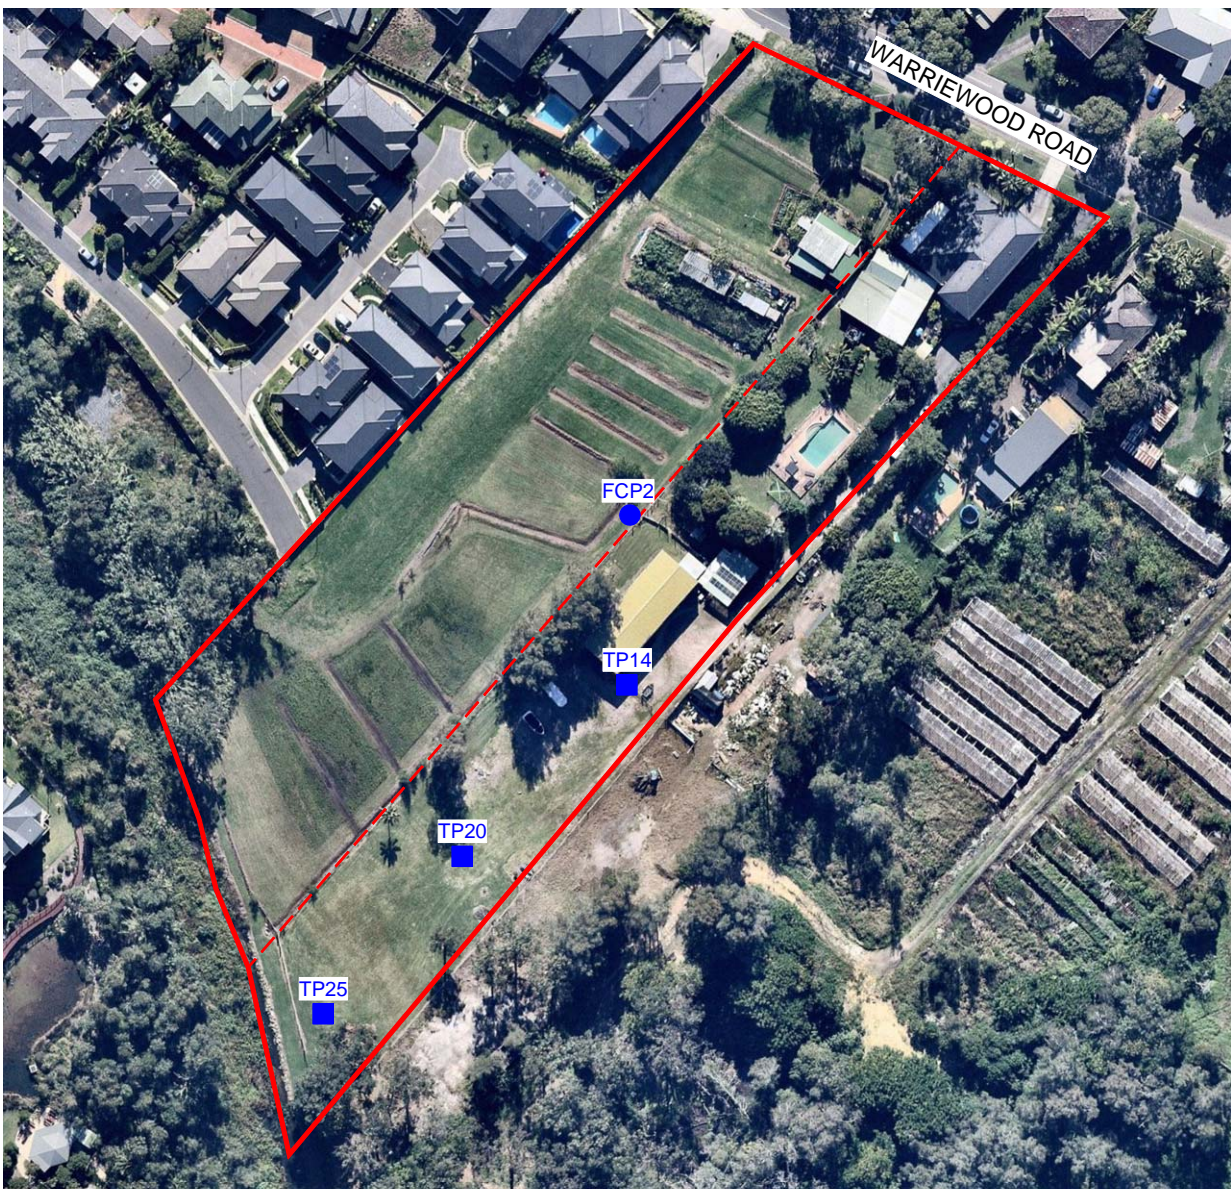
Locations of Concern

- Detailed sampling and testing in the vicinity of locations of concern, as indicated on Drawing No 13757/2-AA2, to delineate the extent of contamination.
- Sampling and testing of soils in the footprints of site features such as the houses, building, sheds, carport, glasshouse, concrete, recycled asphalt, gravel, and bitumen covered areas, after complete demolition and removal or clearing.
- Development of a remedial action plan (RAP) to remediate PAH and asbestos contaminated fill materials with elevated Metals concentrations plus any other contamination identified through the recommended additional sampling and testing, followed by appropriate validation. We consider that the site can be made suitable for the proposed development following appropriate remediation and validation.

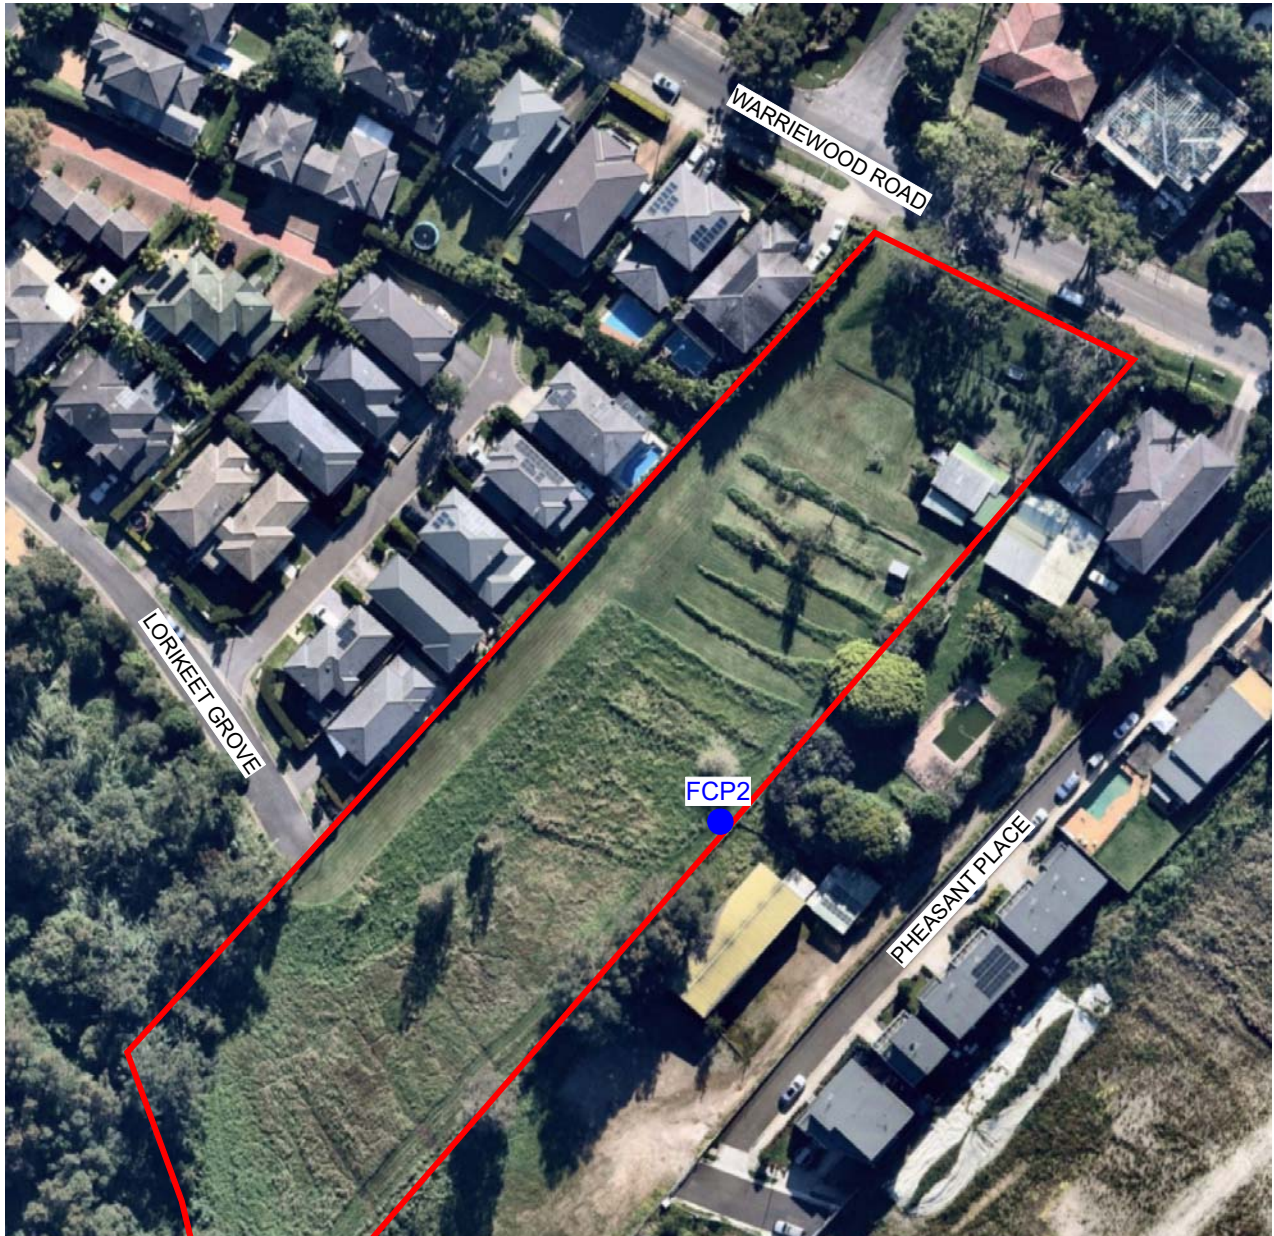
Location of Contamination	Depth (m)	Contaminant	Concentration
FCP2	0-0.1	Asbestos (<7mm AF&FA)	0.007% w/w
Assessment Criteria	0.01%w/w for ACM in soil for residential land use 0.001% w/w for AF & FA in soil No visual asbestos (ACM) for surface soil

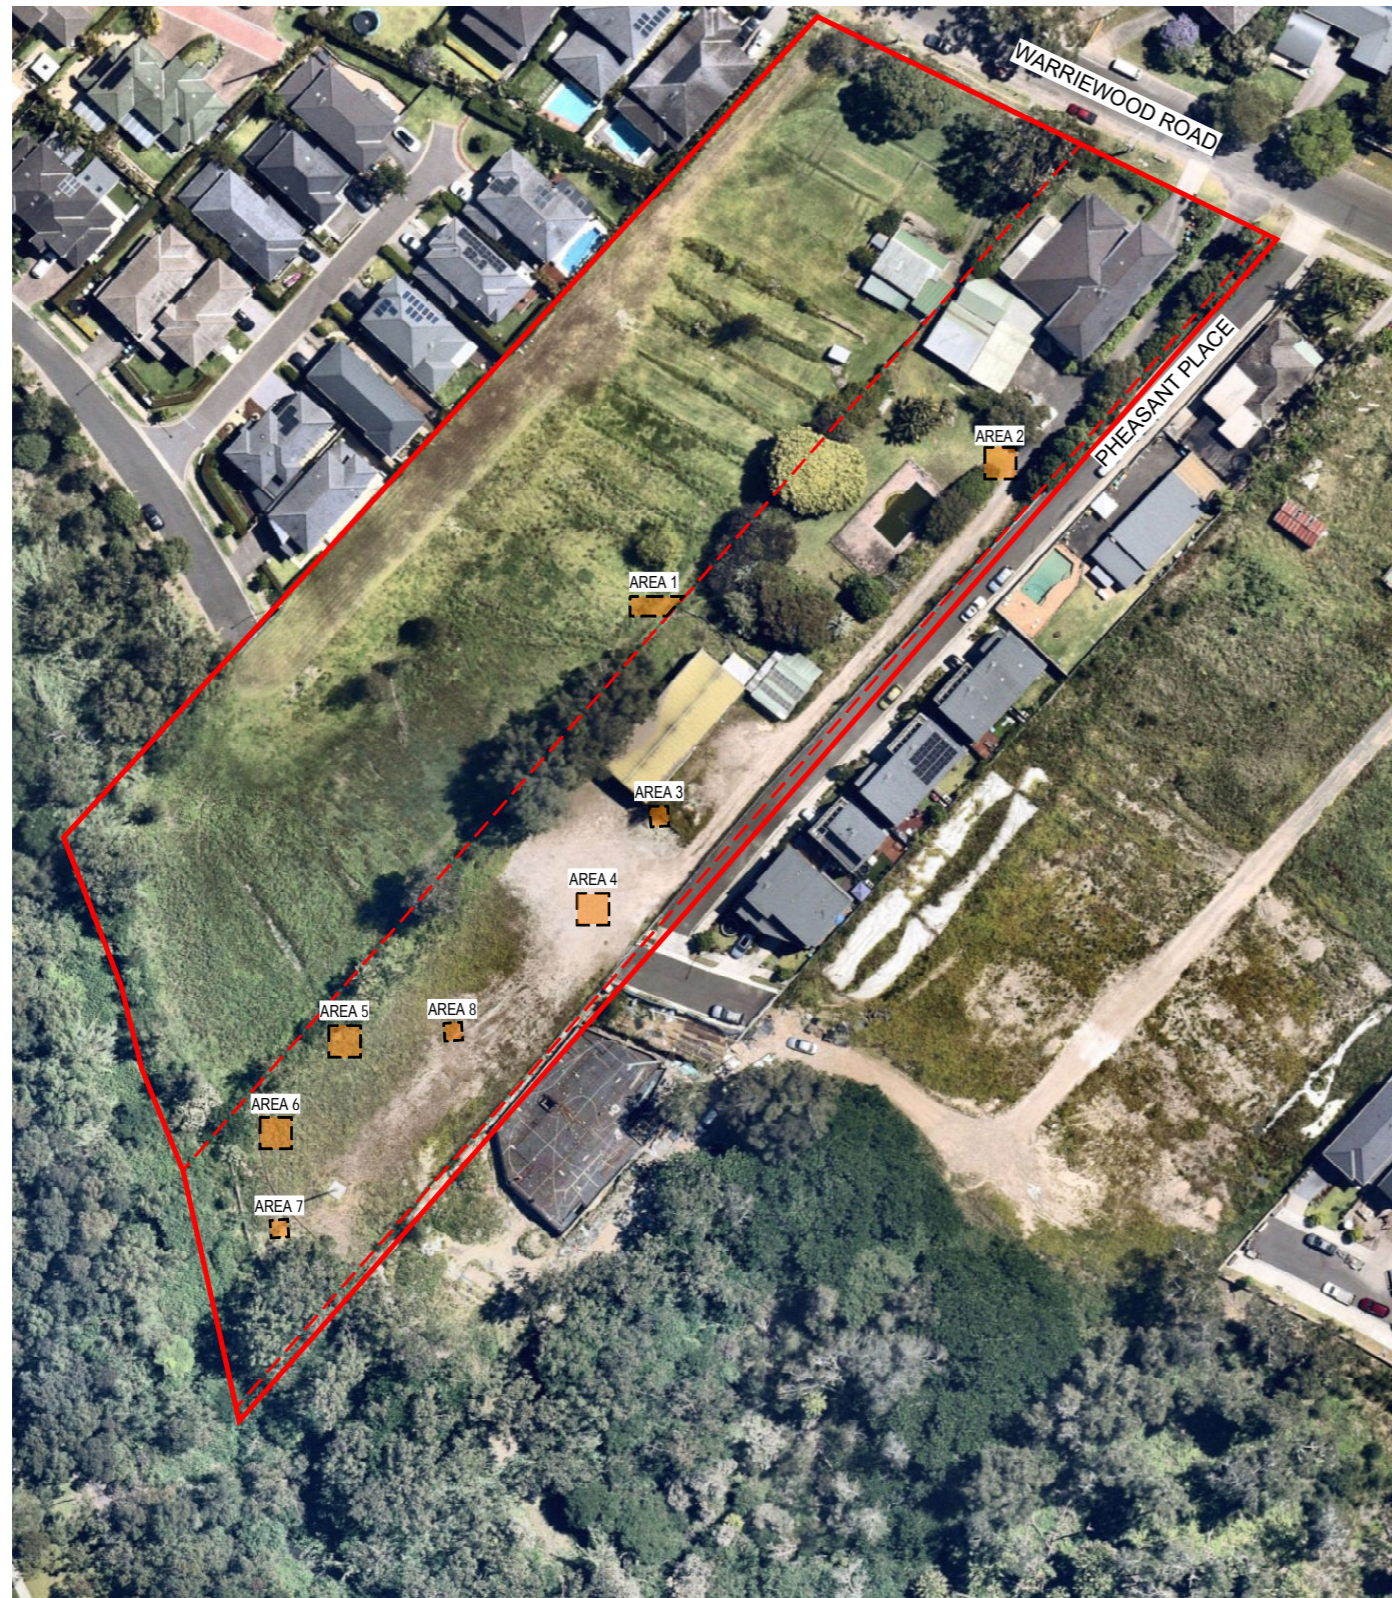
Revised Locations of Contamination

- ACM: Asbestos Containing Material
- AF: Asbestos Fine
- FA: Fibrous Asbestos
- PAH: Polycyclic Aromatic Hydrocarbons

As a precaution, it is recommended to excavate fill materials (about 1m x 1m x full depth of fill) at each sample locations TP14-4, D103 and D107, where asbestos (ACM or AF or FA) was detected but below the acceptable limits and dispose the fill materials at a landfill facility as asbestos waste, during remediation of Areas 1 to 7.
