**STANDFAST TREE SERVICES**  
ESTABLISHED 1979

12/10/2020

Re Arboricultural Impact Assessment (AIA) for 135 Seaforth Cres, Seaforth

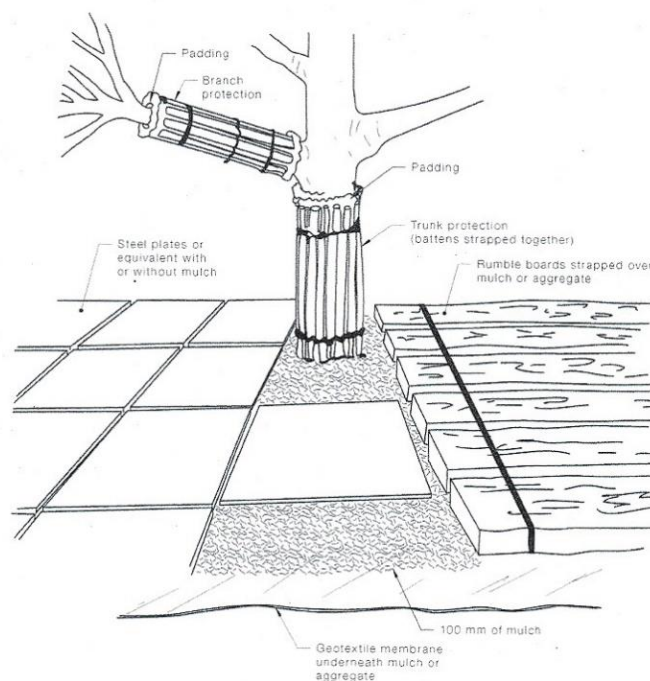
FIGURE 4 EXAMPLES OF TRUNK, BRANCH AND GROUND PROTECTION

Where necessary, install protection to the trunk and branches of trees as shown in Figure 4. The materials and positioning of protection are to be specified by the project arborist. A minimum height of 2 m is recommended.

If temporary access for machinery is required within the TPZ ground protection measures will be required. The purpose of ground protection is to prevent root damage and soil compaction within the TPZ. Measures may include a permeable membrane such as geotextile fabric beneath a layer of mulch or crushed rock below rumble boards as per Figure 4.

- 1 For trunk and branch protection use boards and padding that will prevent damage to bark. Boards are to be strapped to trees, not nailed or screwed.
- 2 Rumble boards should be of a suitable thickness to prevent soil compaction and root damage.

Stem and branch protection should consist of boards and padding that will not damage the bark.

Boards should be strapped to trees and not nailed or screwed.

A minimum height of 2m is recommended.

The purpose of ground protection is to prevent root damage and soil compaction within the TPZ. Ground protection measures may include a permeable membrane such as geotextile fabric beneath a layer of mulch or crushed rock below rumble boards.
