REPORT ON GEOTECHNICAL INVESTIGATION

PROPOSED NEW RESIDENTIAL APARTMENT BUILDING

140-142 OCEAN STREET, NARRABEEN, NSW

Project No.: 2021-073.1

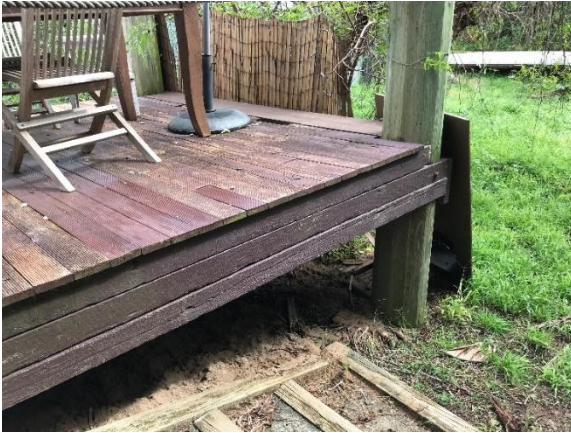
A gentle west dipping soil slope ($\approx 3-5^\circ$) is located within the rear of No.142 between the upper gravel region and the lower grassed area. A wooden deck is located at the crest of this slope, this structure showed signs of minor settlement with some rotting of the timber planks also evident, this is shown in Photograph 4.

Photograph 4: Timber deck within rear of site, with rotation/rotting of timber planks and minor settlement evident, facing south west

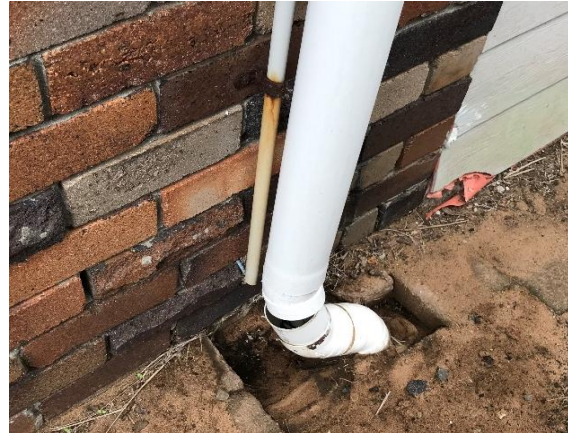
Stormwater drainage and gutter systems were observed across the main structure within No.142, with down pipes discharging into drainage pits, however faults in some of the PVC stormwater pipes and metal water pipes were identified, as shown in Photograph 5, however no determined erosion appeared related to these issues. A Sydney Water (SW) sewer main intersects the south western portion of the site. Based on available DBYD information it is understood the sewer main comprises a 450mm diameter vitrified clay pipe.

Photograph 5: Fault opening in PVC stormwater down pipe along southern external wall of site house, facing north east

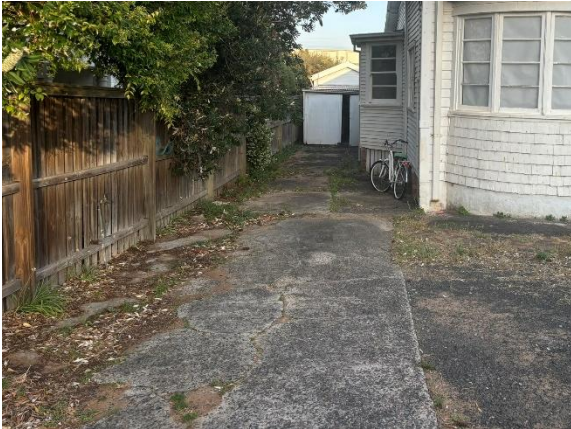
The fibro garage structure within No.140 is accessed via a concrete driveway extending along the southern side boundary, this driveway is in a poor condition with major cracking and settlement identified across the pavement, as shown in Photograph 5. The front portion of No.140 contains a grassed lawn with a pedestrian access paved pathway extending from the front boundary.

Photograph 5: Cracking within front driveway concrete pavement (No.140), facing west

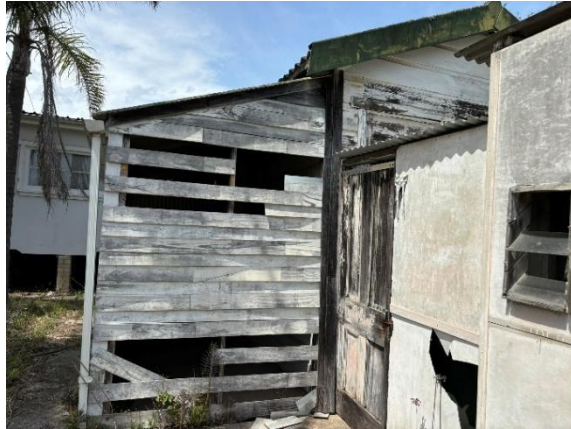
The rear of No.140 contains a large grassed lawn, garden and paved area to the immediate west of the main structure with a low retained concrete block retaining wall ($\leq 0.20\text{m}$ high) positioned centrally. The rear of the garage structure extends into a rear shed and is in a dilapidated condition, as shown in Photograph 6.

Photograph 6: Rear of garage structure (No.140) in a dilapidated condition, facing east
