# **ARBORICULTURAL REPORT** **CONSTRUCTION IMPACT** **ASSESSMENT**

Lam Consulting Engineers  
22 Victoria Parade,  
MANLY

Report Reference: CIA - LAM 06/15

23<sup>rd</sup> June, 2015

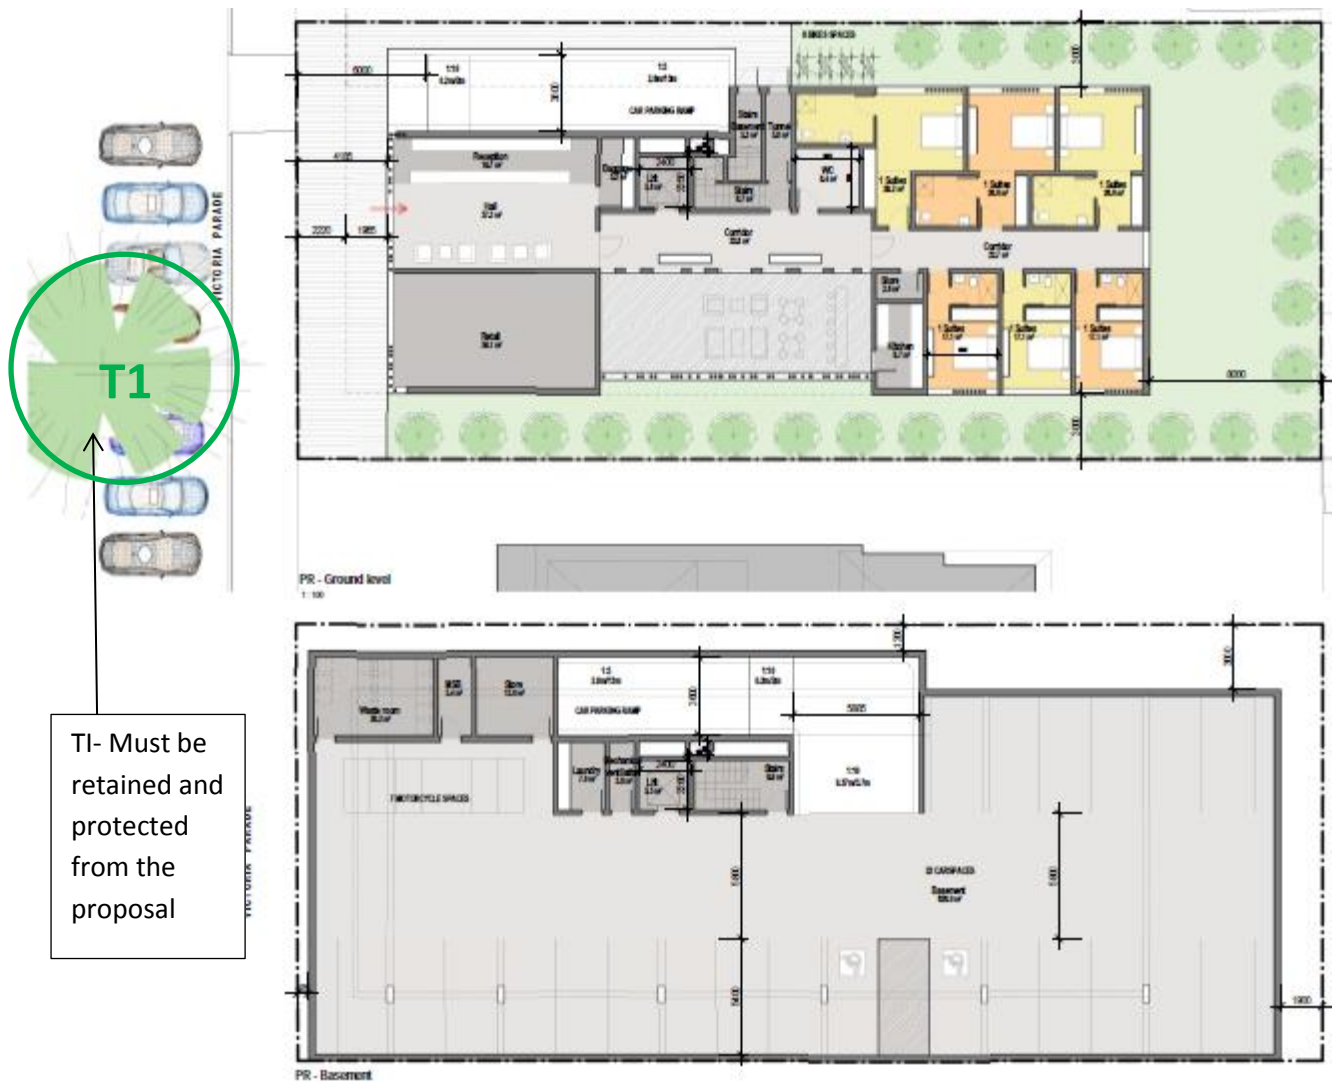
## Site Plan

- V. A Site Map (Appendix A), using plans provided by the client and overlaid by the Arborist is included in this report.
- VI. Trees physical characteristics are noted by the Arborist, including age, vigour and crown characteristics, general health and condition, defects and the presence of pest and disease. Findings are tabled in Table 1 - Tree Assessment. This is to be read in conjunction with Appendix B- Table 3.2 Definitions and Descriptors.
