Report Title: Geotechnical Report 1744 Pittwater Road, Bayview  
Report Date: 14/2/24

## **GEOTECHNICAL INVESTIGATION:**

### **New Boat Ramp at 1744 Pittwater Road, Bayview**

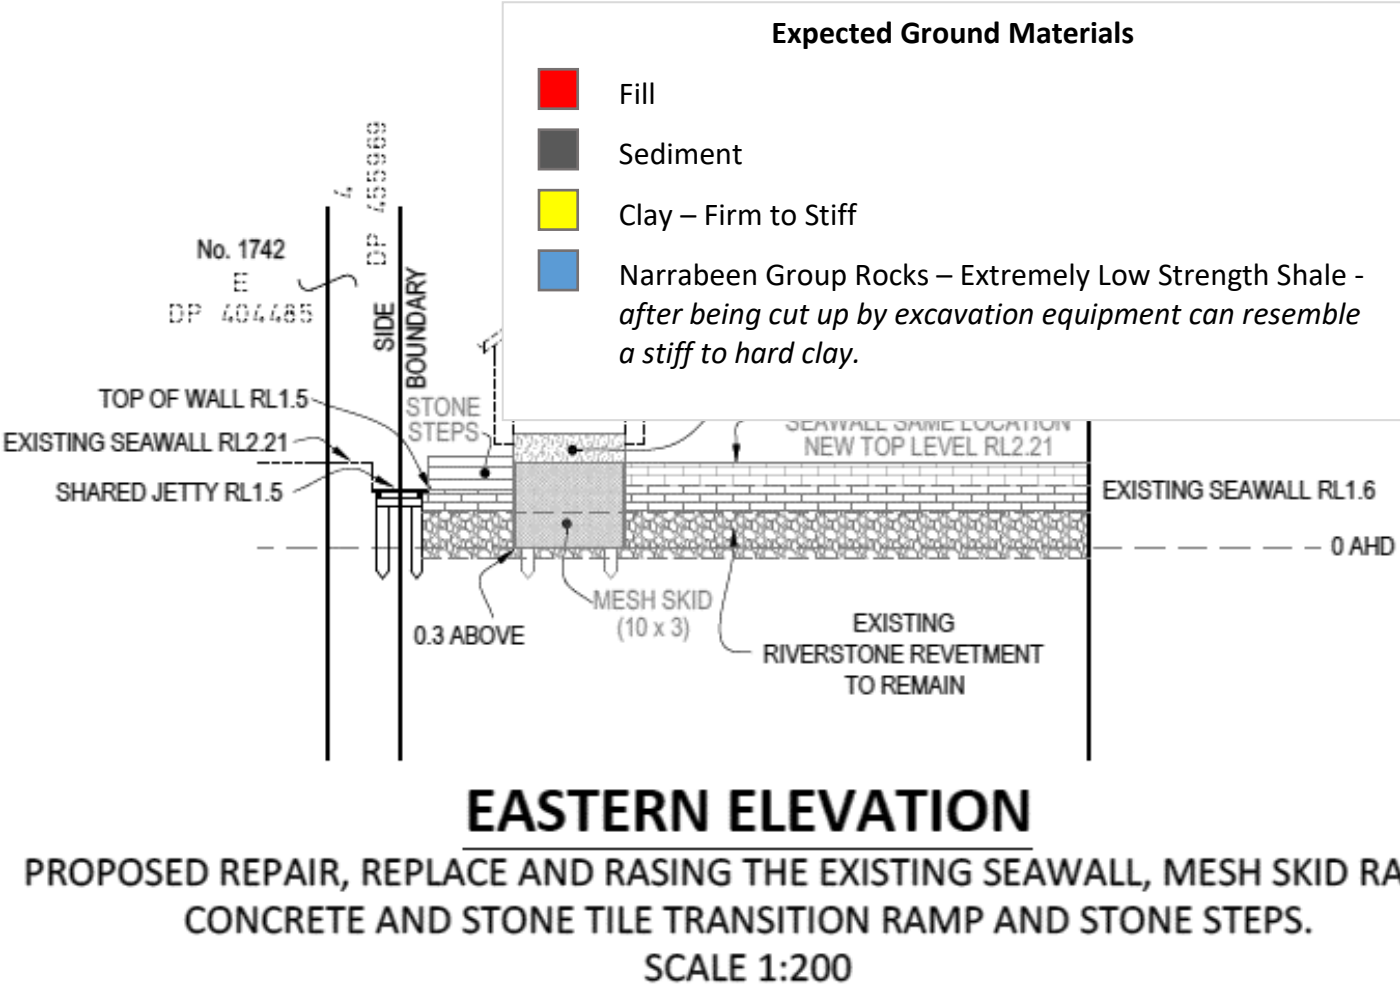
TYPE SECTION – Diagrammatical Interpretation of expected Ground Materials

The excavations carried out onsite during previous works show that the profile consists of shallow soil and Firm to Hard Clays that merge into the underlying Extremely Low to Very Low

Strength Shale at depths of between 0.9 to 1.8m below the current surface. Thin bands of Low to Medium Strength Sandstone are present through the shale.

As the bulk of the proposed works take place over Pittwater, it is likely sediment will be encountered at increasing depths overlying the Extremely Low to Medium Strength Rock underneath. The depth to Extremely Low to Medium Strength Rock ranged between ~2.0m at 20m from the shoreline to 2.5m at 40m from the shoreline. The underlying rock is likely to drop away at similar angles as it extends into Pittwater.
