Geotechnical Report
Lot 2, 1110 Barrenjoey Road, Palm Beach NSW 2108

Report Number: WittC-CplusC-R-A

October 2019

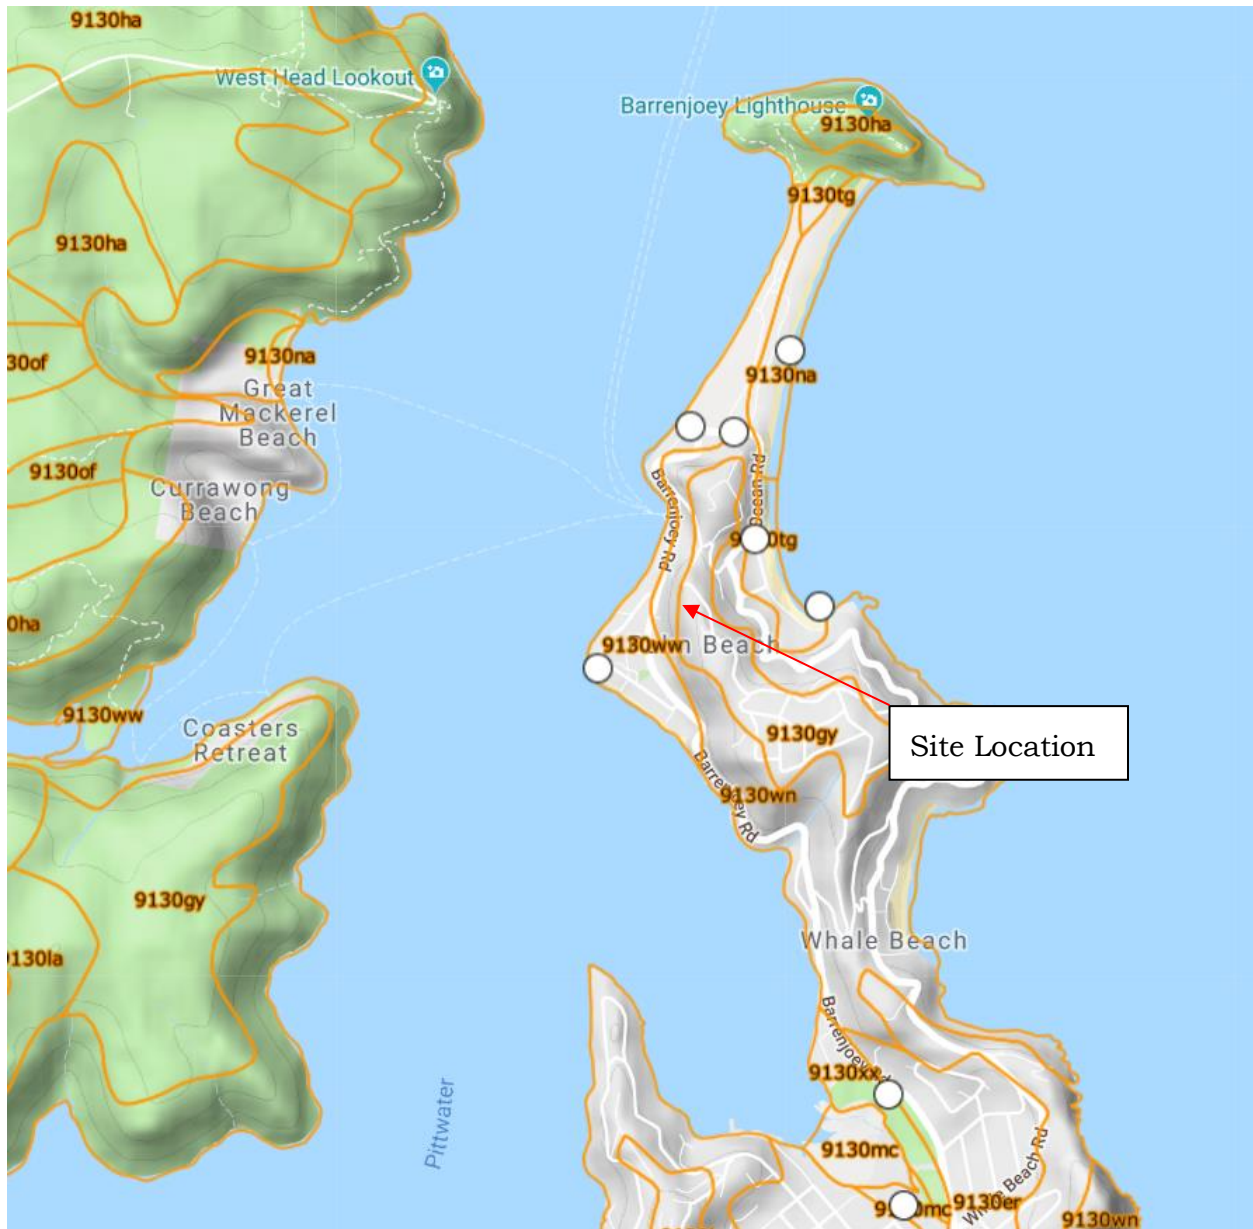
Appendix C. Soil Landscape

Excerpt of eSPADE web application with site location

An excerpt of the eSPADE web application showing the location of the site with the associated soil landscapes is presented in **Appendix C**.

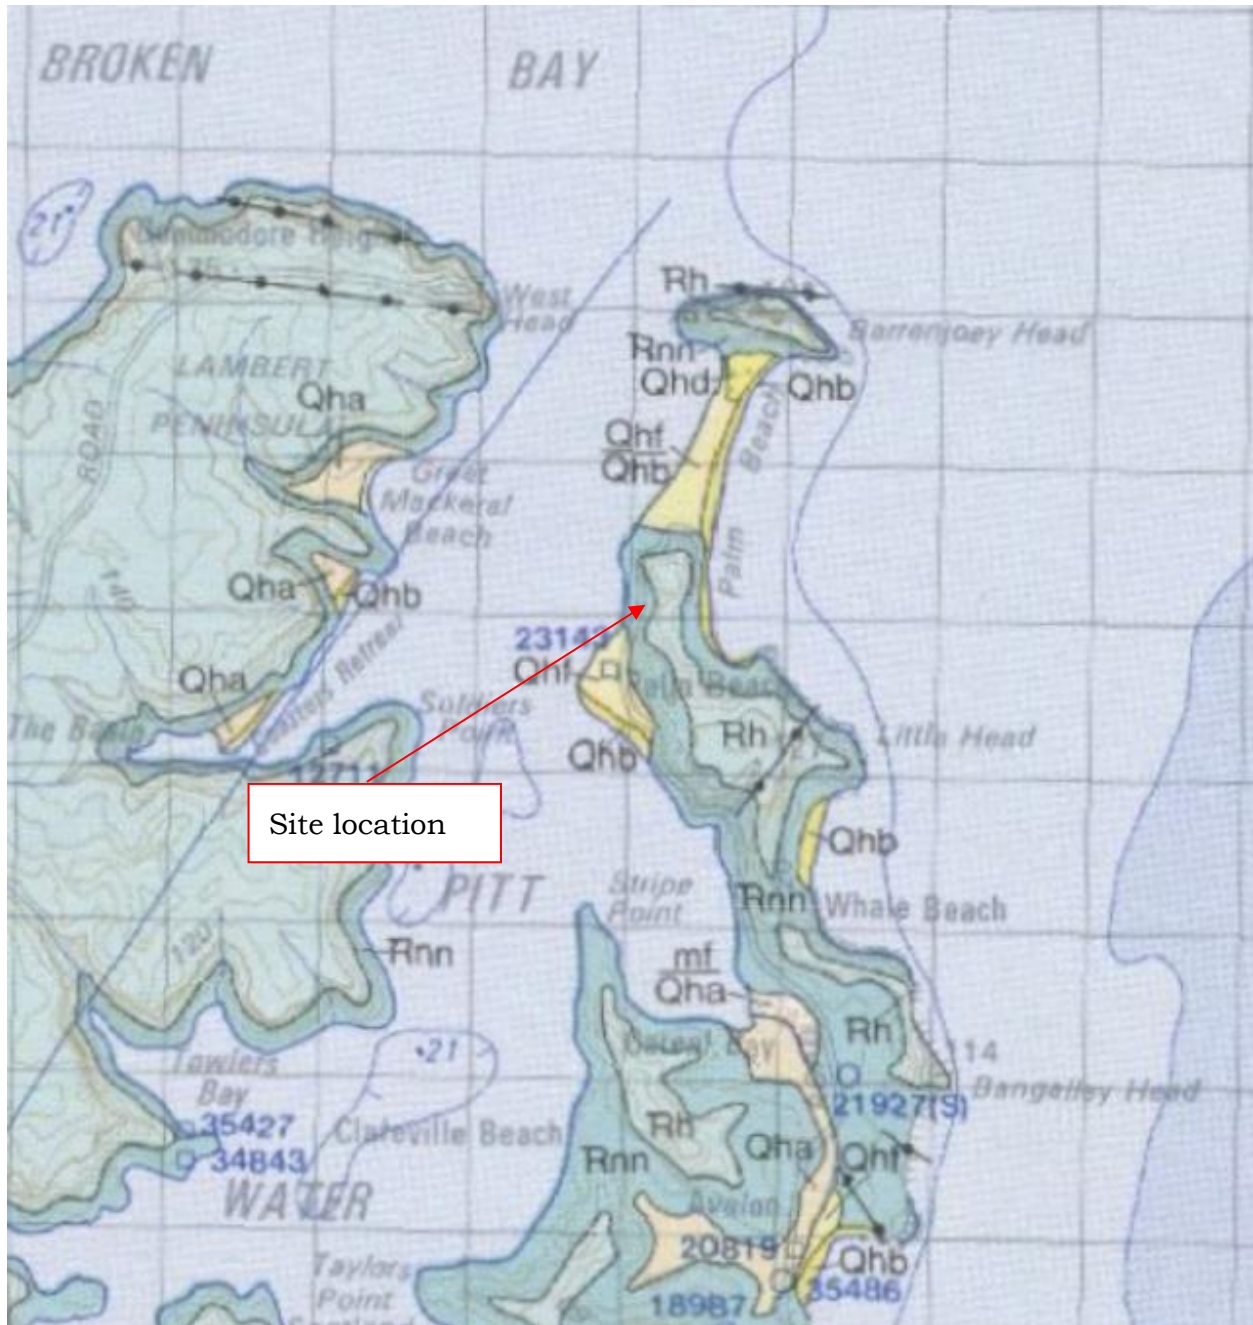
Appendix D. Geological Mapping Sheet

Excerpt from Sydney 1:100,000 Geological Series Sheet

The Sydney 1:100,000 Geological Series Sheet 9130 indicates that the site is underlain by Newport Formation and Garie Formation (Rnn) of the Narrabeen group.

The geological series sheets describe the lithology of Newport Formation and Garie Formation as ‘*interbedded laminite, shale and quartz, to lithic-quartz sandstone; clay pellet sandstone*’.
