Site Audit Report

Part A Unregulated Area, 4-10 Inman Road, Dee Why, NSW

Client: Roche Products Pty Ltd

AECOM Australia Pty Ltd

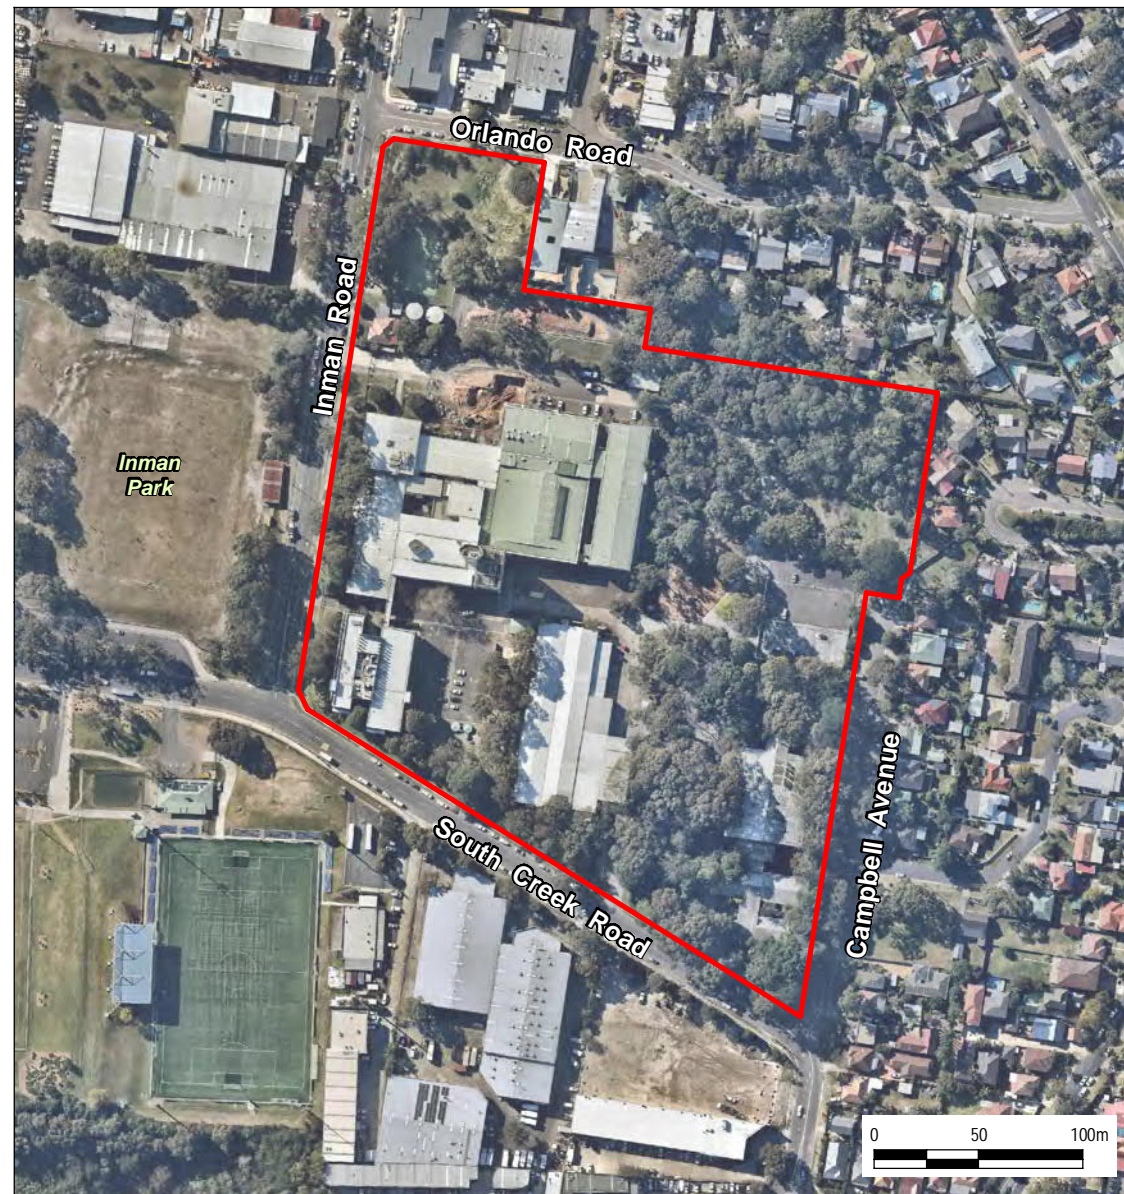
Figure 5 – Groundwater Exceedances

The Part A ESA (ERM, 2017a) provided a summary and discussion of the groundwater results which concluded that the heavy metal (i.e. zinc and copper) exceedances of the adopted ecological criteria were considered to be representative of elevated background conditions due to the relatively widespread and consistent nature of the concentrations. Additionally, groundwater was considered unlikely to infiltrate the on-site natural drainage line given the water table was measured at depths 1 to 3 m greater than the creek bed. Therefore, it was concluded that a significant risk to aquatic ecological receptors was unlikely to be present on the Part A Unregulated Area.

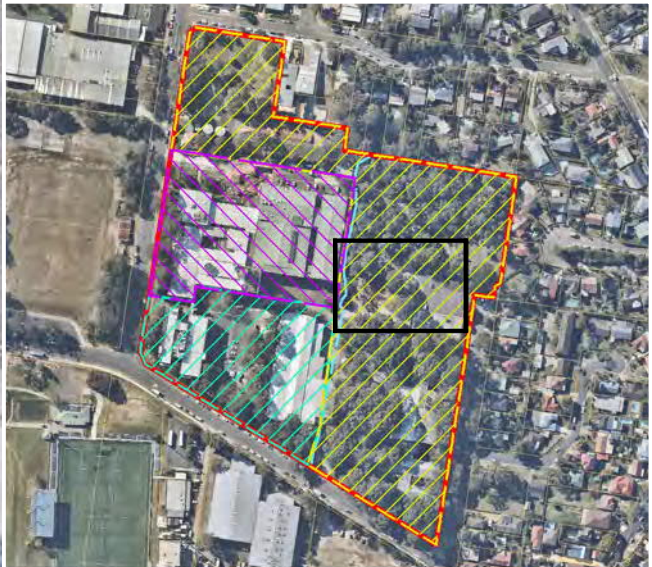
PRA_TRENCH_02	Depth	Asbestos	Asbestos Type
	0.3	Yes	Ch + Am

Analyte	Friable Asbestos (as Asbestos in Soil)
Units	%(w/w)
SL(1)	0.001
SL(1)	NEPM (2013) HSL A* & B Residential for Asbestos contamination in soil
0.5	Sample Depth (m)
0.001	Exceeds Screening Level (SL)
*	Residential A with garden/accessible soil also includes children's day care centres, preschools and primary schools.
