JAK NEWPORT PTY LTD

Geotechnical Investigation

54-58 Beaconsfield Street, Newport, NSW

E26083.G03
11 October 2023

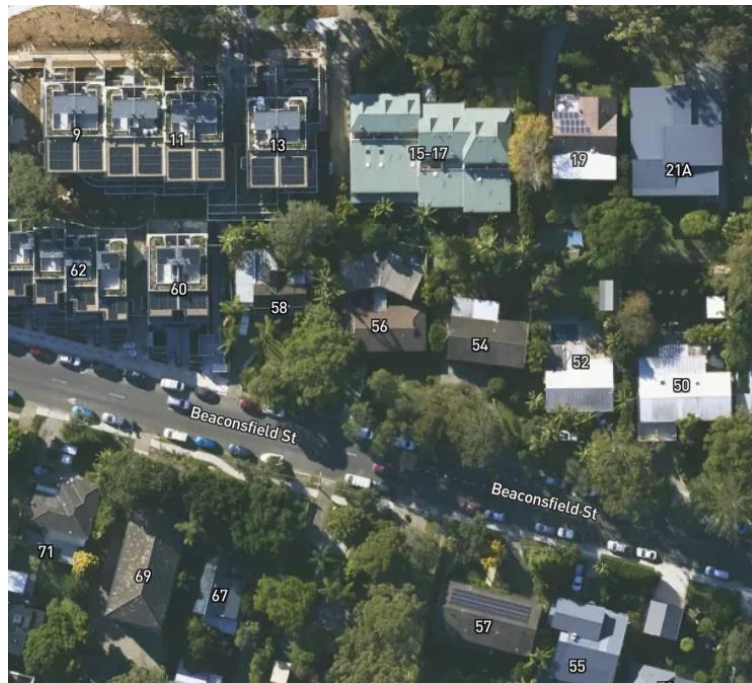
Plate 1: Aerial photograph of the site (source: Metromap, dated 6/5/23)

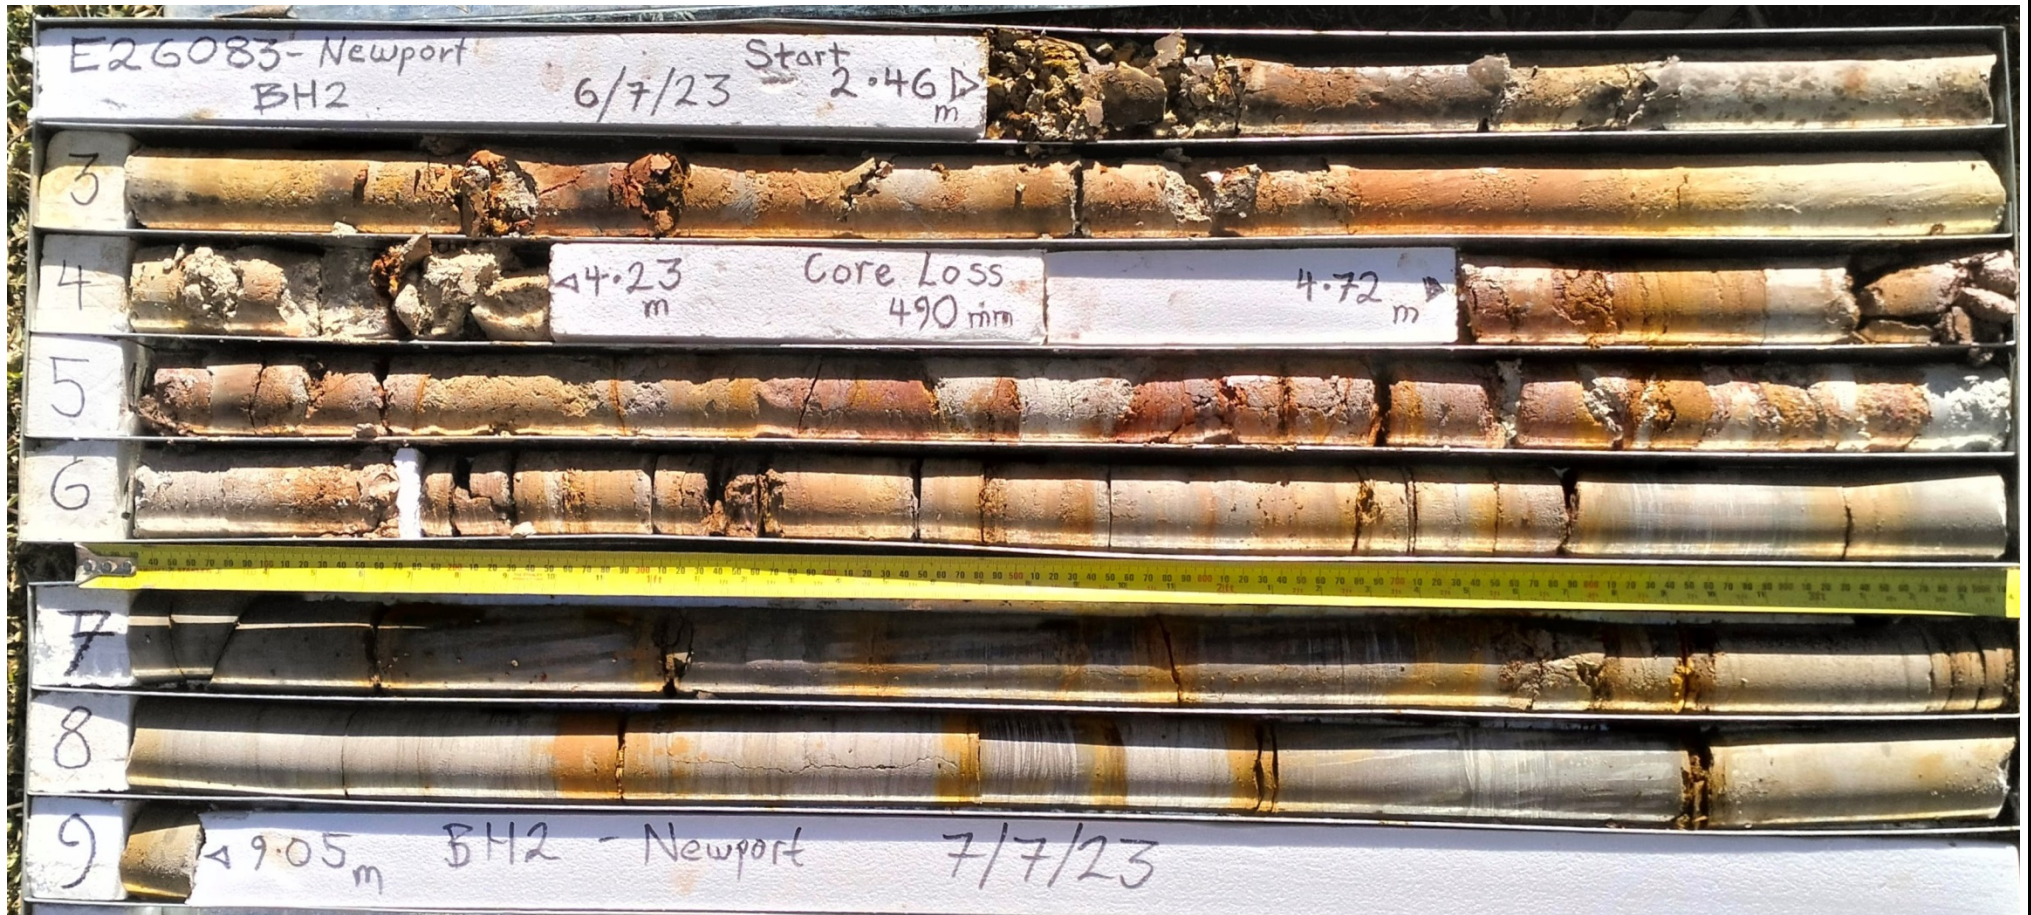
CORE PHOTOGRAPH OF BOREHOLE: BH2

Project	Proposed Residential Development	Depth Range	2.46m to 9.05m BEGL
Location	54-58 Beaconsfield Street, Newport NSW	Contractor	Geosense Drilling Pty Ltd
Position	See Figure 2	Drill Rig	Comacchio Geo 205
Job No.	E26083.G03	Logged	DD Date 7/7/2023
Client	JAK Newport Pty Ltd	Surface RL	≈ 19.3m AHD
		Inclination	-90°
		Box	1-2 of 2
		Checked	SK Date 10/10/2023
