Acid Sulphate Soil Management Plan

Proposed Stormwater Works
and Stage 1 Redevelopment
Warringah Mall
Brookvale

Prepared for
Westfield Design & Construction Pty Ltd

Project 71015.20
December 2013

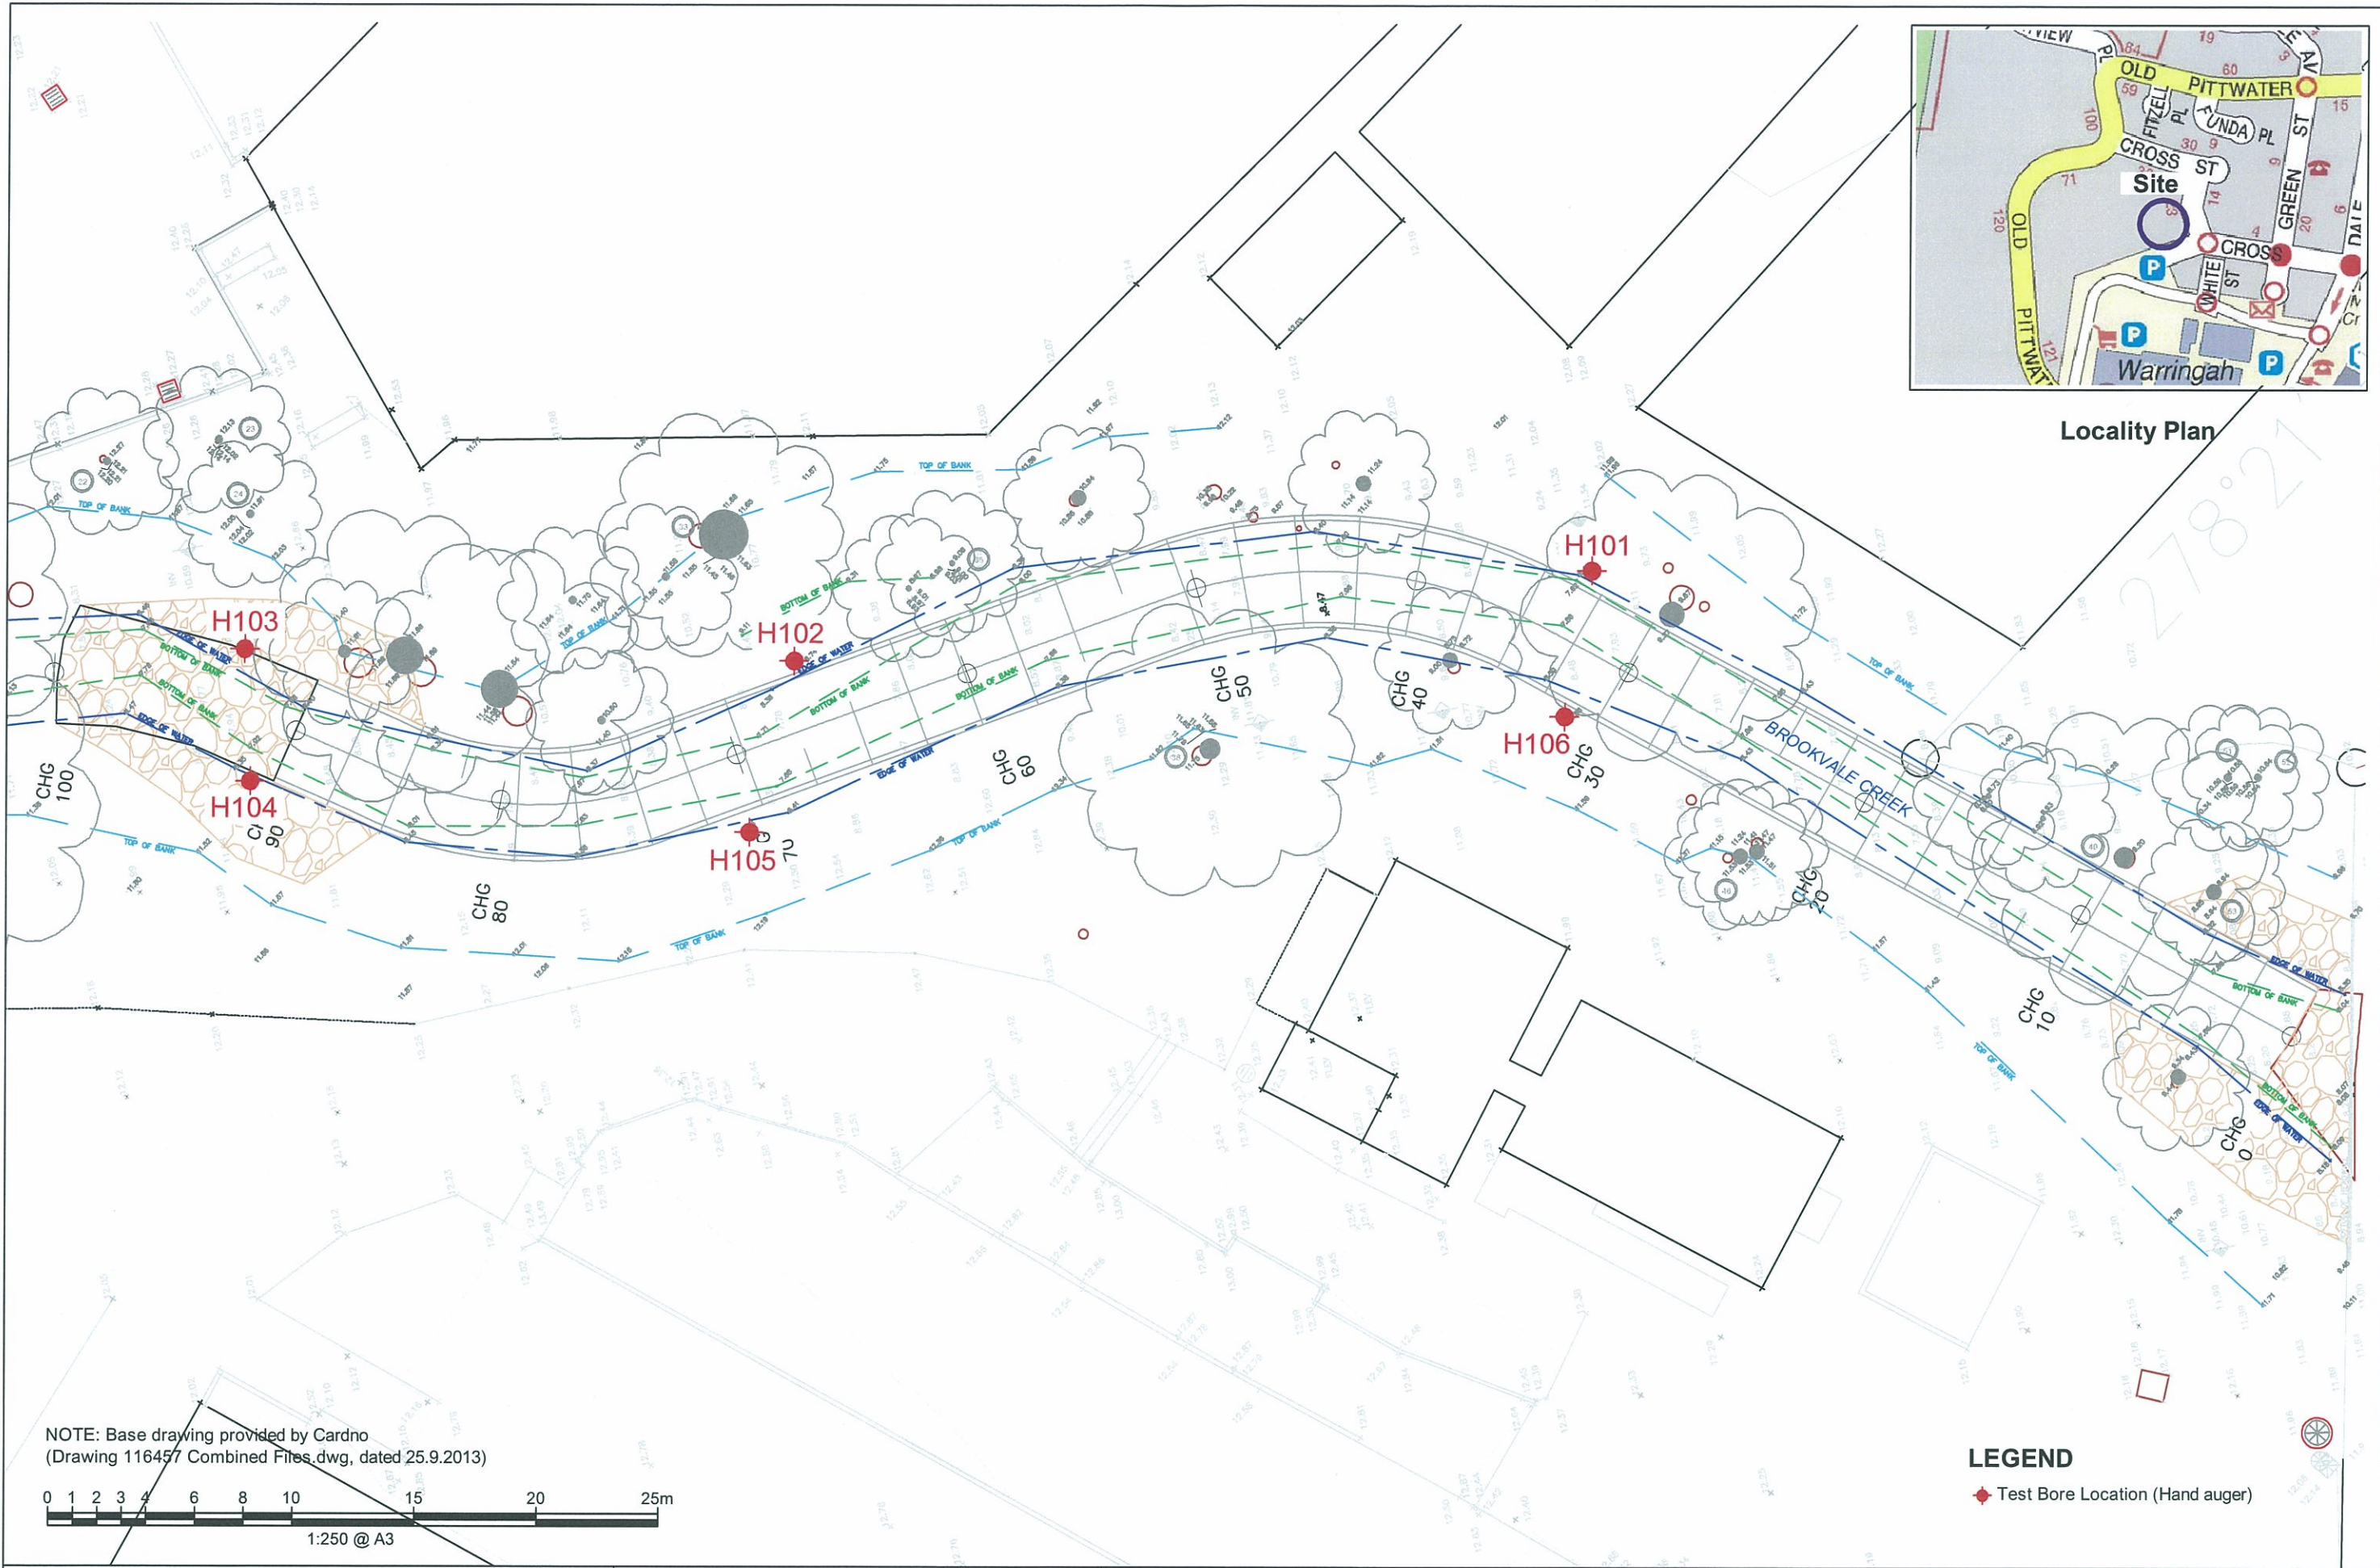
NOTE: Base drawing provided by Cardno
(Drawing 116457 Combined Files.dwg, dated 25.9.2013)

These proposed stormwater works areas are shown in Drawing 1 and Drawing 2, Appendix A. It is noted that an area of major building works for the Stage 1 redevelopment overlaps with the proposed new culvert alignment at the Palm Tree car park and adjacent roundabout.
