Address of site 121 Pacific Road, Palm Beach

Report Ref No: 34390YTrpt

**REPORT TO
KEDE CARBONI**

**ON
GEOTECHNICAL ASSESSMENT
(In Accordance with Pittwater Council Risk
Management Policy)**

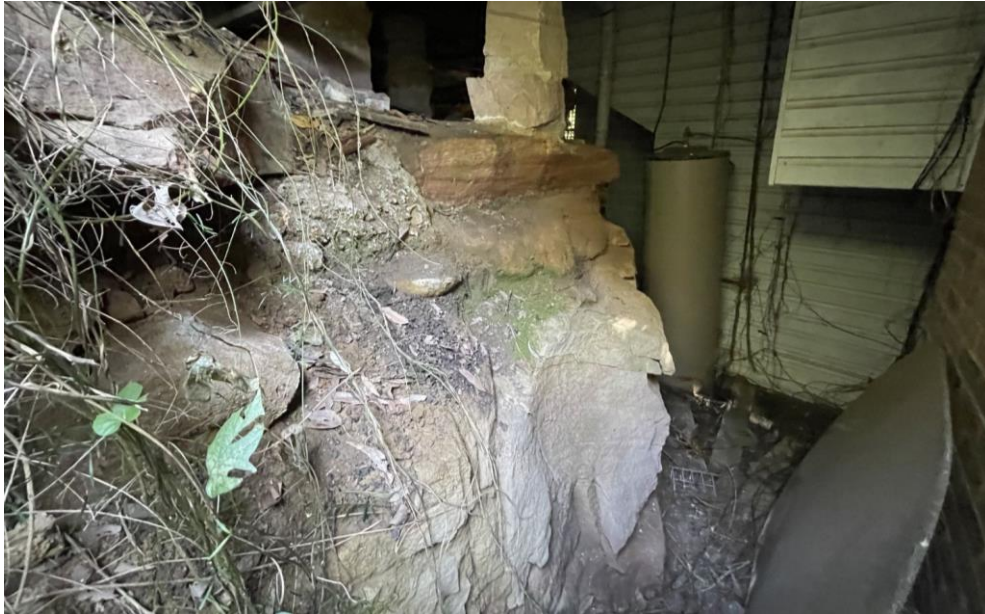
Underneath and around the western and southern sides of the existing house sandstone bedrock is exposed. Below the single storey western portion of the existing house, sandstone bedrock is exposed and the house in this area is supported on sandstone piers founded on the surface of the bedrock (see Plate 1 below). The surface of the bedrock dips down to the north-east below the house and, where the house is two-storeys it appears to have been cut to form the lower ground floor level at the rear of the house. Sandstone bedrock is also exposed on the southern side of the house and steps down a maximum of about 2.2m to the lower ground floor level. The sandstone was massive except for a 0.05m to 0.2m wide sub-horizontal bedding

parting with extremely weathered infill situated towards the crest of the cut. The surface of the sandstone adjacent to the southern wall of the house dips down to the east. The sandstone was generally assessed to be of at least medium strength. Between the southern boundary and the house, dense vegetation covers the ground surface although isolated exposures of sandstone bedrock can be observed stepping down to the north.

Plate 1. Exposed sandstone shelf below western end of existing residence

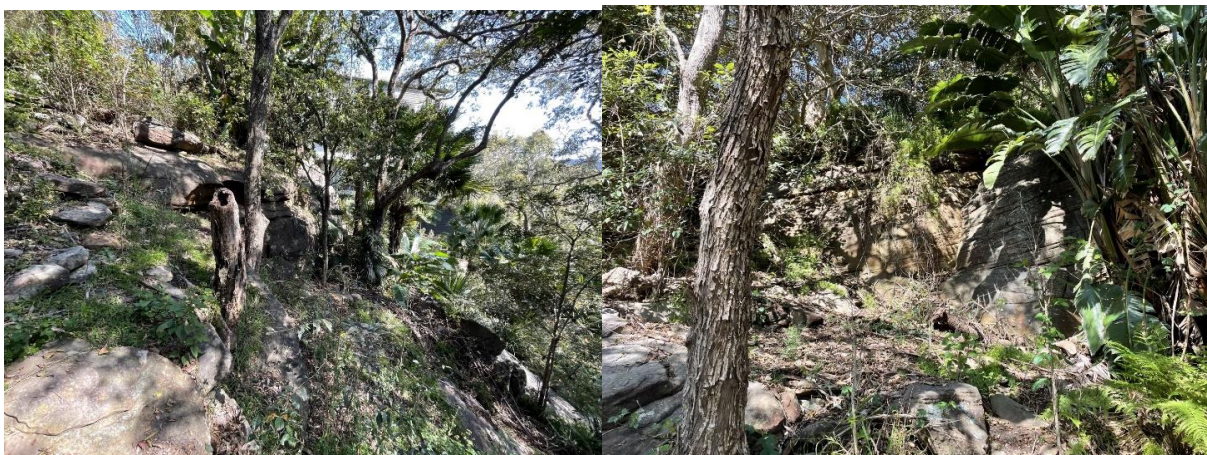
Roughly halfway across the site, a metal chain link fence provides a delineation between the developed western portion and the steeper, undeveloped eastern portion of the site. The northern half of this fence is situated at the crest of a sandstone boulder wall which increases in height from 1m to 2.1m towards the northern boundary. The wall appears to be founded on the surface of sandstone bedrock which is exposed at the toe on the northern boundary. An overgrown path extends roughly east-west from a gate at the centre of the fence to the boundary with the neighbouring property to the south-east, No. 117 Pacific Road. The path is predominantly situated above exposed sandstone bedrock which appears to dip down to the north-east at approximately 25° overall before stepping down through a sub-vertical cliff line.

Plate 2. Sandstone cliff line exposed in eastern half of site

The cliff line (partially shown in Plate 2 above) extends from the south-eastern corner of the residence at No. 123 on the northern boundary and then strikes roughly south-east and then east adjacent to the southern site boundary. The cliff line generally has maximum sub-vertical faces that range in height up to about 4m to 5m. Defects within the cliff line generally comprise sub-horizontal bedding partings and sub-vertical joints. Weathering along the bedding partings has resulted in undercut portions of sandstone particularly towards the crest of the cliff line. The sandstone was assessed as being generally at least medium strength. At the toe of the cliff line surface levels slope down at between 20° and 30° to the north and north-east with numerous large sandstone boulders (up to 20m² in surface area) observed. The boulders are generally 'platy' in shape and appear to be embedded within the soils.

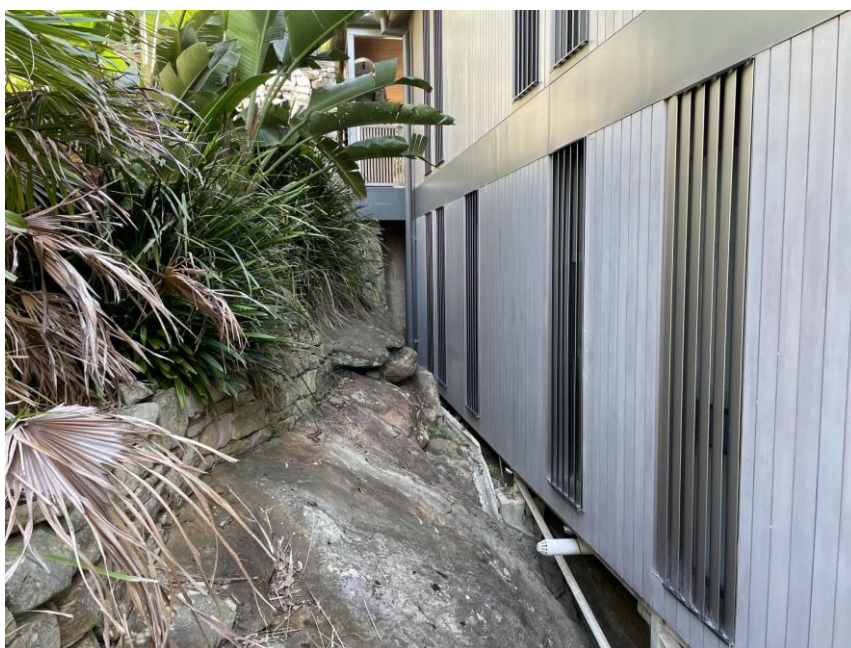
The driveway ends at No. 123 Pacific Road, which contains a one to three-storey residence located adjacent to the middle portion of the northern site boundary. This house is set back about 1.2m from the common boundary, is of steel frame construction and appears to be in good condition. The residence appears to be primarily founded on the exposed sandstone cliff line which slopes down to the north-east below the building footprint (see Plate 3 below). The land adjoining the eastern end of the northern boundary is heavily vegetated. Surface levels across the boundary follow the contours of the sandstone cliff line.

Plate 3. Southern side of residence at No. 123 Pacific Road north of site looking west
