# ACID SULPHATE SOIL (ASS) INVESTIGATION AND MANAGEMENT PLAN REPORT

Client – Jonathan Odisho
Project Title – 1 & 3 Careel Head Road, Avalon Beach
Project Type – Mixed-Use Development
Project No. – ER24020Arev01
Date Issued – 30/07/2024
Description of Services – Acid Sulphate Soil (ASS) Investigation and Management Plan Report

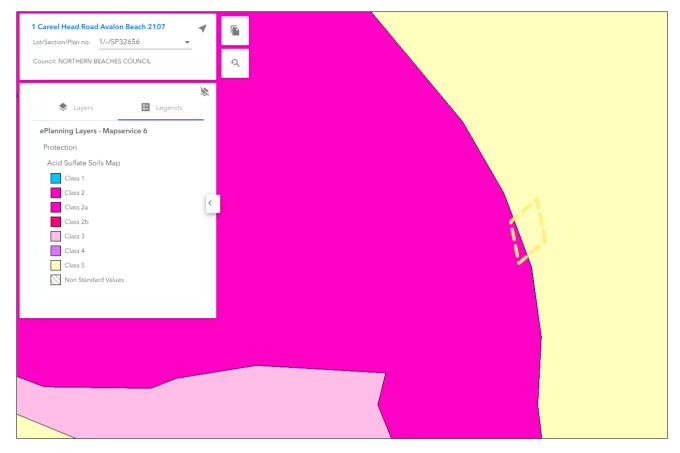
Figure 1: NSW Planning portal, Site is subject to ASS Class 2 and 5

Reference made to the NSW Planning Portal indicates the site is situated within an area of general ASS occurrences, identified as a Class 2 and 5 region, as shown in **Figure 1 in Appendix A**.

As mentioned above, the Acid Sulphate soil map included in the Site Contamination Assessment indicates that the development area is within Class 2 and 5 Land, **Figure 1 in Appendix A**. Therefore, it is considered that there is a likely risk of ASS being present within the proposed development area.

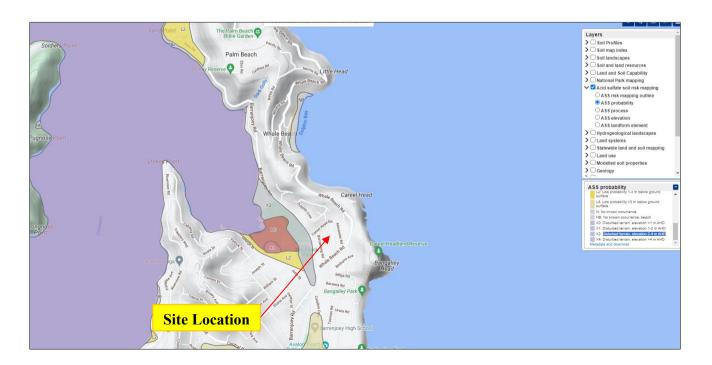
Figure 2: ASS potential for the Site Location

The pointed location in **Figure 2 in Appendix A** shows the construction location is likely to be found below the natural soil, and the western end of the site is located within X2 (Disturbed terrain, elevation 2-4 m AHD).

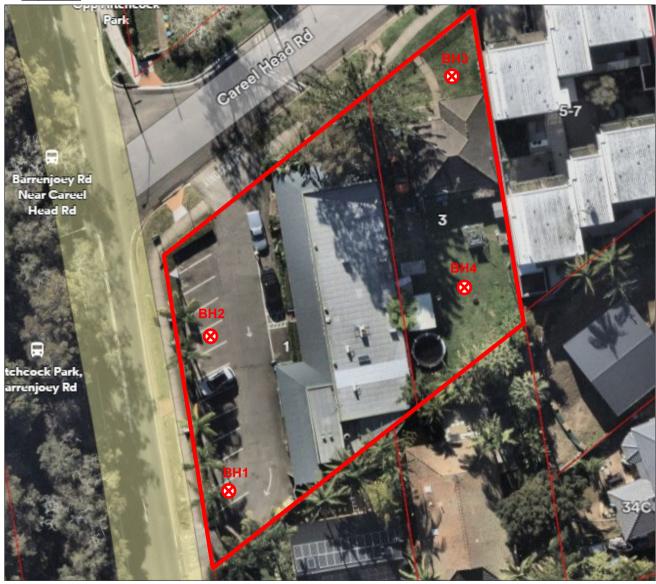
Figure 3: Site Plan

A preliminary soil sampling programme was undertaken following the Acid Sulphate Soil Guidelines. Four (4) boreholes (BH1, BH2, BH3 and BH4) were drilled utilising a truck mount solid flight auger drill rig in the area of the proposed development (**Figure 3, Appendix A** – for the borehole locations).
