## Arboricultural Impact Assessment

Prepared For: School Infrastructure NSW

Narrabeen Education Precinct

20th July 2022

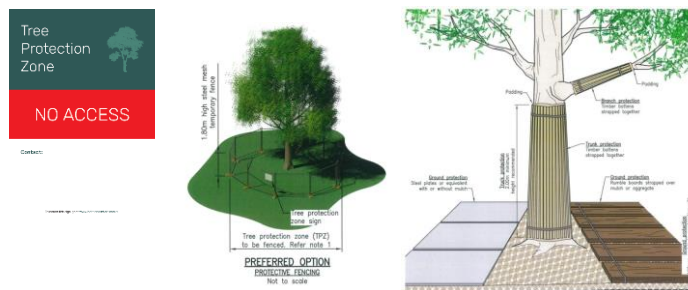
Tree Protection Fencing to be utilised. Where works will be undertaken close to and within Tree Protection Zones specific tree protection measures to be utilised as directed by the project Arborist.

An exclusion zone is to be established along the perimeters of retained trees and cordoned off with a physical barrier of wire mesh fence, 1.8m in height, which is securely anchored (as noted on the Tree Protection Plan). The role of these fences is to prevent any damage to the complete tree including root system (SRZ & TPZ), stem and branch structure as well as the crown or canopy. Alternatively, and on approval of a minimum AQF5 Project Arborist, plastic mesh fencing, 1.2m in height, secured with star pickets and caps with straining wire can be utilised. All TPZ fencing will require appropriate signage to signify the relevant protection zones. This will require audit and sign off prior to operational works onsite.

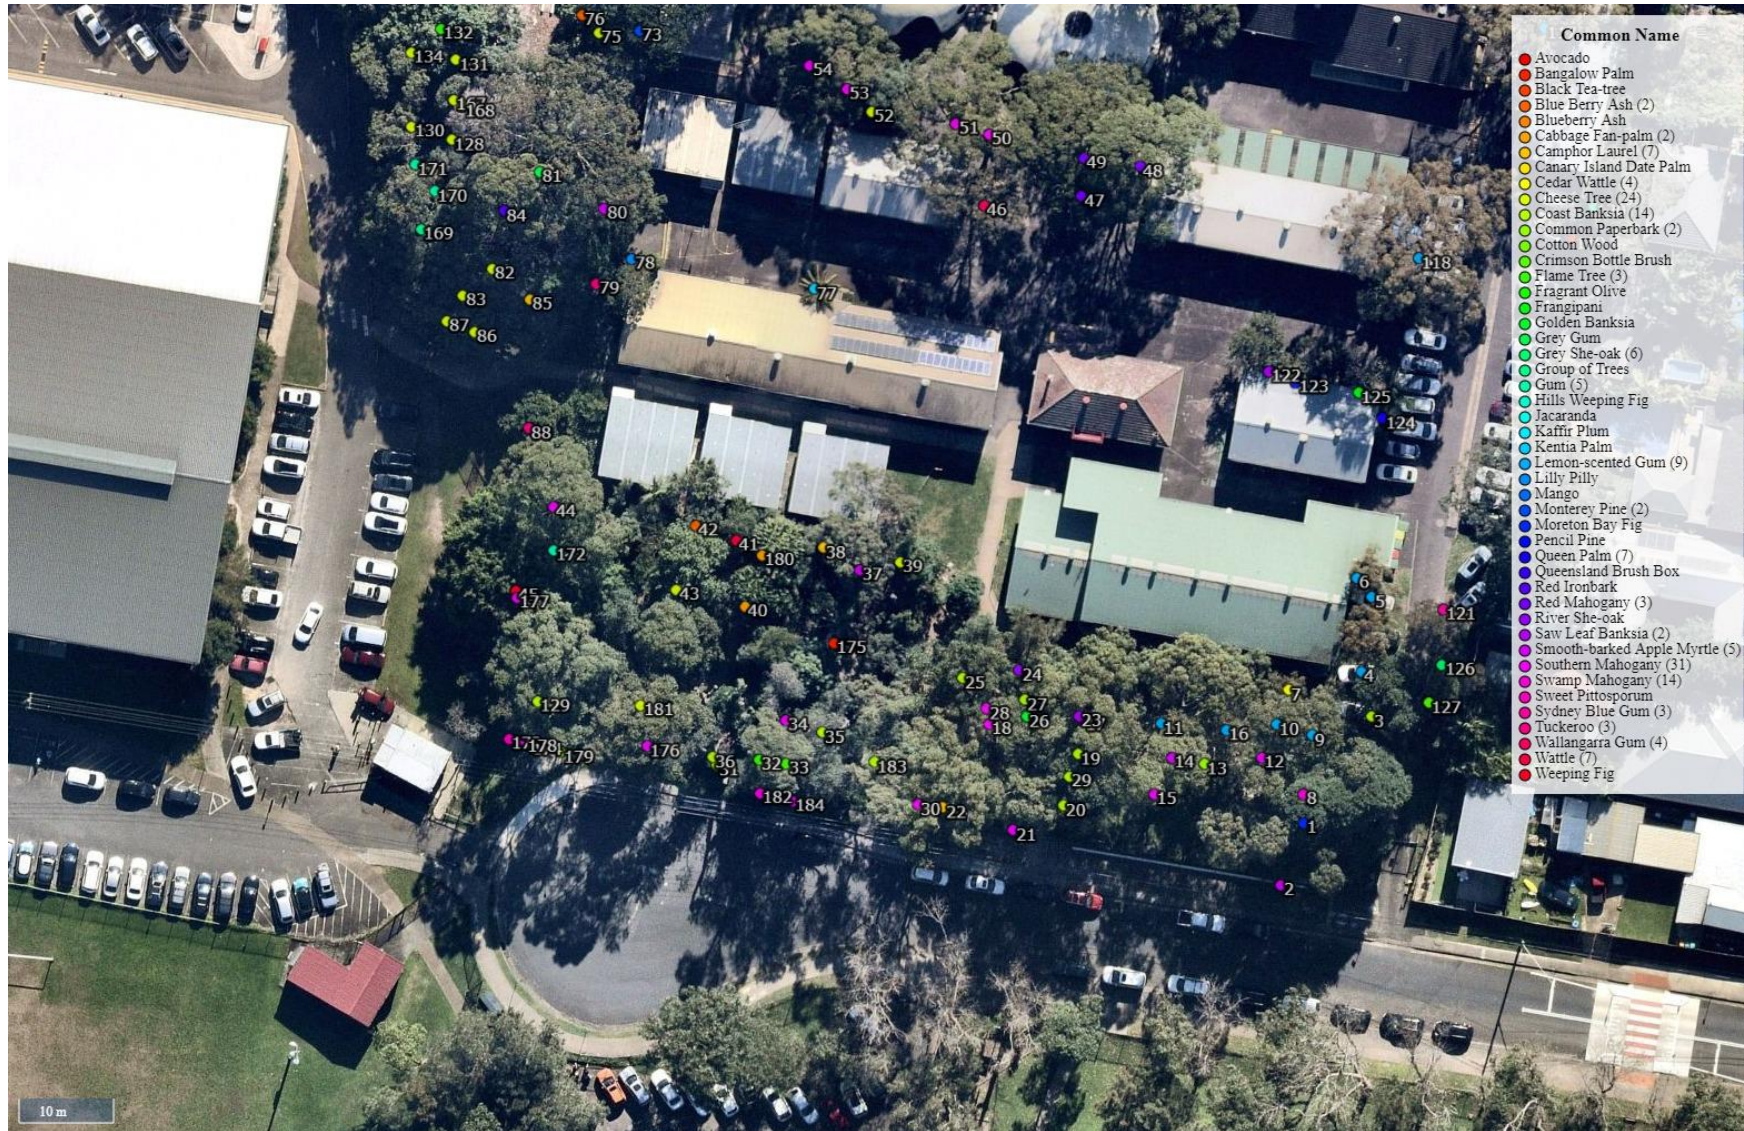
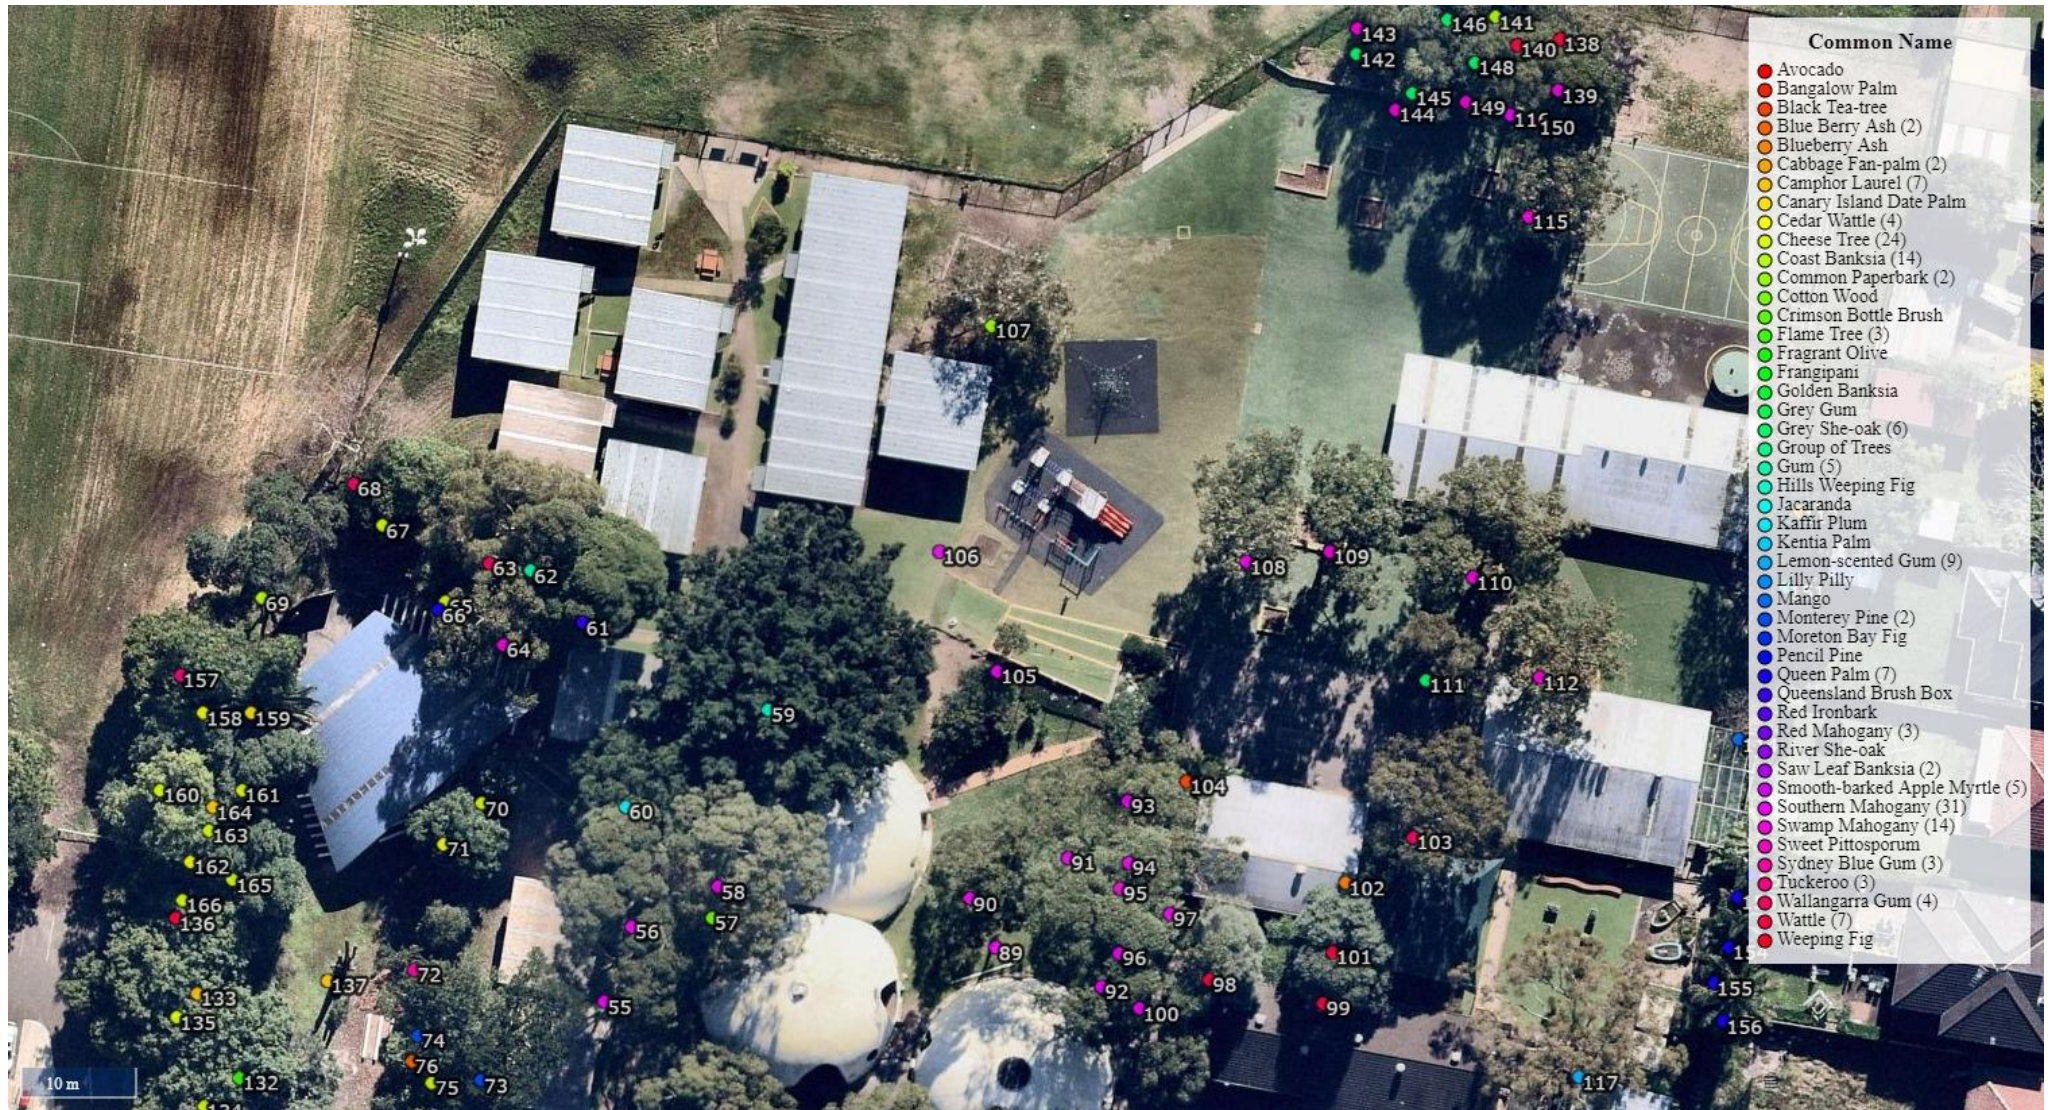
## Tree Locations W/O TPZ

Please Note: Tree Locations are approximate only. Green circles represent TPZ as defined in AS4970 -2009 Protection of trees on development sites
