GEOTECHNICAL ASSESSMENT FOR ALTERATIONS AND ADDITIONS

138 PRINCE ALFRED PARADE, NEWPORT

Project No.: 2025-016

February 2025

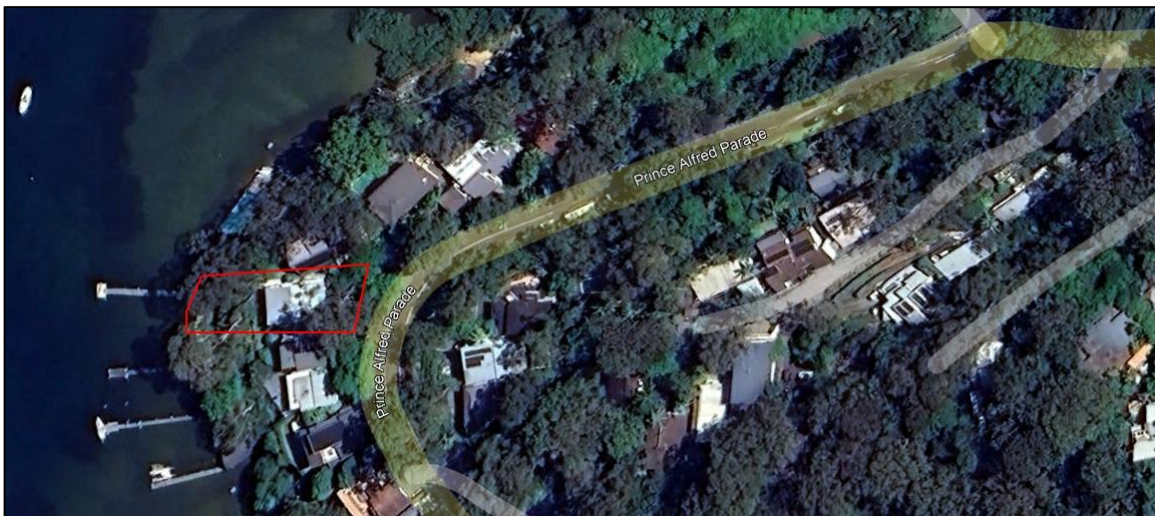
Photograph 1: Aerial photo of site (outlined red) and surrounds

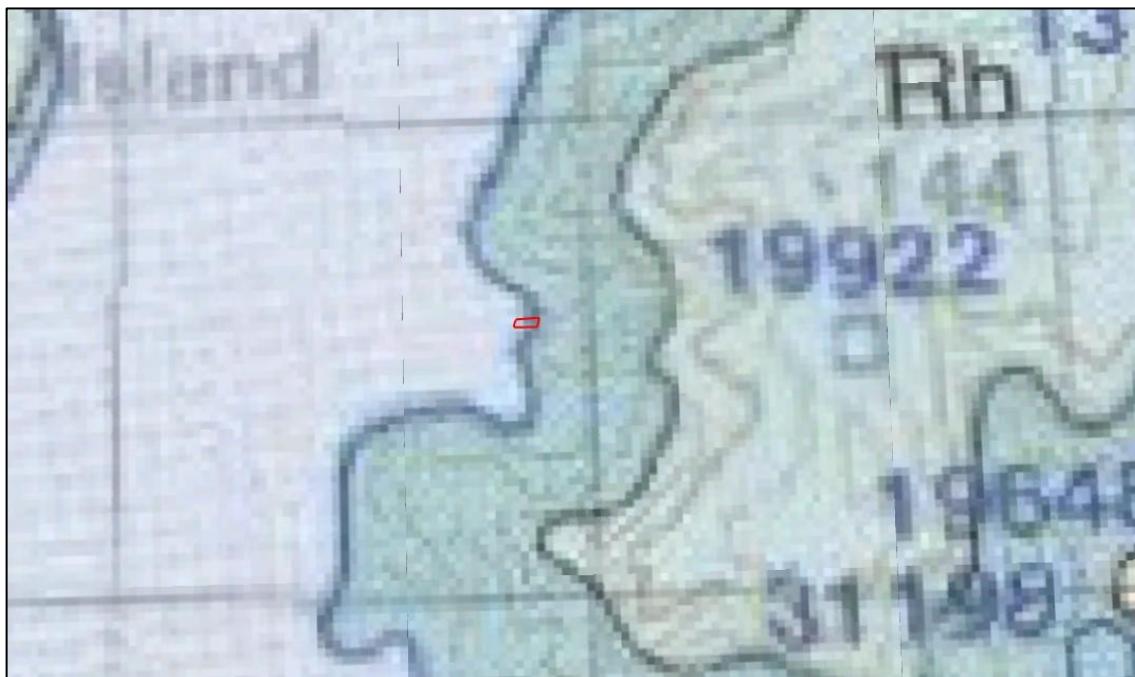
Reference to the Sydney 1:100,000 Geological Series sheet (9130) indicates that the site is underlain by Newport Formation (Upper Narrabeen Group) rock (Rnn) which is of middle Triassic Age. The Newport Formation typically comprises interbedded laminite, shale and quartz to lithic quartz sandstones and pink clay pellet sandstones. The rock unit was identified and mapped on the present and adjacent sites.

Narrabeen Group rocks are dominated by shales and thin siltstone beds and often form rounded convex ridge tops with moderate angle ($<20^\circ$) side slopes. These side slopes can be either concave or convex depending on geology, internally they comprise interbedded shale and siltstone beds with close spaced bedding partings that have either close spaced vertical joints or in extreme cases large space convex joints. The shale often forms deeply weathered silty clay soil profiles (medium to high plasticity) with thin silty colluvial cover containing cobble to boulder size fragments of sandstone from the overlying unit. An extract of the relevant geological map is provided as Extract 1.

Extract 1: Geological map extract and the site (outlined red)

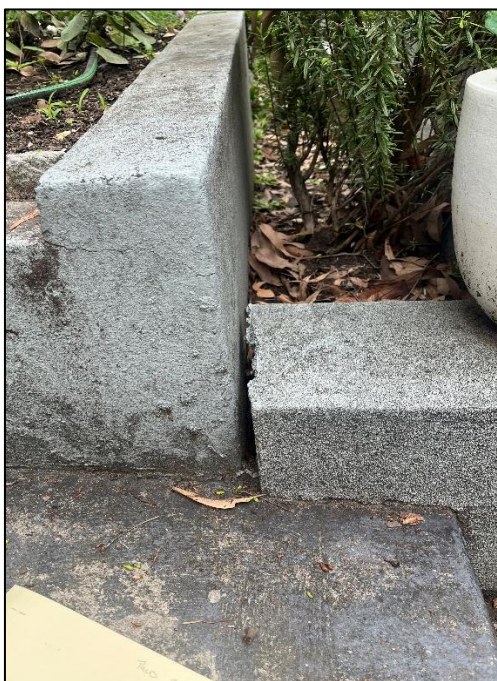
The existing house comprises a rendered brick residence which appeared in good condition with no cracking or signs of movement observed. Some rotation was observed within a planter bed adjacent to the garage however it is considered to be a result of construction technique rather than a stability issue. (See Photograph 2).

Photograph 2: Rotation of low retaining wall adjacent to site garage.

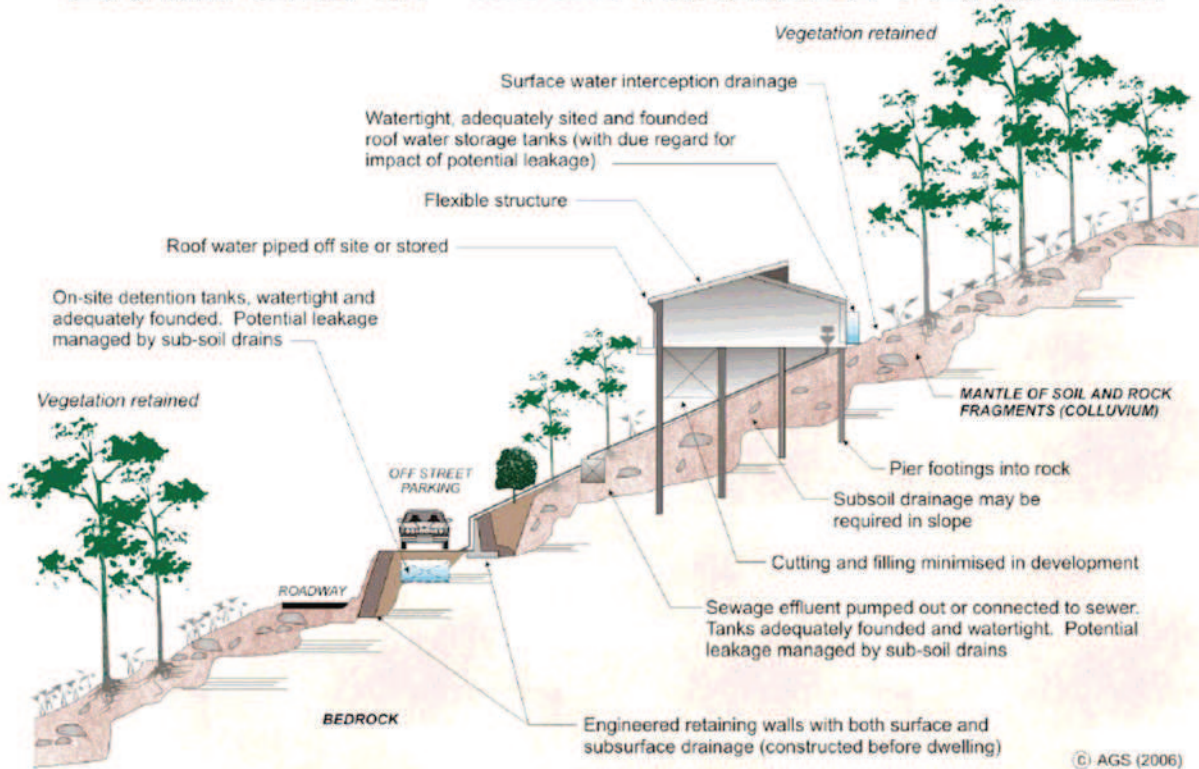
EXAMPLES OF **GOOD** HILLSIDE PRACTICE
