# FORESTWAY SHOPPING CENTRE WARRINGAH ROAD & FOREST WAY, FRENCHS FOREST

## ARBORICULTURAL IMPACT ASSESSMENT

**ARE Chemin De La Foret Pty Ltd**

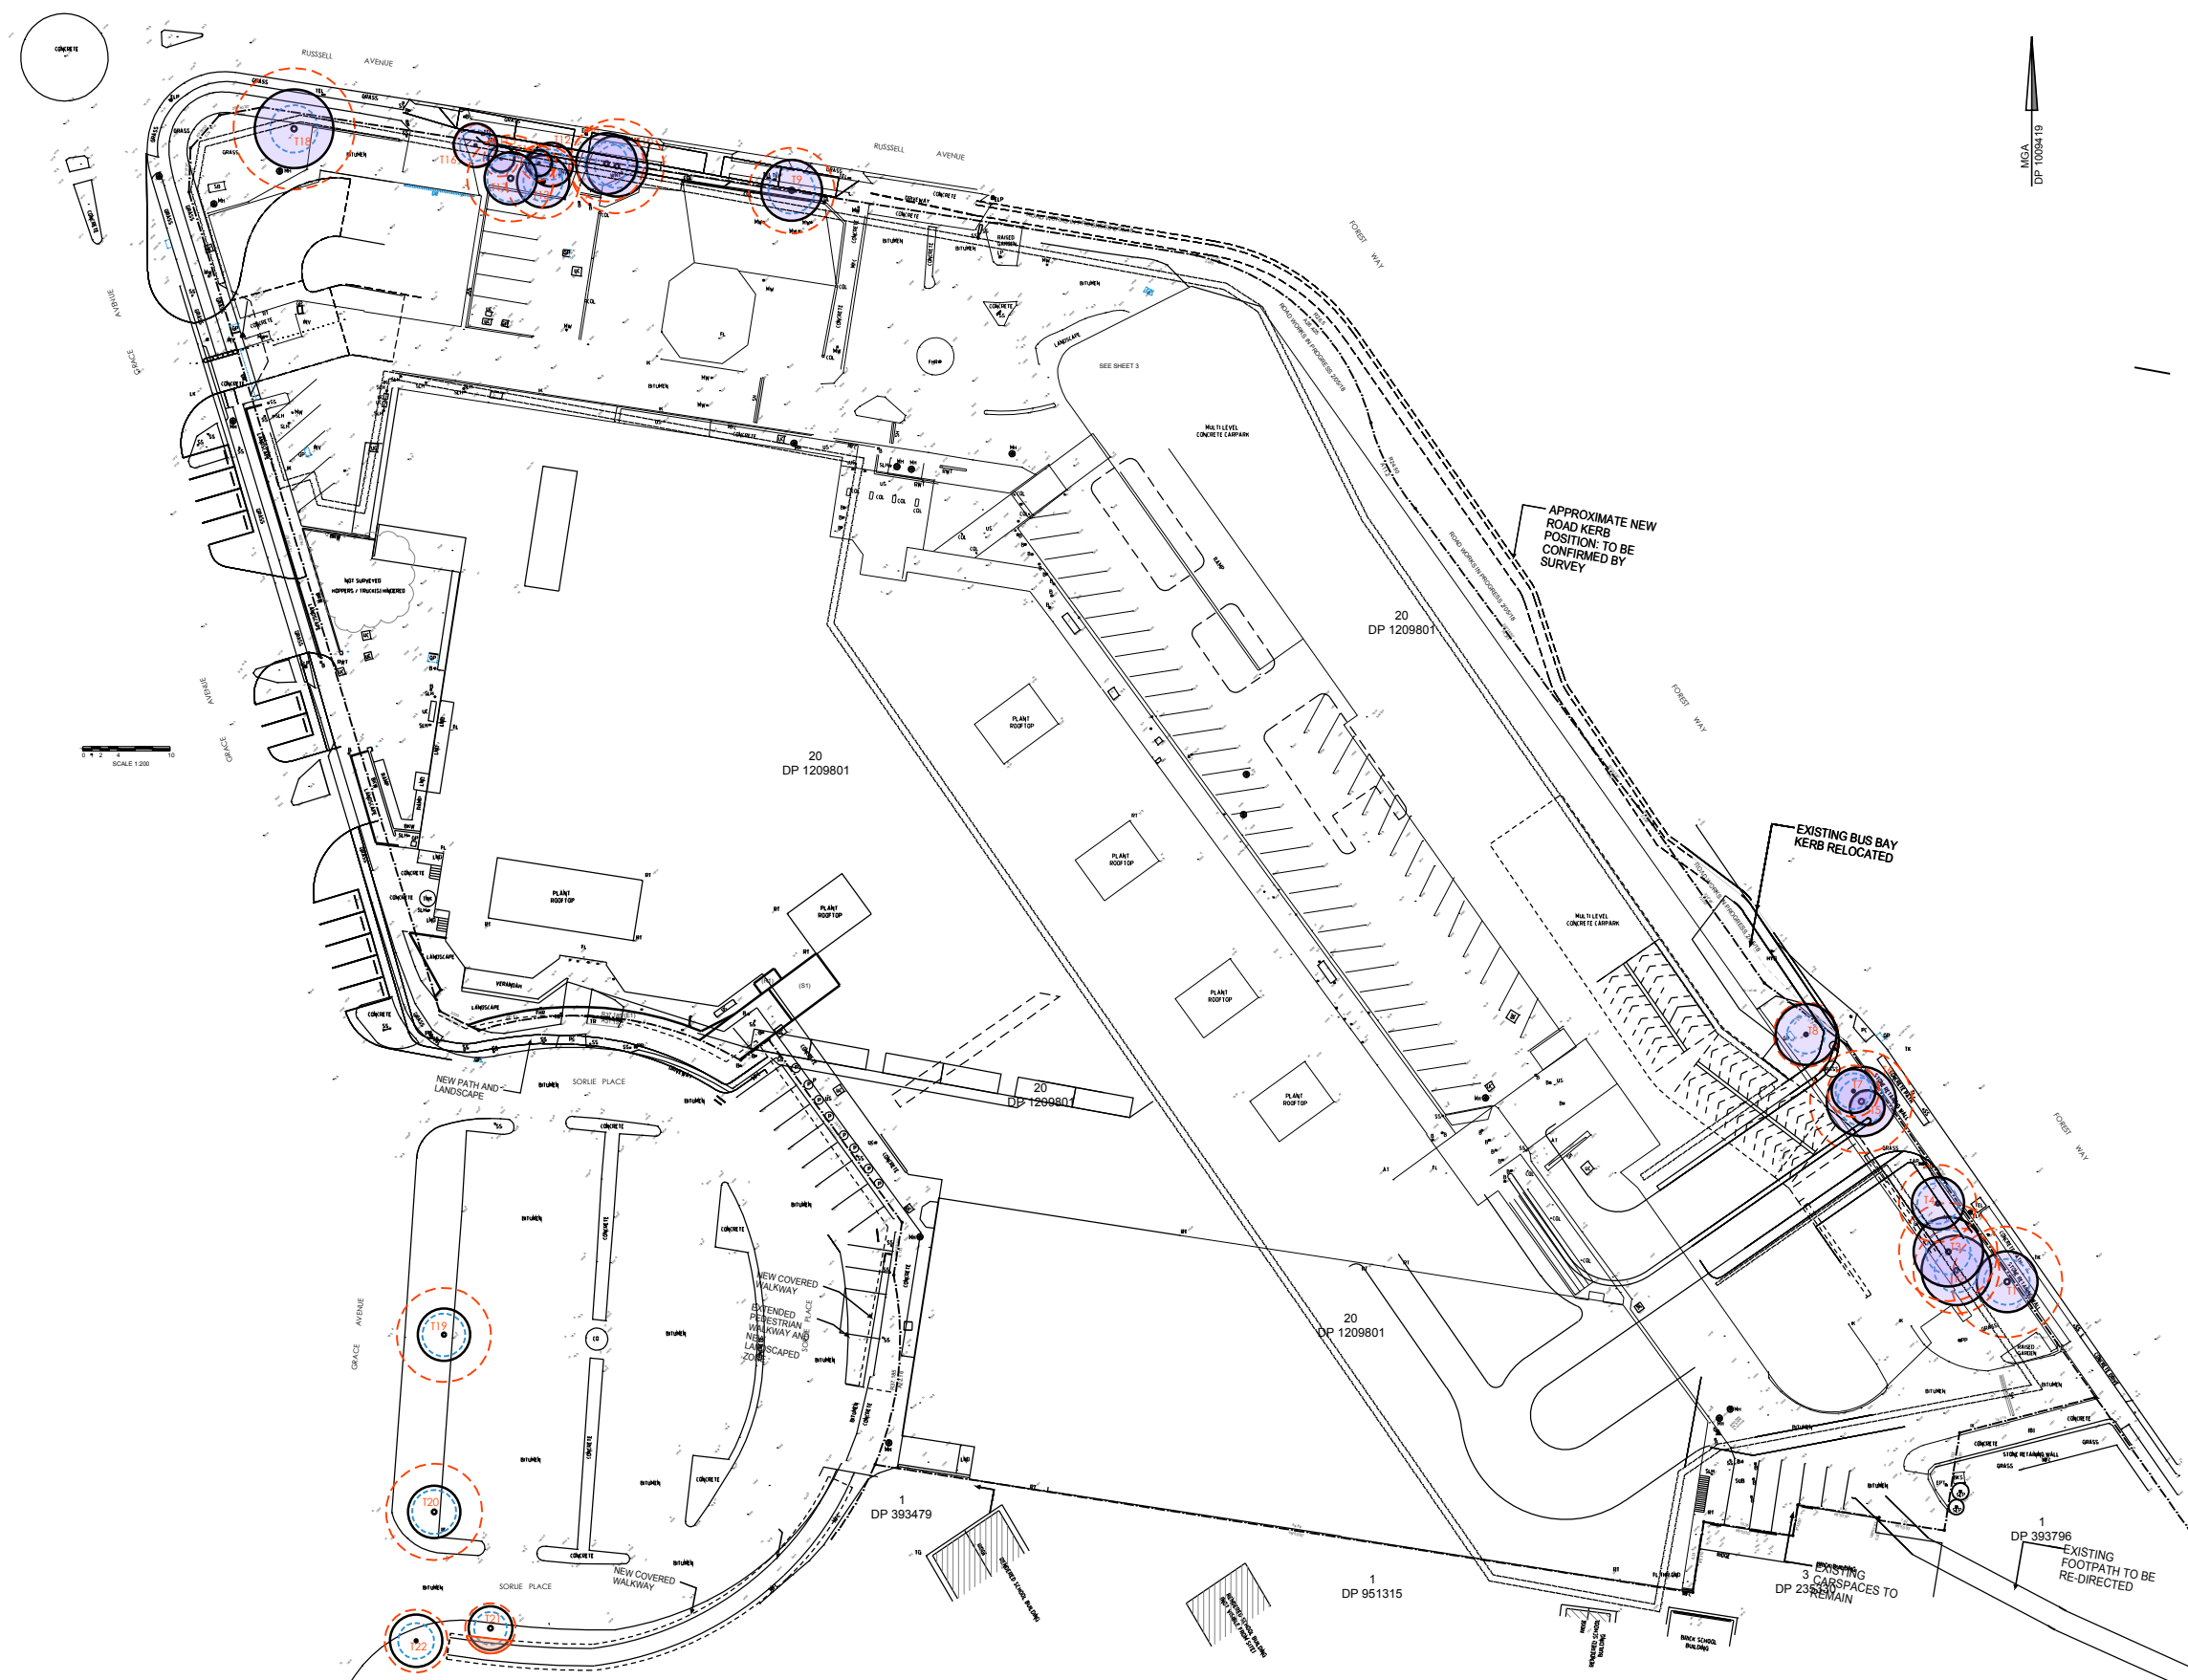
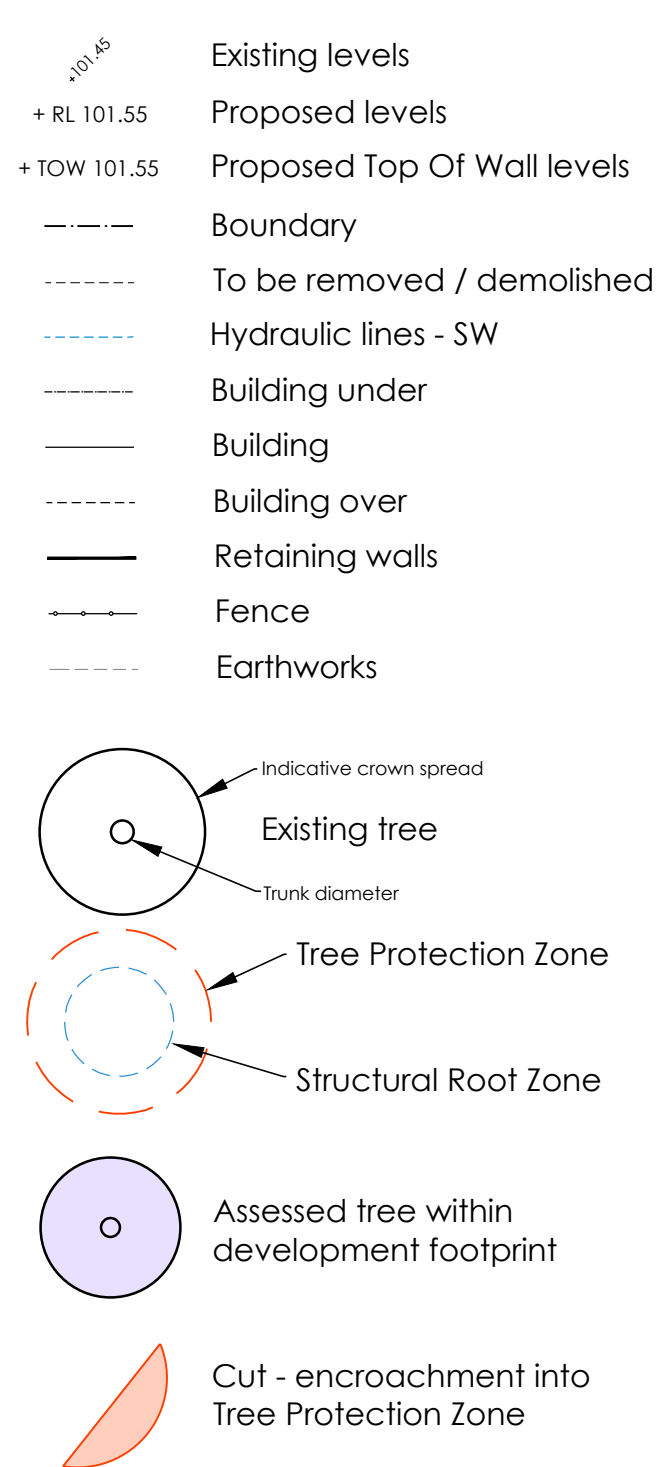
## 9. Tree Location Plan

Generally the site's vegetation was observed to have a majority native tree canopy, with an exotic shrub midstorey and paved ground. The existing surveyed trees are shown at **9. Tree Location Plan** (page 20).

The physical data for tree locations, crown width and DRB is schematically described in **9. Tree Location Plan** (page 20).
