**GEOTECHNICAL RISK MANAGEMENT POLICY FOR PITTWATER  
FORM NO. 1 – To be submitted with Development Application**

Development Application for <u>Reform Projects Pty Ltd</u>	Name of Applicant
Address of site <u>14 Ocean Road, Palm Beach, NSW</u>

REPORT TO  
**REFORM PROJECTS PTY LTD**

**Figure 3: Plan of Notable Geotechnical Features and Geotechnical Hazards**

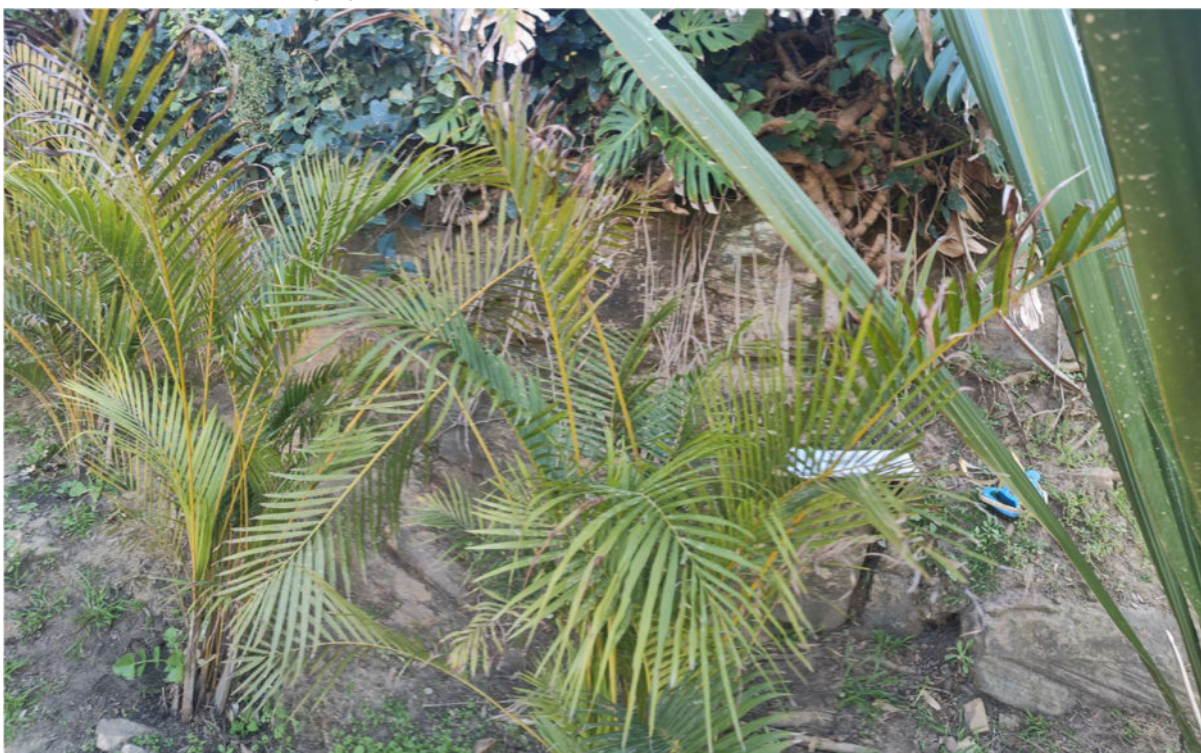
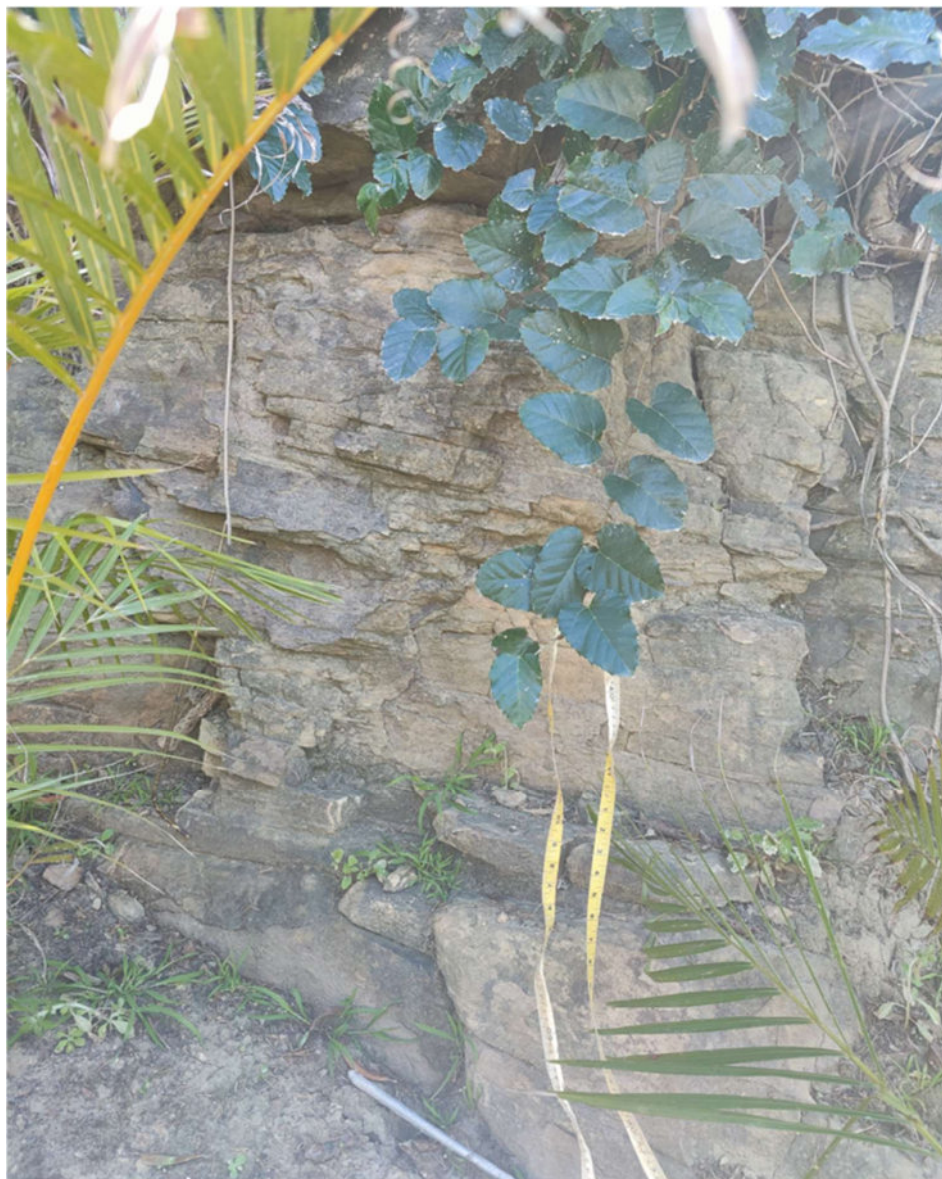
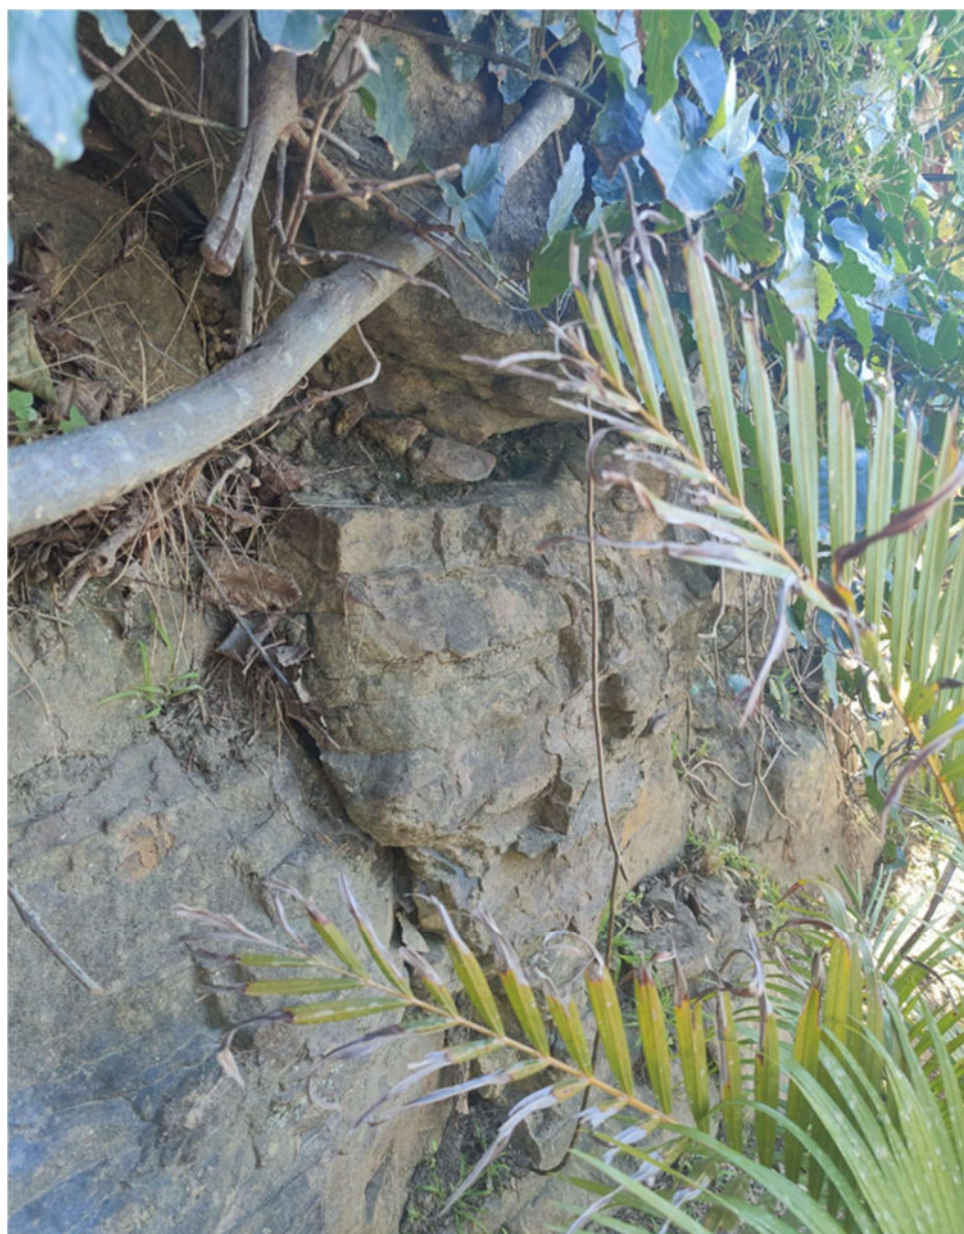
**Plate 1 - Hazard A (3 Photographs)**

From the rear of the property the site steps/slopes down towards the south-east and the existing house through a series of vertical sandstone bedrock rock ledges/cliff-line (Hazard A) and steep slopes, varying up to about 45° (Hazard C). The slopes comprise soil and extremely to highly weathered rock of soil strength to medium strength. A cliff-line on the southern side is estimated to have a maximum height of 3.5m to 4m high. The upper portion of the cliff-line and area upslope is densely vegetated and inaccessible. The cliff-line was assessed to be highly weathered and of low to medium strength. Some blocks of rock were isolated by joints/bedding partings in the cliff-line (Hazard A), and is discussed in more detail in Section 3.1. Some low

Weathered sandstone bedrock was outcropping on the hillside, including a 2m to 4m high sandstone cliff-line, assessed to be highly weathered and of low to medium strength. Within the cliff-line three adverse joints, dipping down at about 60° and 80°, were observed. The joints intersect bedding partings and have isolated blocks of rock within the cliff-line.

Hazard A (cliff-line instability) can be addressed by clearing and exposing the face so that it can be clearly viewed and then remediated by either removing or supporting any loose or unstable zones. Where zones require support, this may be achieved by the installation of rockbolts, mesh and shotcrete.

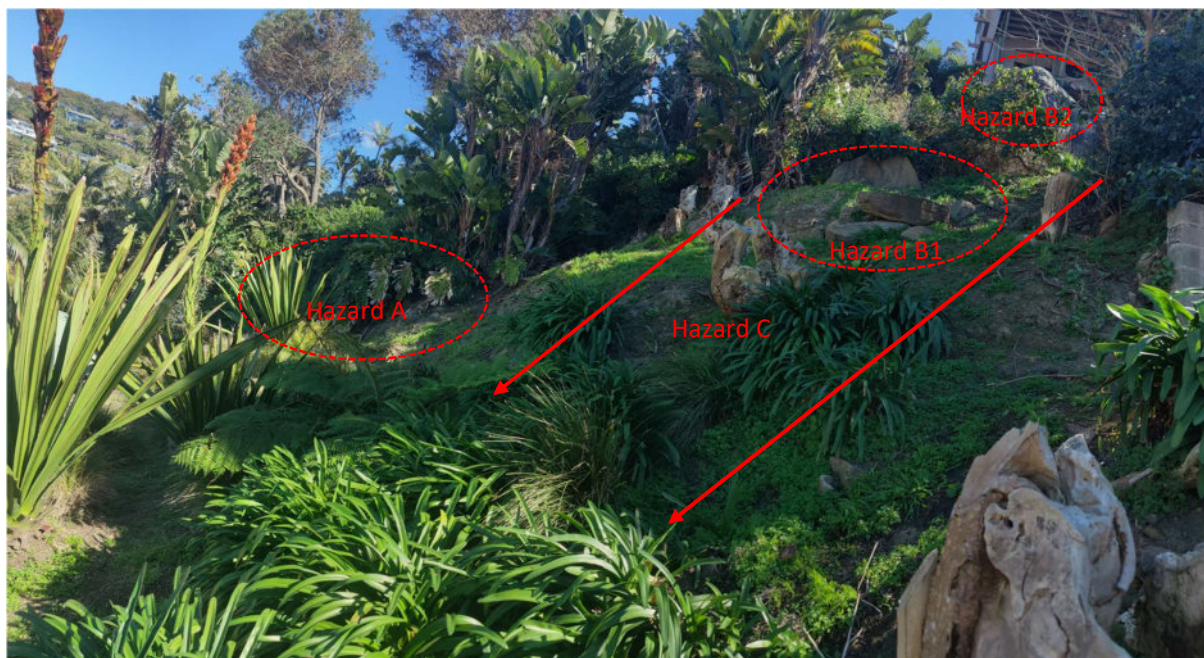
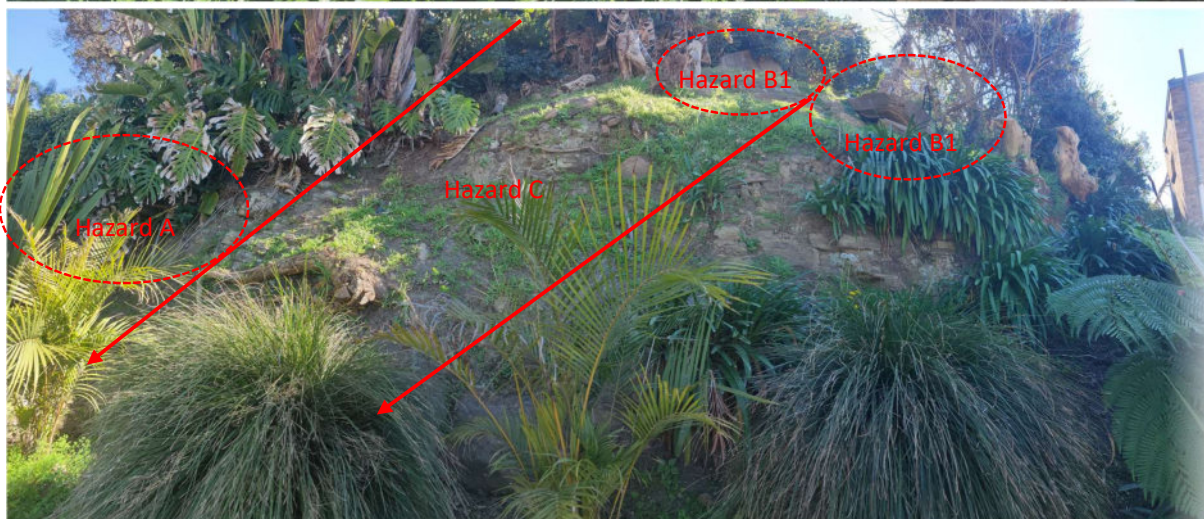
Plate 2 - Hazard A, B1, B2 and C (2 Photographs) – Taken from downslope

height rock ledges were also observed and assessed to be of medium strength. Loose boulders ranging in diameter of 0.5m to 1.5m (Hazard B1), were observed on the surface of the slopes/bedrock outcrops. At the north-western boundary there is a very large sandstone boulder, with dimensions of ~8m (north to south) x 5.5m (west to east) x maximum 5m (high, measured from the ground surface). The boulder is embedded into the ground which is sloping down at about 25° to 30°.

6.1.1 Assuming that Hazard D1 will be removed during construction, the existing hazards that pose an unacceptable risk to the life and/or property, i.e. Hazards B1, B2 and C, must be either treated, removed or further investigated so that a more accurate understanding of the risk posed can be made. In addition we recommend Hazard A be remediated.

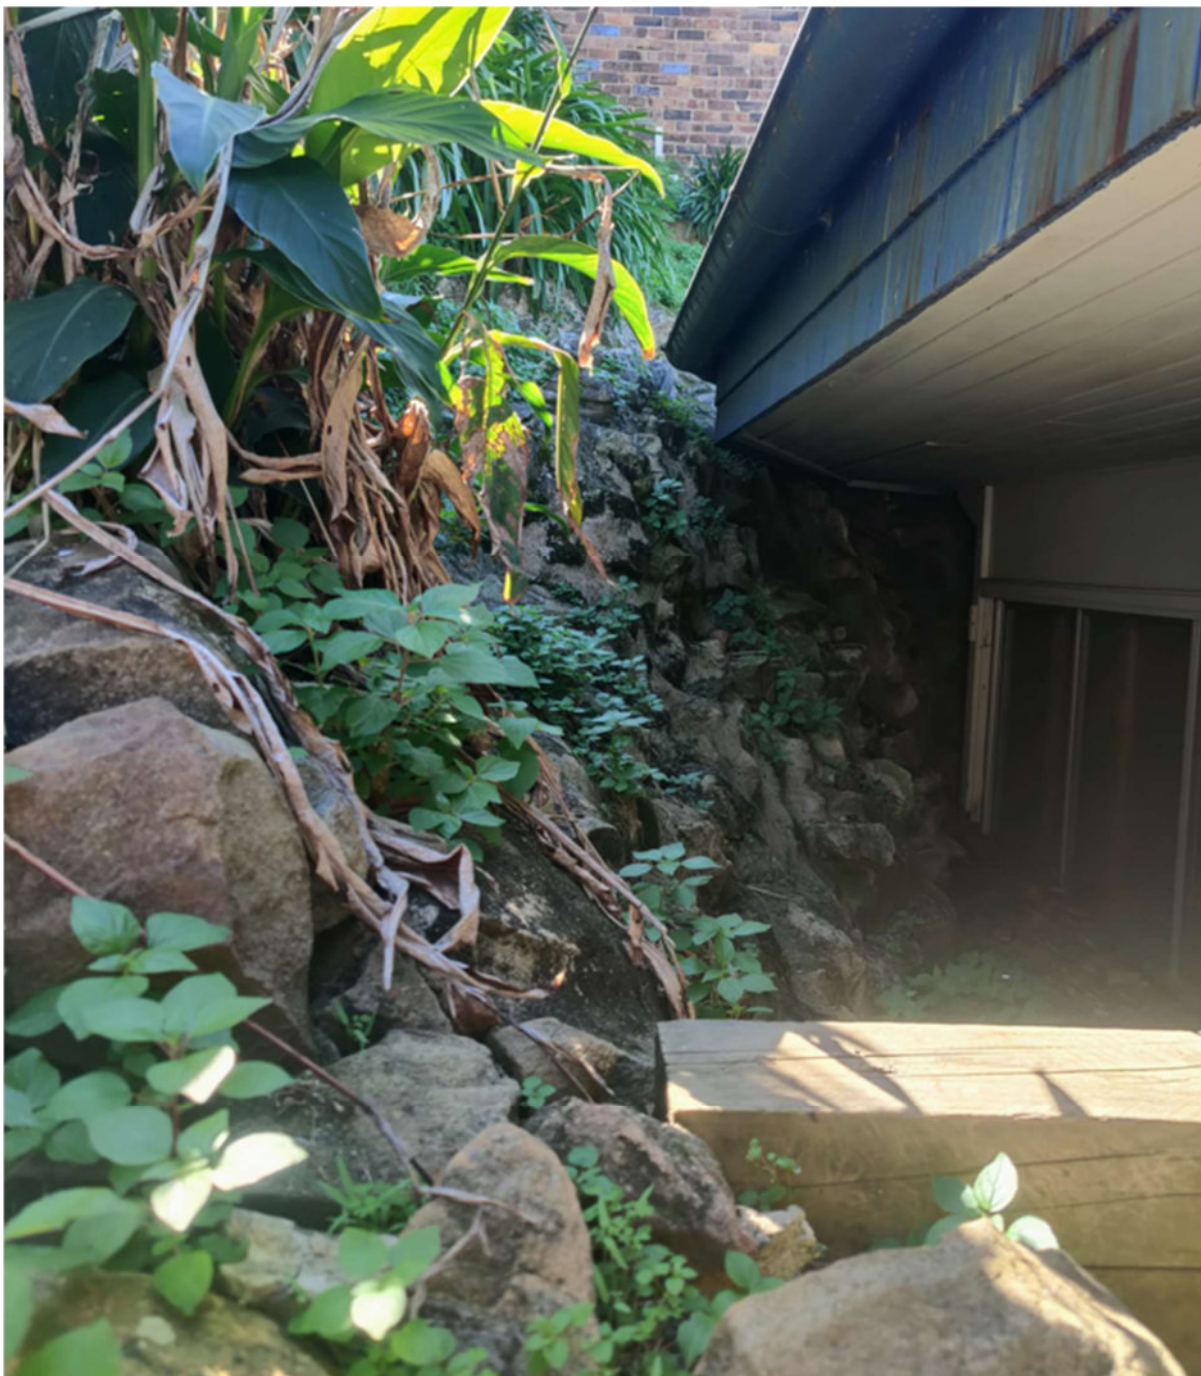
Plate 5 - Hazard D1a and D1b and D3 (2 Photographs)

To the rear of the southern portion of the house is a suspended timber deck/gazebo surrounded by an irregular rough-hewn sandstone block retaining wall with a maximum height of 1.5m and a timber retaining wall with a maximum height of 1.6m. A block had become loose in the sandstone block retaining wall and it appears that it may detach at any time without warning. The timber wall appears to be in good condition. The retaining walls have been classified as Hazard D. Hazard D has been sub-divided based on the types of the walls as follows, D1a for rough-hewn sandstone block retaining walls, D1b for sandstone block/brick masonry retaining walls, D2 for the concrete masonry retaining wall and D3 for the timber retaining walls.

Our risk assessment has considered Hazards D2 and D3 to have been previously engineered and certified during construction. We understand that the retaining wall hazards, i.e. Hazards D1a, D1b, D2 and D3, will be demolished during construction and that Hazards A, B1, B2 and C can be managed during construction. In preparing our recommendations given below, we have adopted the above interpretations of the Risk Management Policy requirements. We have also assumed that no activities on surrounding land which may affect the risk on the subject site would be carried out. We have further assumed that all services, including the sewer on the surface near the western boundary are, and will be regularly maintained to remain, in good condition.
