Tree Removal and Tree Pruning Application

Re.: 30 Herbert Ave, Newport

STRUCTURAL REPORT

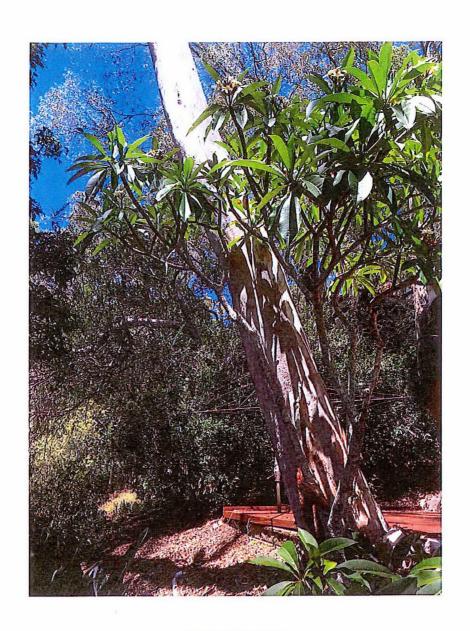
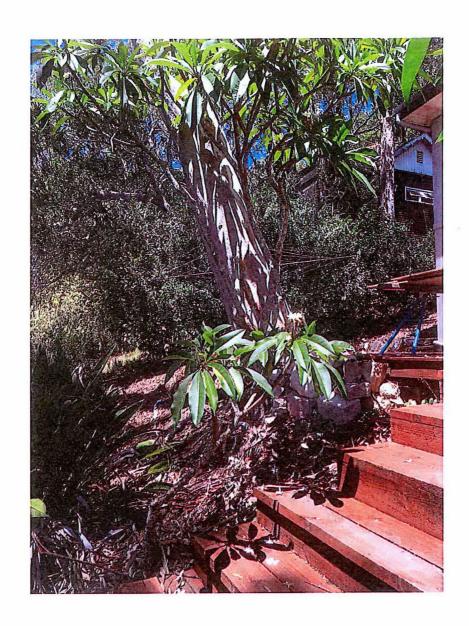
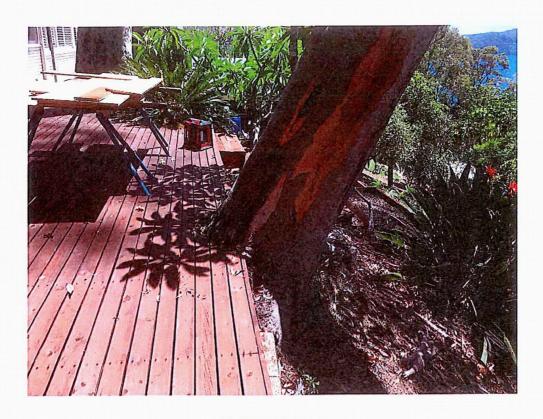
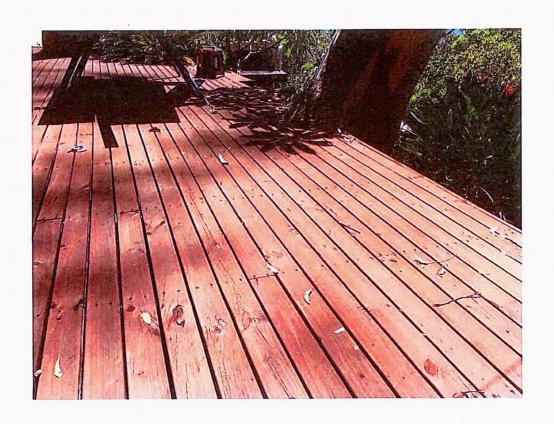
The first tree shown on photographs 1-4 is on the edge of a steep hill around 2.5 m away from the main building. The tree is very large and leaning dangerously. If in a big storm the tree falls, because of the tree's close proximity to the building it would cause disastrous damage to the building structure. The tree roots are going deep under the building foundations and as they are growing they lift the footing and causing cracks in the walls. (see photograph 5) The edge of the timber deck has been lifted too as a result of the growing roots underneath.

Our recommendation is that these two trees to be cut. They are too large and causing too much structural damage and there is a high risk that they will cause personal injuries. Trees

of these sizes are not for a backyard. In heavy rains the soil could get saturated and loosened, combined with strong winds and with the fact that they are on the edge of a steep hill are just the perfect conditions for the tree to fall.

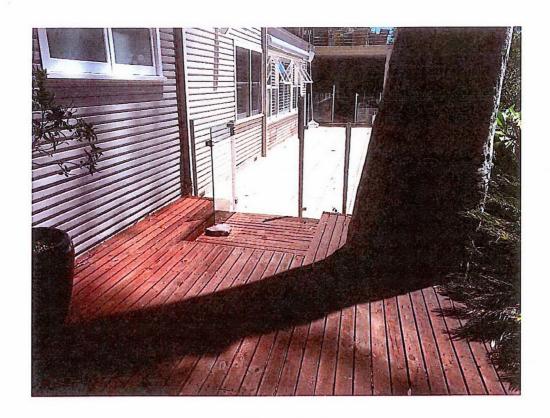
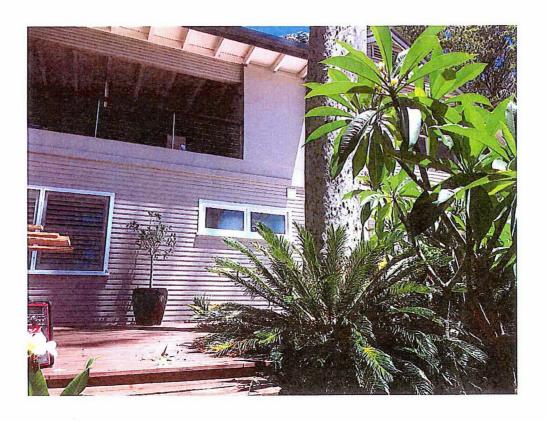
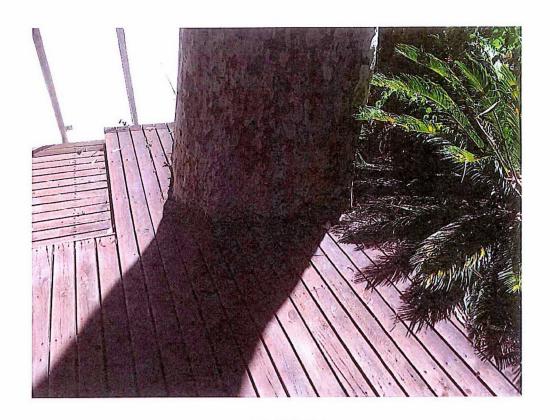
The second tree is shown on photographs 6-8. It is larger in diameter (approx. 1-1.2m) and is closer to the building (approx. 2m). A tree of this size should not be allowed so close to any structure. The pool deck has already moved (see photograph 9) and the large roots could damage the nearby pool and building. This tree sits on the edge of a steep hill too, and there is always a risk that the tree will fall. If it falls it would cause even more serious damage than the first tree. On top of the structural damage that these trees can cause, there is the risk of falling branches. The tree canopy covers the pool area and the rear deck area, a falling branch could cause serious personal injuries.

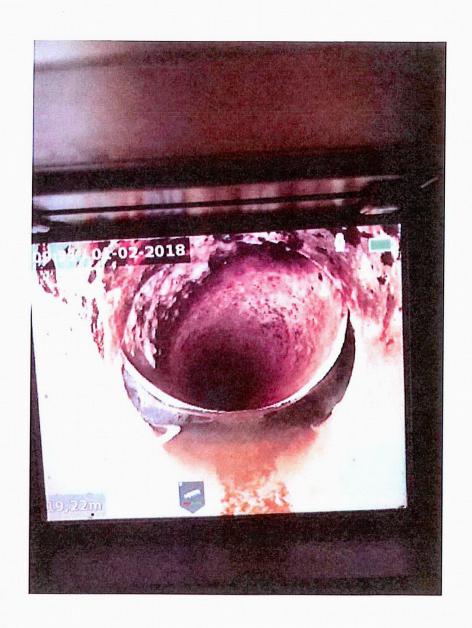
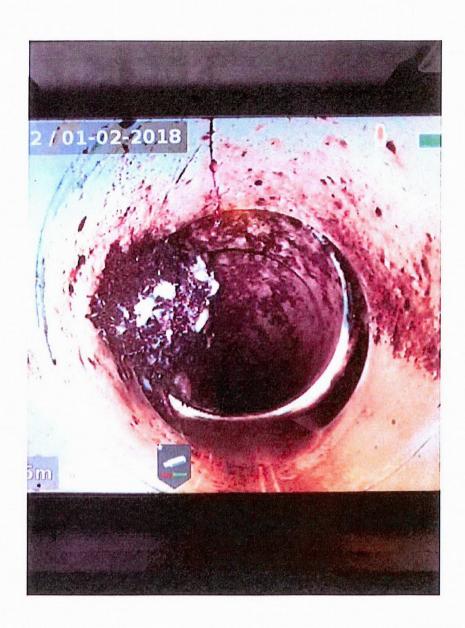
Finally, the large tree roots are damaging the sewer and stormwater pipe work at the back of the property. Photographs 10-11 show the sewer pipe near these trees, crushed by the roots. Photograph 12 shows the stormwater pipe pulled apart by the growing roots.
