## STRUCTURAL DETAIL

## SITE PLAN

Colour Schedule  
12A Wewak Place, Allambie Heights  
(Lot 7128, DP 1156937)

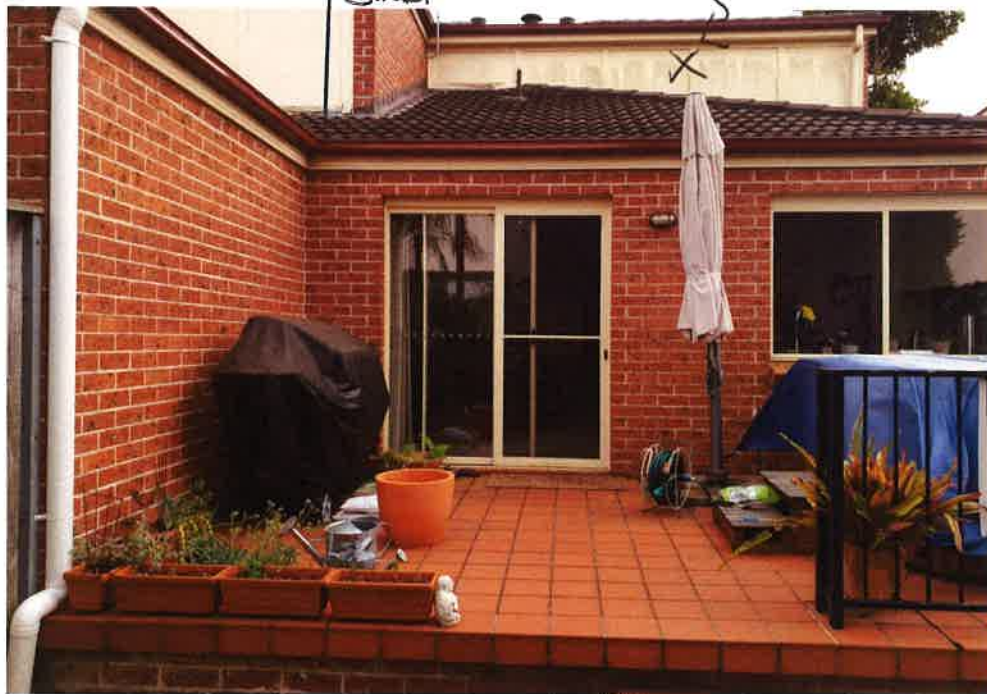
NEW WINDOW BY OTHER

REMOVE + REPLACE WITH WIRES

This photograph shows the patio after the railing has been removed and replaced with black metal wires. A blue tarp is draped over the railing area. A black grill is covered with a black tarp, and a large orange pot sits on the tiles. A white patio umbrella is closed and leaning against the wall. A blue tarp is draped over a table or bench area. A white downspout is visible on the left side of the brick wall.

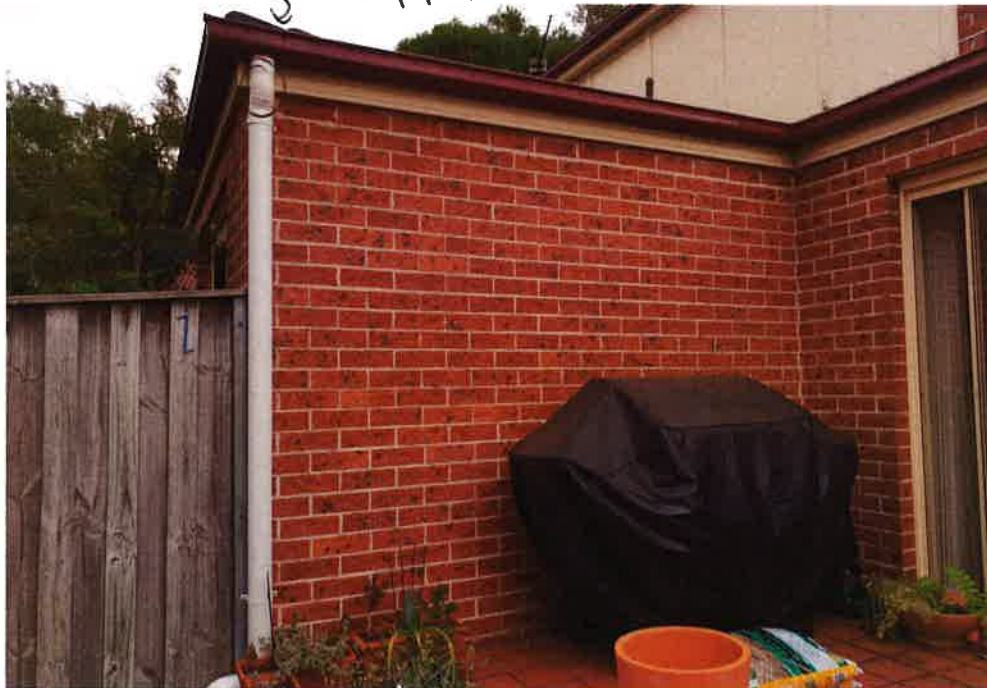
DOWNPIPE TO STORM
