ARBORICULTURAL IMPACT ASSESSMENT

Mr and Mrs Rooney
205 Riverview Rd,
AVALON BEACH

Report Reference: AIA – ROO 09/19

12th September 2019

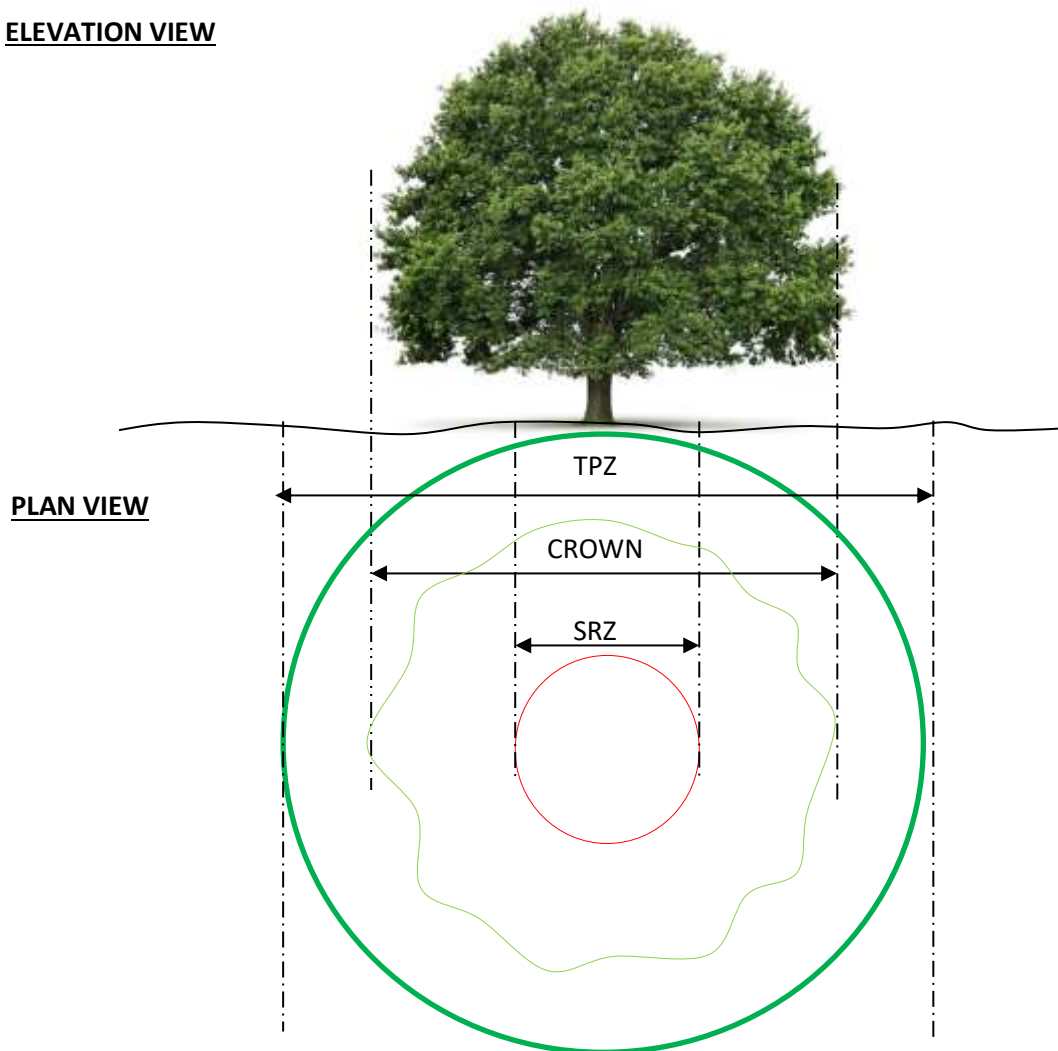
ELEVATION VIEW

Indicative TPZ and SRZ (AS 4970/2009)

$$\text{TPZ (Radius)} = \text{DBH} \times 12$$

$$\text{SRZ (Radius)} = (D \times 50)^{0.42} \times 0.64$$

- The Australian Standards provides a formula for calculating both the TPZ and SRZ. The TPZ is a combination of both root and crown area requiring protection for viable tree retention. Basically, it is the area isolated from construction disturbances. The TPZ incorporates the SRZ, the area required for tree stability.
