## Arboricultural Impact Appraisal and Method Statement

(Revision B)

9 Fern Creek Road  
Warriewood, NSW

Prepared for  
Morehuman Warriewood Pty Ltd

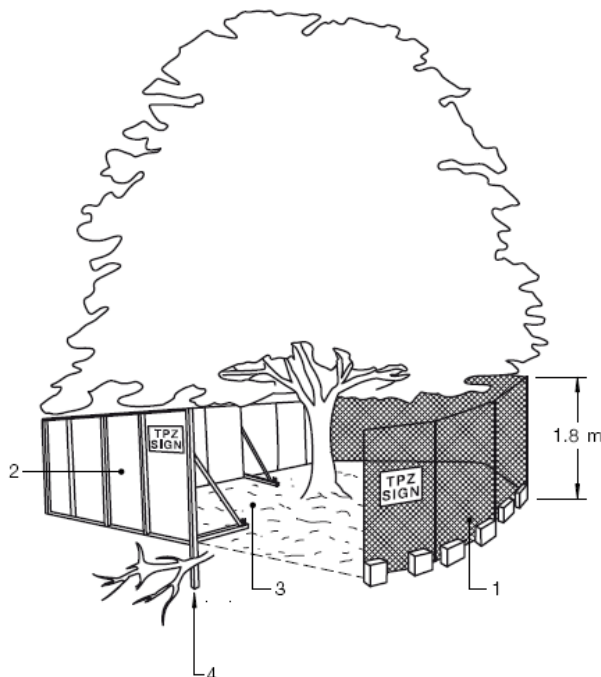
1. Chain wire mesh panels with shade cloth (if required) attached, held in place with concrete feet.
2. Alternative plywood or wooden paling fence panels. This fencing material also prevents building materials or soil entering the TPZ.
3. Mulch installation across surface of TPZ (at the discretion of the project arborist). No excavation, construction activity, grade changes, surface treatment or storage of materials of any kind is permitted within the TPZ.
4. Bracing is permissible within the TPZ. Installation of supports should avoid damaging roots.

Shade cloth or similar should be attached to reduce the transport of dust, other particulate matter and liquids into the protected area and signage must be attached to outside of fencing.

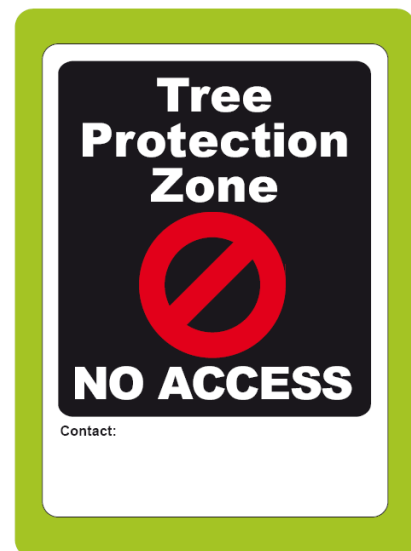
Signage example:

**Signage:** All signs are to provide clear and readily accessible information to indicate that a TPZ has been established. Signage identifying the TPZ must be attached to outside of fencing and be visible from within the development site.
