GEOTECHNICAL INVESTIGATION:

New Pool and Additions and Alterations at **26 Parr Avenue, North Curl Curl**

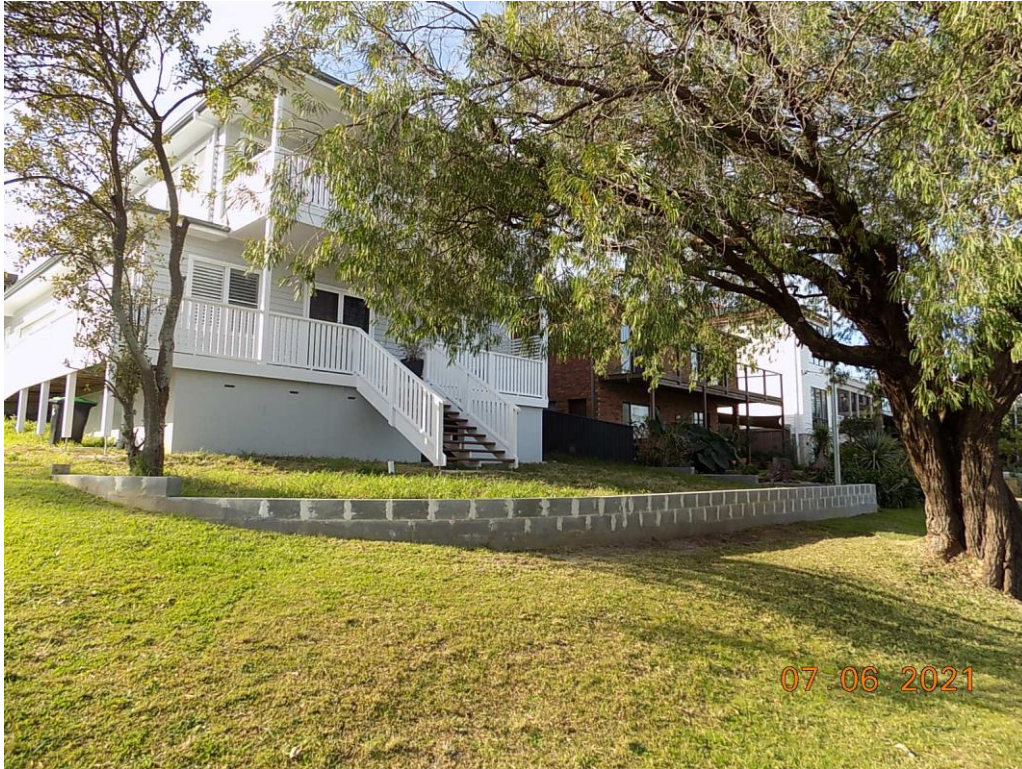
Photo 1

- 2.3** Between the road frontage to Parr Avenue and the house is a gently sloping lawn covered fill. The fill is supported by a low stable concrete block retaining wall (Photo 1). A two-storey timber framed and clad house is supported on rendered brick walls (Photo 2). The brick walls show no significant signs of movement. A concrete driveway extends from Playfair Road to a garage on the ground floor of the house

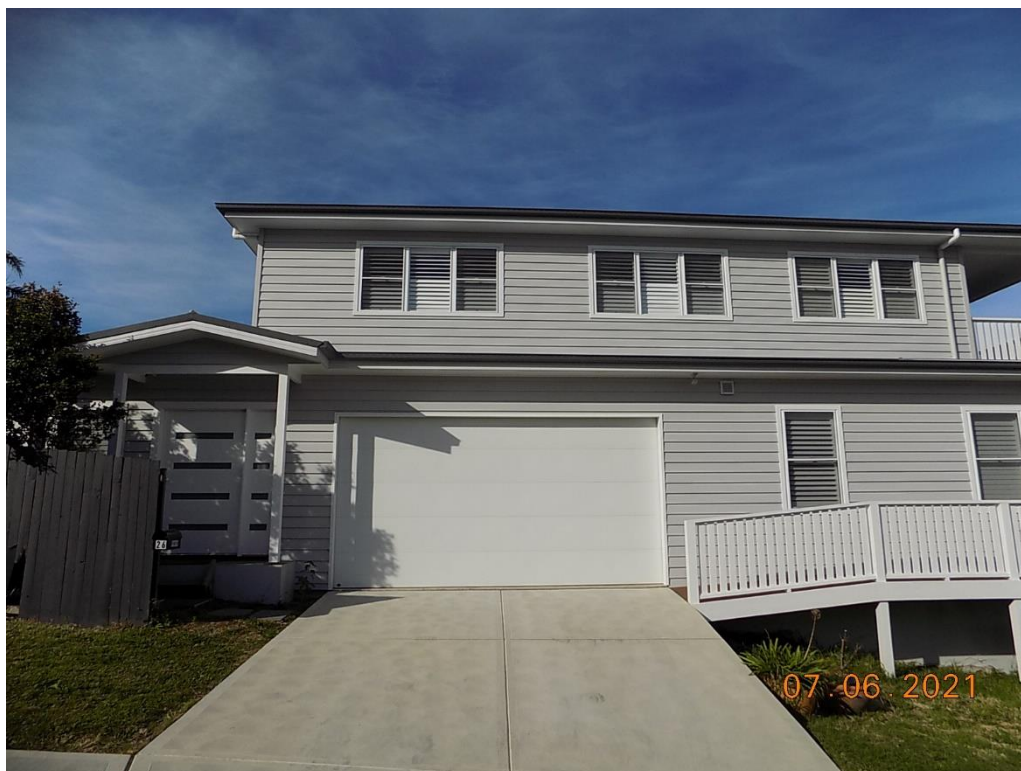
Photo 3

(Photo 3). A gentle to moderately sloping lawn area rises to the upper common boundary (Photo 4). A ~1.0m high brick retaining wall near the upper common boundary supports the cut for the lawn area (Photo 5). This wall is to be demolished as part of the proposed works.

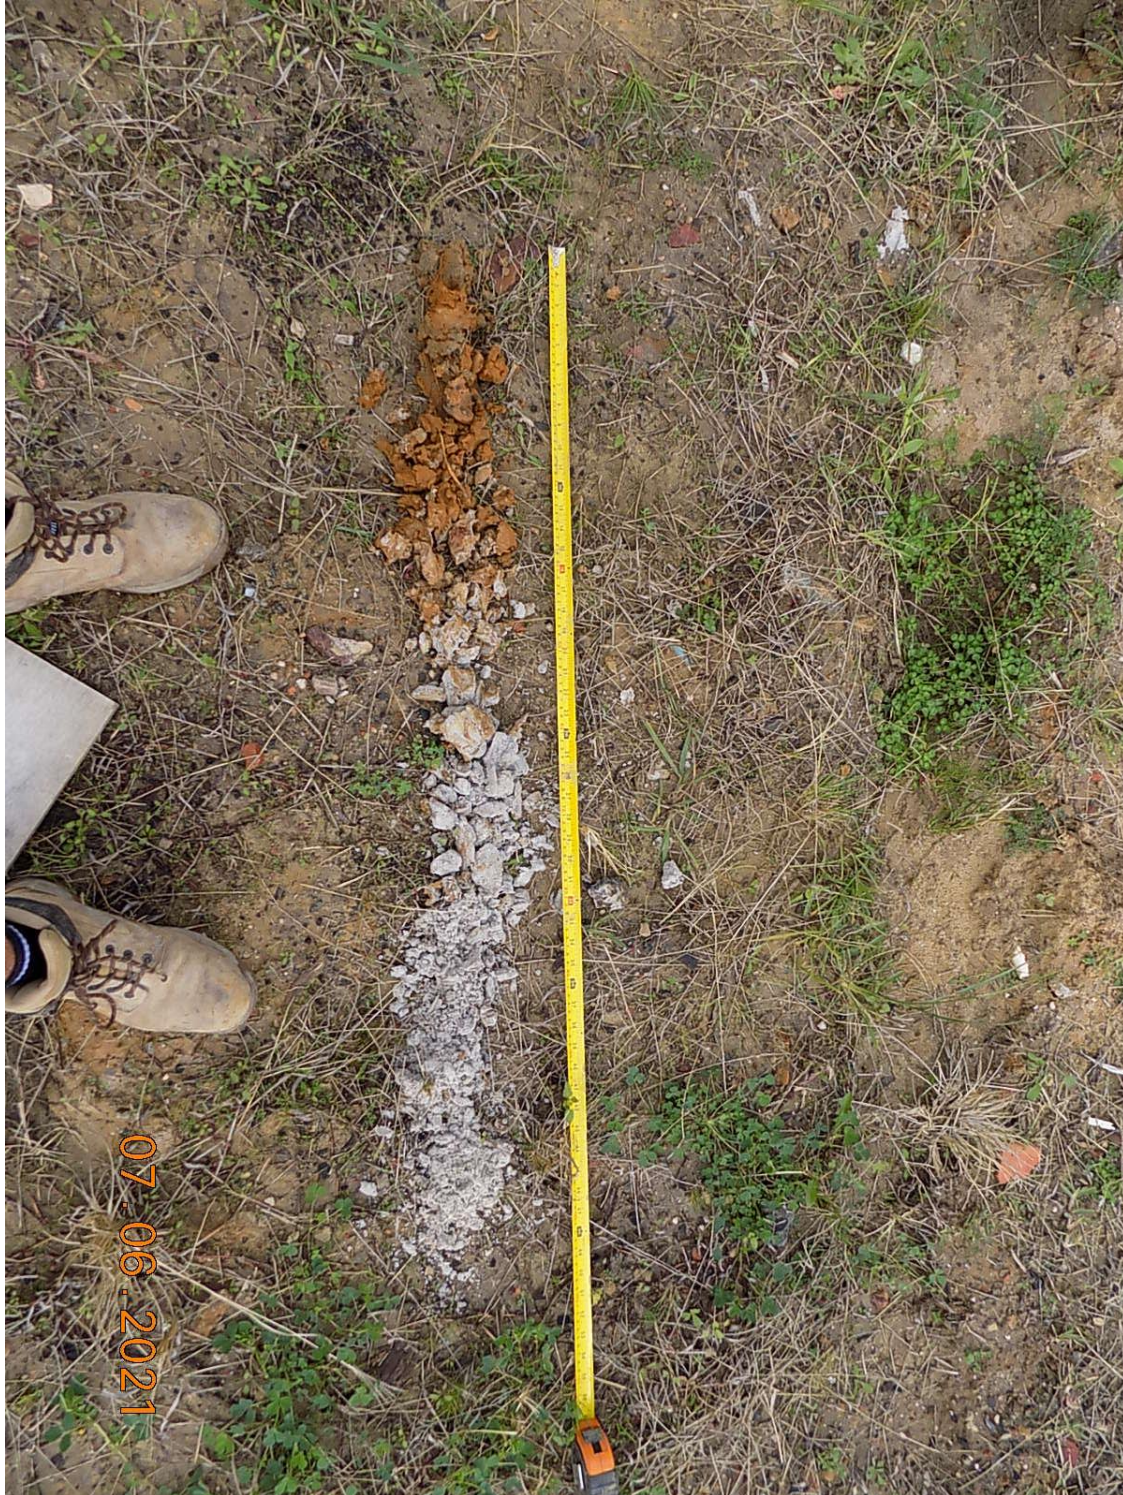
Photo 6 (top of photo is downhole)

AUGER HOLE 1 (~RL34.3) – AH1 (Photo 6)

Depth (m)	Material Encountered
0.0 to 0.4	SANDY CLAY , orange, firm, dry, fine to medium grain, fine traces of organic matter.
0.4 to 0.8	SANDY CLAY , mottled grey, red, and orange, dry, stiff to very stiff, fine to medium grain.
0.8 to 1.2	CLAYEY SAND , grey, dry, loose to medium dense, medium to coarse grained.

Refusal @ 1.2m on rock. No water table encountered.
