#### 11 Coolawin Road, Avalon Beach

Comments on Updates to Plans

#### **GEOTECHNICAL INVESTIGATION:**

New Granny Flat at 11 Coolawin Road, Avalon Beach

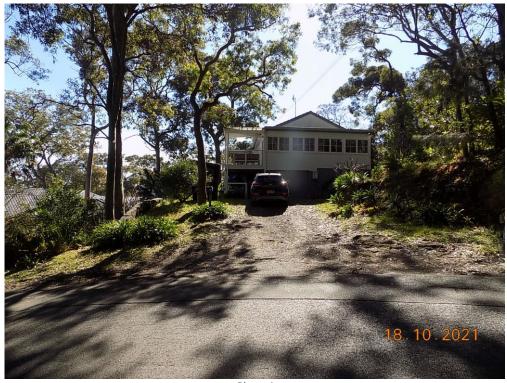
- 2.3 At the road frontage to Palmgrove Road, a gravel driveway runs to a garage under the downhill side of the house (Photos 1 & 2). The fill for the driveway and for a lawn area on the downhill side of the house is supported by a stable mortared sandstone block retaining wall ~1.4m high (Photo 3). Between this wall and the road frontage for Coolawin Road is a gentle to moderate slope with a dense covering of native and exotic grasses and shrubs (Photo 4). The part two-storey rendered masonry and timber framed and clad house is supported on masonry walls (Photo 5). No significant signs of movement were observed in the supporting wall of the house. Between the driveway, house, and road frontage to The Knoll, the slope has been

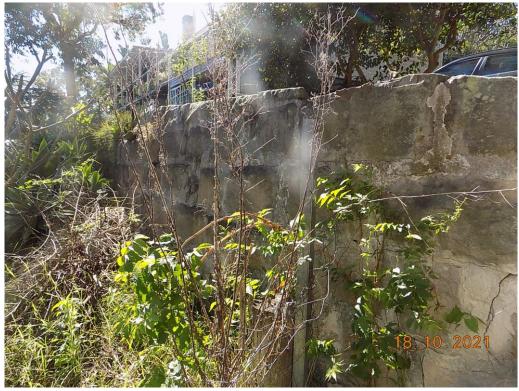
Photo 3

The excavation will reach a maximum depth of ~2.0m and will come flush with the sandstone

block retaining wall below the house (Photo 3). The excavation will be set back sufficiently

from all other surrounding structures and boundaries. As such, the sandstone block retaining

wall will be within the zone of influence of the proposed excavation.

Where the retaining wall falls within the zone of influence of the excavation, exploration pits in this location will need to be put down by the builder to determine the foundation depth and material. The pits are to be inspected by the geotechnical consultant.

If the wall is found to be supported below the base of the proposed excavation, the excavation may commence. If it is not supported below the base of the proposed excavation, the wall will need to be underpinned prior to the excavation commencing. See the site plan attached showing the minimum extent of the required exploration pits/underpinning.

Underpinning is to follow the underpinning sequence 'hit one miss two'. Under no circumstances is the bulk excavation to be taken to the edge of the wall and then underpinned. Underpins are to be constructed from drives that should be proportioned according to footing type and size. Allowances are to be made for drainage through the underpinning to prevent a build-up of hydrostatic pressure. Underpins that are not designed as retaining walls are to be supported by retaining walls. The void between the retaining walls and the underpinning is to be filled with free-draining material such as gravel.

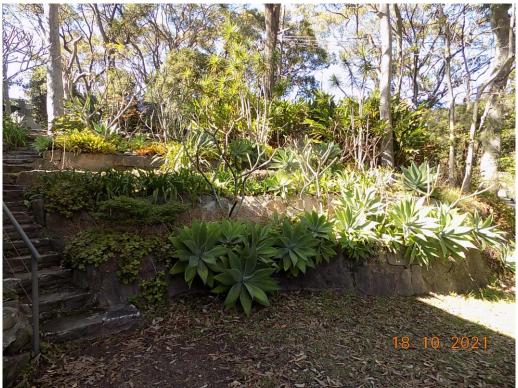
Photo 6

terraced with a series of low sandstone flagging walls (Photo 6). The fill for The Knoll is supported by a stable ~0.5m high timber retaining wall that lines the road frontage (Photo 7).

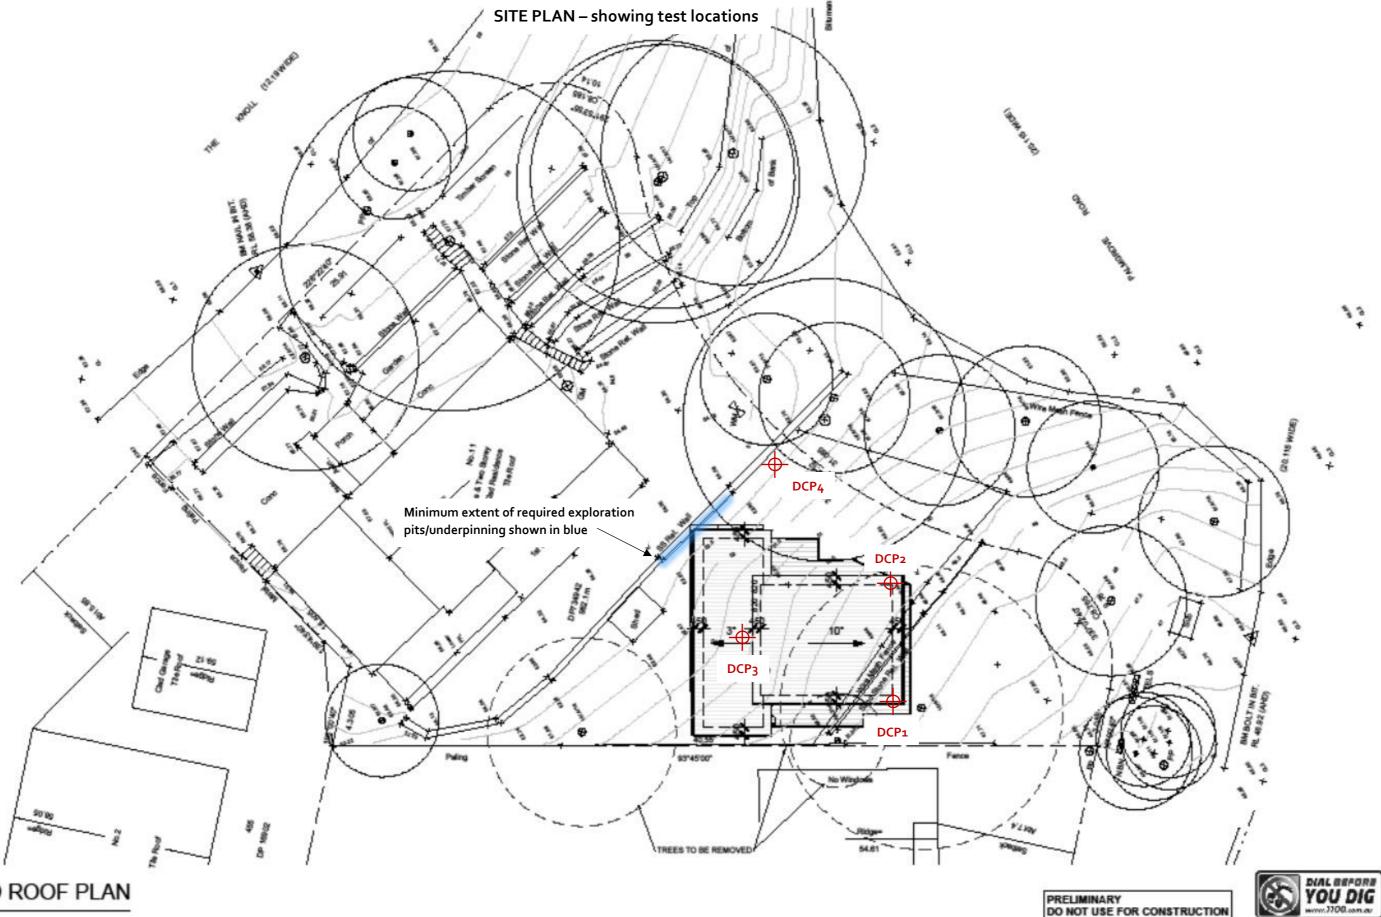
## SITE AND ROOF PLAN

Four Dynamic Cone Penetrometer (DCP) tests were put down to determine the relative density of the overlying soil and the depth to weathered rock. The locations of the tests are shown on the site plan attached. It should be noted that a level of caution should be applied when interpreting DCP test results. The test will not pass through hard buried objects so in some instances it can be difficult to determine whether refusal has occurred on an obstruction in the profile or on the natural rock surface. This is not expected to be an issue for the testing on this site. However, excavation and foundation budgets should always allow for the possibility that the interpreted ground conditions in this report vary from those encountered during excavations. See the appended "Important information about your report" for a more comprehensive explanation. The results are as follows:
