Report Title: Geotechnical Report <b>40 Tatiara Crescent, North Narrabeen</b>
Report Date: <u>30/9/24</u>
Author: <u>BEN WHITE</u>
Author's Company/Organisation: <b>White Geotechnical Group Pty Ltd</b>

## **GEOTECHNICAL INVESTIGATION:**

New Granny Flat at **40 Tatiara Crescent, North Narrabeen**

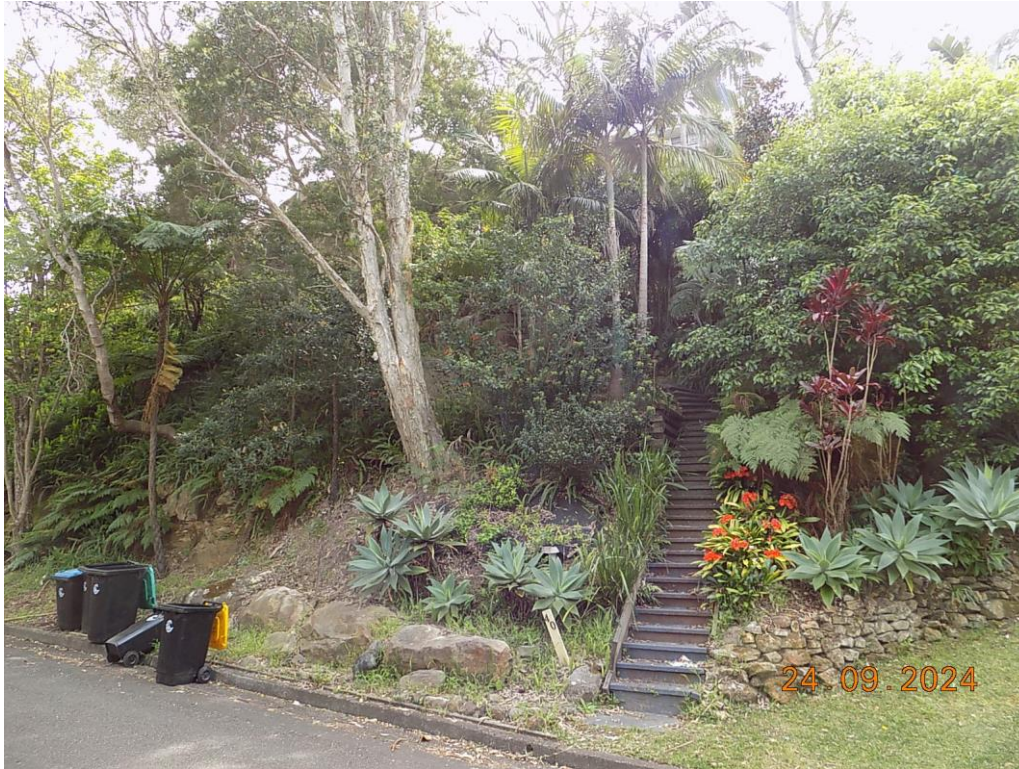
Photo 1

- 2.3** The steep slope between the road frontage and the downhill side of the house (Photo 1) is terraced in stable retaining walls of timber crib and dry stack sandstone composition reaching up to ~1.0m high (Photos 2 & 3). Where the slope is not supported by retaining walls, it is sufficiently covered in vegetation (Photo 4). Competent Medium Strength Sandstone outcrops and steps up the property in this location. The outcropping rock was observed to be free from significant geological defects that could affect its stability. Boulders and detached joint blocks across the

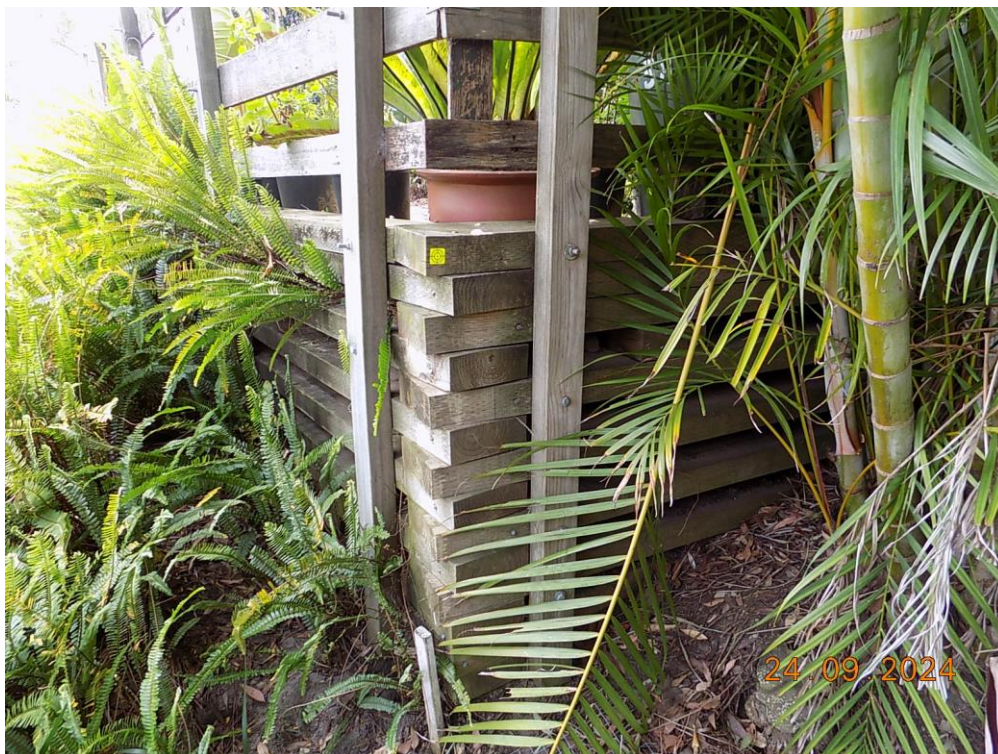
Photo 8

HAZARDS	Hazard Three	Hazard Four
<b>TYPE</b>	The excavation (to a depth of ~1.2m) collapsing onto the work site before retaining walls are in place.	The proposed excavation undercutting the W timber retaining wall (Photo 8) causing damage or failure.
<b>LIKELIHOOD</b>	'Possible' ( $10^{-3}$ )	'Possible' ( $10^{-3}$ )
<b>CONSEQUENCES TO PROPERTY</b>	'Medium' (15%)	'Medium' (35%)
<b>RISK TO PROPERTY</b>	'Moderate' ( $2 \times 10^{-4}$ )	'Moderate' ( $2 \times 10^{-4}$ )
<b>RISK TO LIFE</b>	$8.3 \times 10^{-6}$ /annum	$5.3 \times 10^{-5}$ /annum
<b>COMMENTS</b>	This level of risk property is 'UNACCEPTABLE'. To move risk to 'ACCEPTABLE' levels, the recommendations in <b>Section 13 and 14</b> are to be followed.	This level of risk to life and property is 'UNACCEPTABLE'. To move risk to 'ACCEPTABLE' levels, the recommendations in <b>Section 13</b> are to be followed.

The excavation for the proposed granny flat will reach a maximum depth of ~1.2m in the SE corner. Allowing 0.5m for back wall drainage, the excavation will come flush with a timber retaining wall which supports fill for the E neighbouring property (Photo 8).

As such, the timber retaining wall will lie within the zone of influence of the proposed excavation. In this instance, the zone of influence is the area above a theoretical 45° line (from horizontal) from the base of the excavation or top of Medium Strength Rock, whichever is encountered first, towards the surrounding structures and boundaries. This line reduces to 30° through the fill and soil.

Given the shallow depth to rock, we think it is likely the wall is supported on rock. However, to be sure, where the wall falls within the zone of influence of the excavation, exploration pits along the wall will need to be put down by the builder to determine the foundation depth and material. These are to be inspected by the geotechnical consultant.

If the foundations are confirmed to be supported on rock, the excavation may commence. Otherwise, the W as well as the N side of the cut will need to be permanently supported prior to the commencement of the excavation through rock, or during the excavation process in a staged manner due to the steep grade of the slope, to protect the integrity of the timber retaining wall, and so cut batters are not left unsupported. The support will need to be designed by the structural engineer in consultation with the Geotechnical Consultant. See the site plan attached for the minimum extent of the required shoring shown in blue.

- The exploration pits to determine the foundation material along the E timber retaining wall (Photo 8) are to be inspected by the geotechnical consultant to determine if permeant support prior to excavation is required. This is to occur before the bulk excavation for the granny flat commences.
- During the excavation process, the geotechnical consultant is to inspect the excavations as they approach no less than 1.0m horizontally from the foundations of the wall/underpins to confirm the stability of the cut to go flush with the footings.

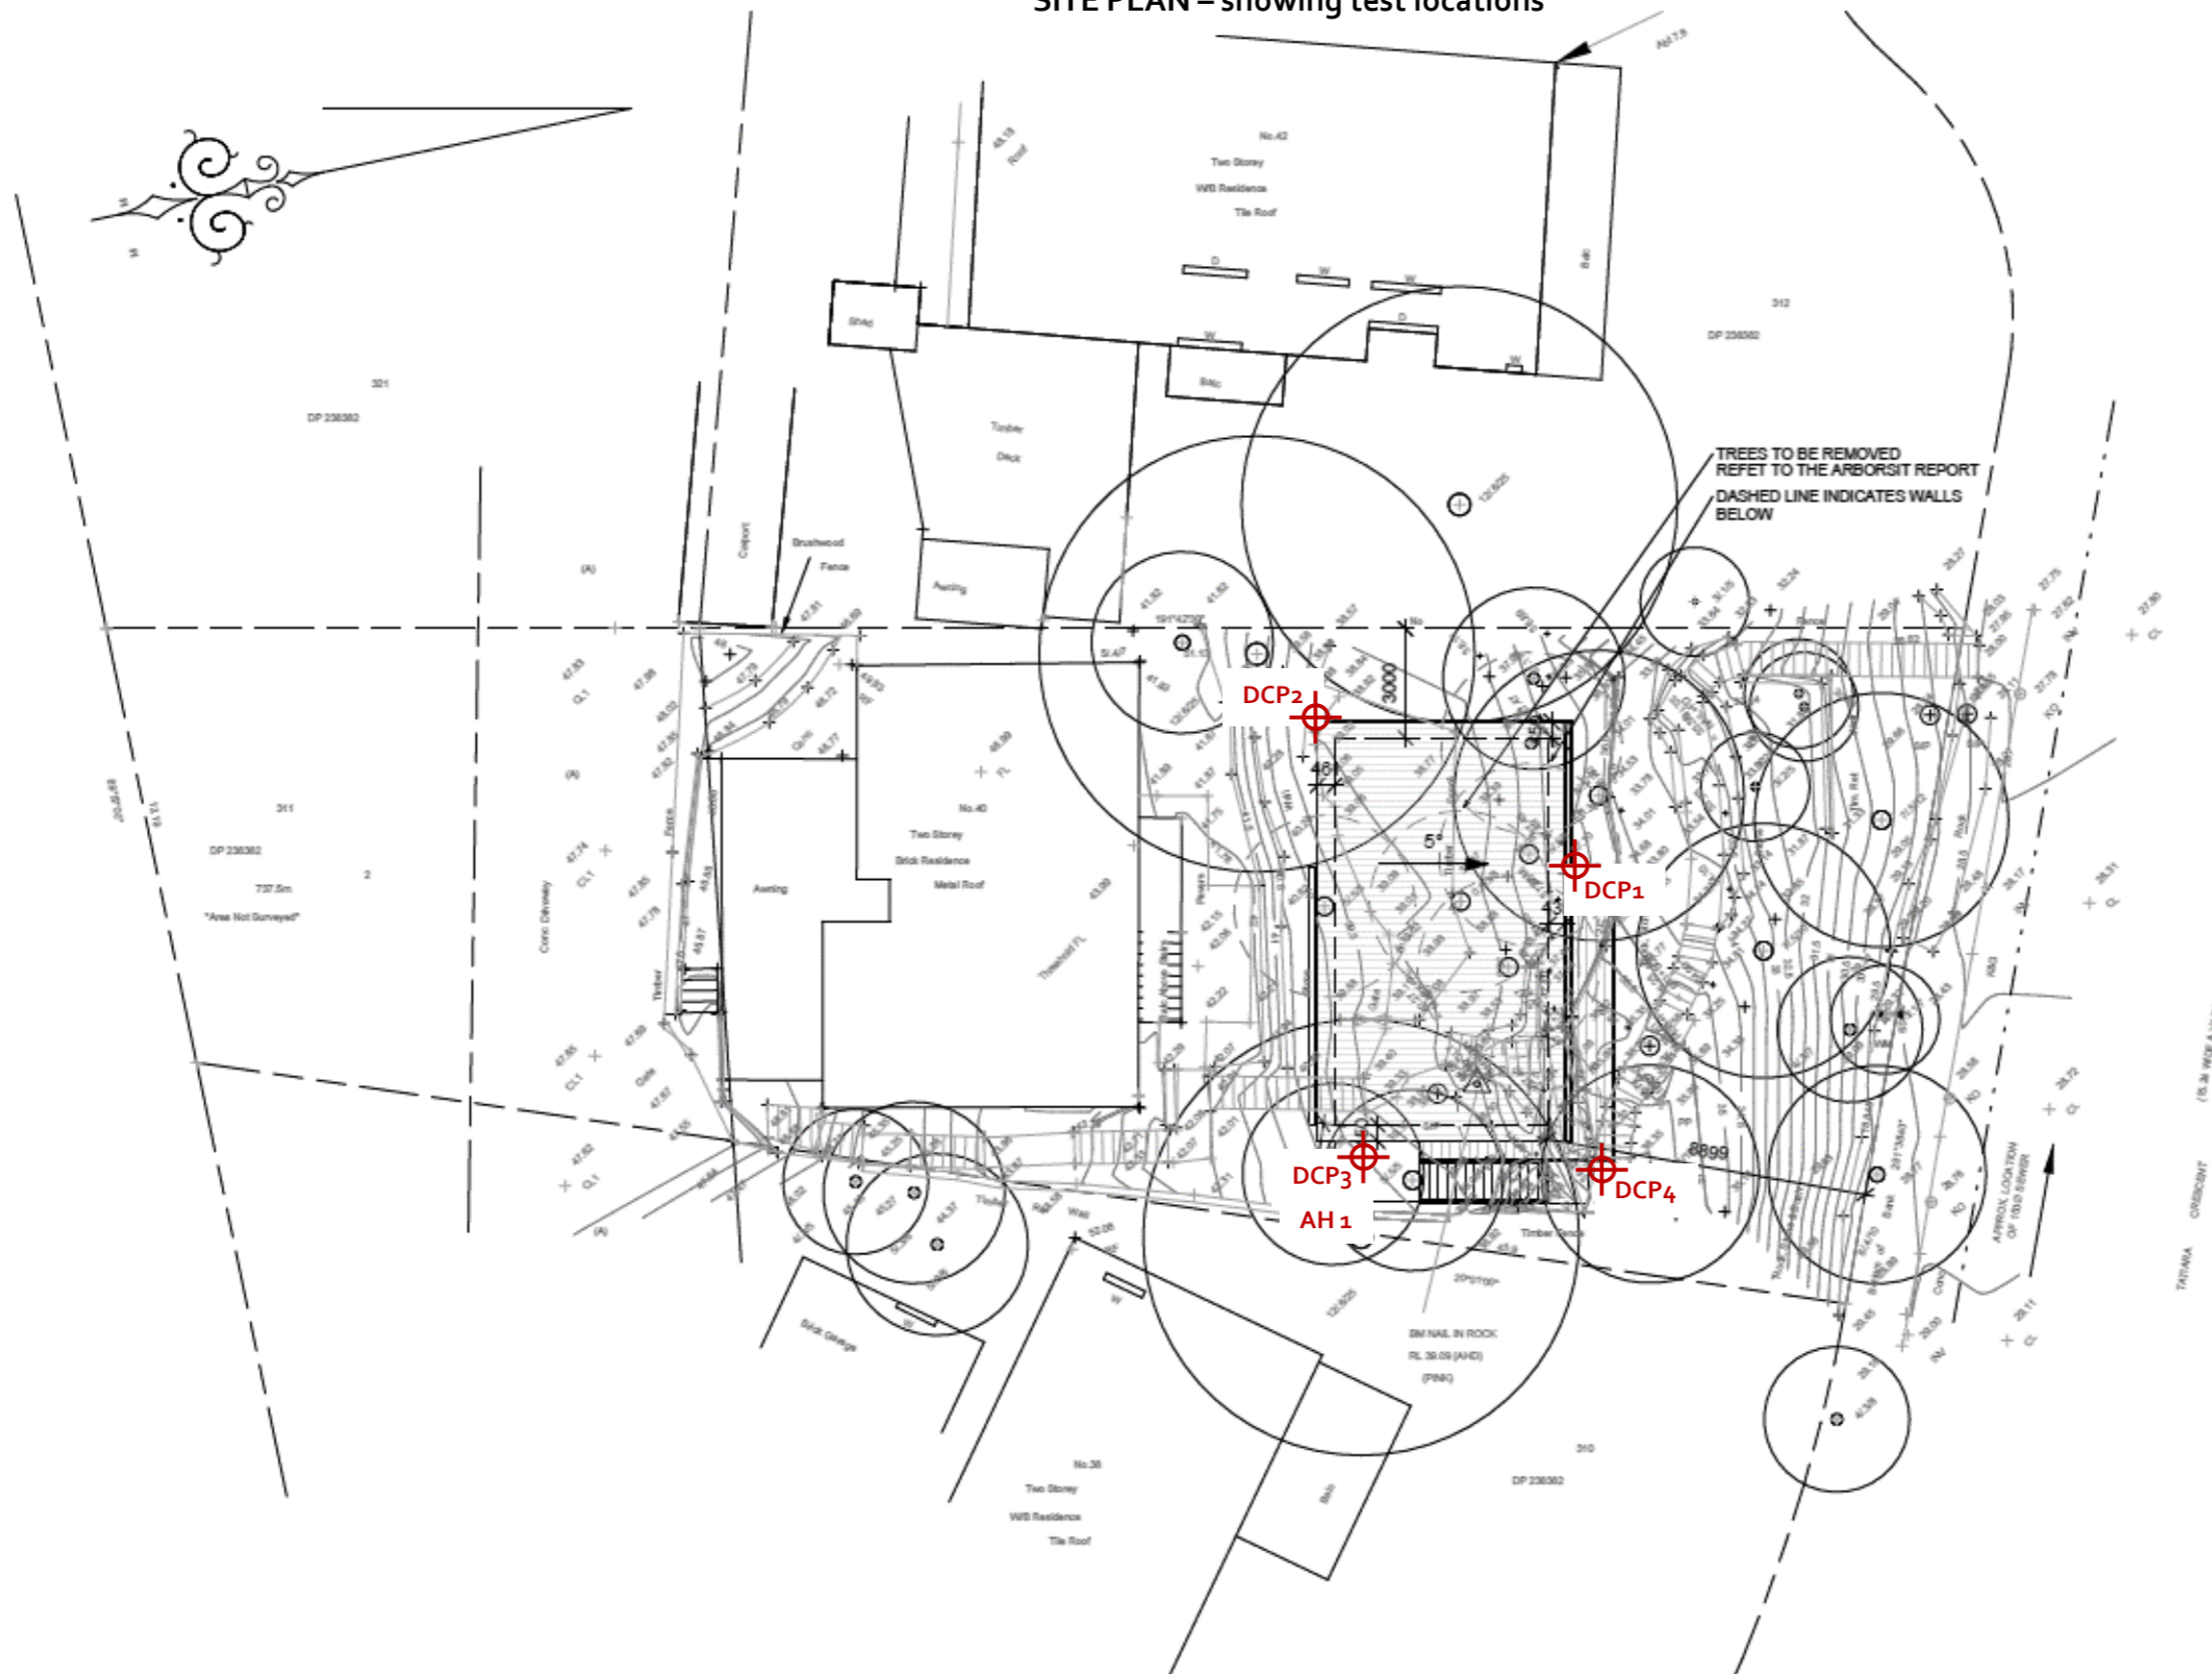
SITE PLAN – showing test locations

One hand Auger Hole (AH) was put down to identify the soil materials. Four Dynamic Cone Penetrometer (DCP) tests were put down to determine the relative density of the overlying soil and the depth to bedrock. The locations of the tests are shown on the site plan attached. It should be noted that a level of caution should be applied when interpreting DCP test results. The test will not pass through hard buried objects so in some instances it can be difficult to determine whether refusal has occurred on an obstruction in the profile or on the natural rock surface. This is not expected to have been an issue for this site. But due to the possibility that the actual ground conditions vary from our interpretation there should be allowances in the excavation and foundation budget to account for this. We refer to the appended "Important Information about Your Report" to further clarify. The results are as follows:
