HERITAGE IMPACT STATEMENT

Kooloora Avenue, Freshwater

Freshwater Surf Life Saving Club

HERITAGE IMPACT STATEMENT FOR FRESHWATER SURF LIFE SAVING CLUB

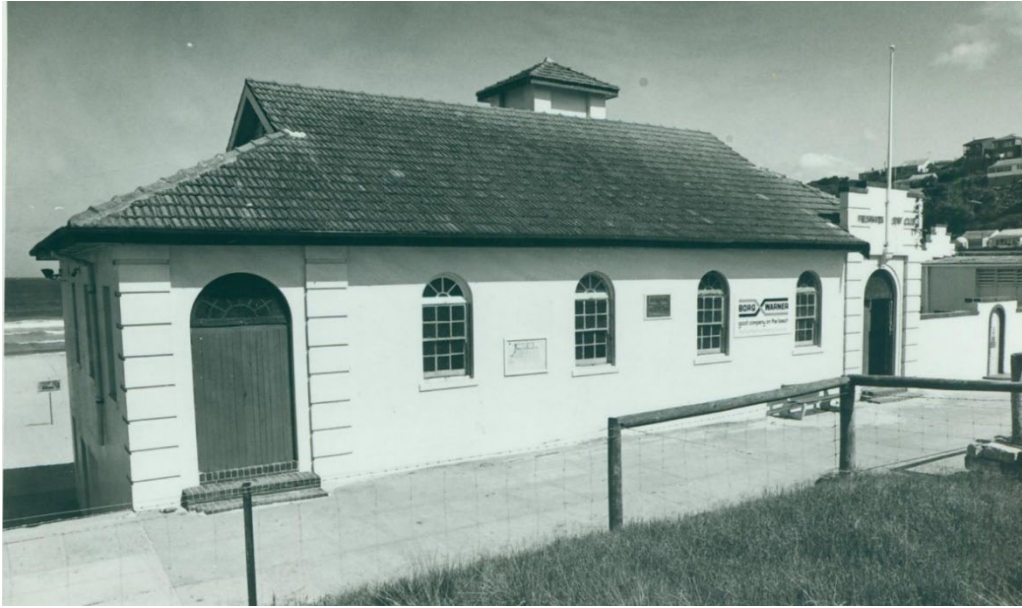
Figure 12: c.1935 – “Showing the surf clubhouse in its original form soon after it was constructed” (Source: Northern beaches Council Library Local Studies, <https://northernbeaches.recollect.net.au/> accessed 29 May 2023)

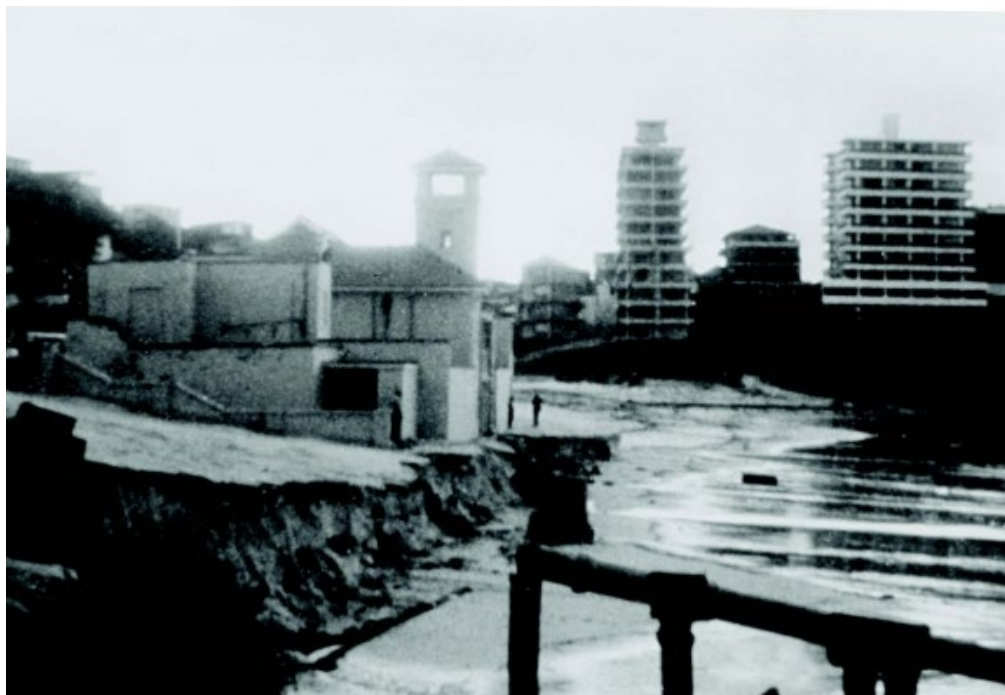
Figure 18 – Storm damage to Freshwater Beach, 1974. (Source: <http://www.freshwaterslsc.com/galleries/category/history/303>, viewed 16 November 2016)

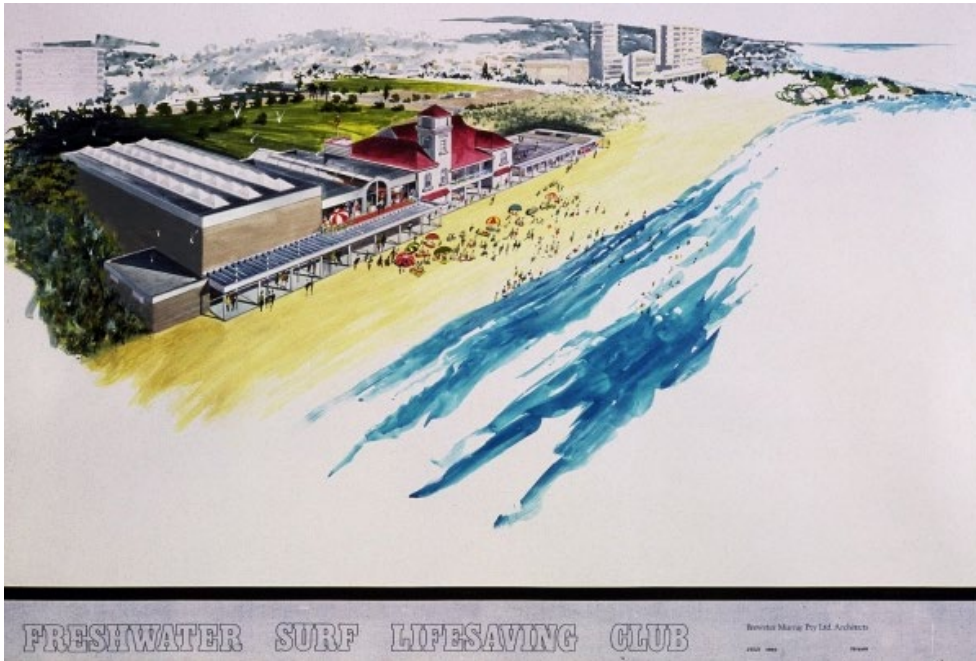
Figure 20 – Architectural rendering of one of the schemes for the rebuilding of the Freshwater Surf Lifesaving Club by Brewster Murray Pty Ltd Architects. (Source: <http://www.freshwaterslsc.com/galleries/category/history/303>, viewed 16 November 2016)

By the 1960s, the club house was outdated and in urgent need of repairs and extensions. A building committee was formed but no further action took place until the mid-1970s when a member of the Club, Bob Obern, architect, prepared several drawings and different schemes for the new club house (Figure 20). The Warringah Shire Council subsequently appointed Obern's firm, Brewster, Murray and Partners as architects for the project. The project stalled after the State Government dismissed the Warringah Shire Council and appointed an Administrator. Following a period of upheaval in the Shire, a new Council was elected in 1987 and plans for the building project were approved. The new club house was completed in 1988.⁵ The Freshwater Beach Reserve was extended with an additional 1.452 hectares in October 1999.

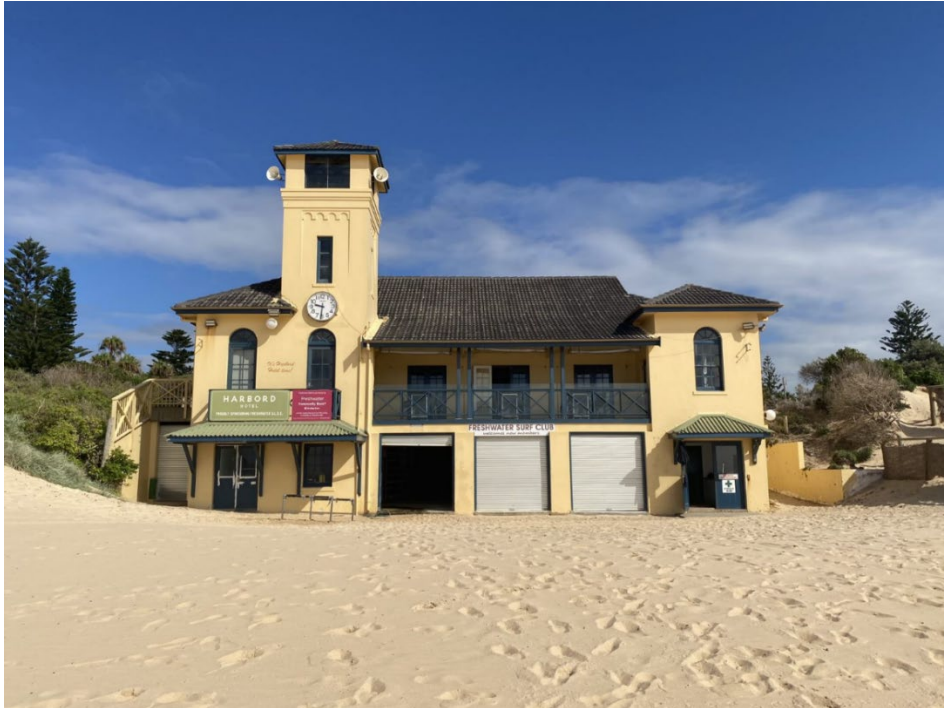
Figure 21: Principal facade of the Freshwater SLSC, view looking northwest from Freshwater Beach (Source: NBRS, 1 February 2023)

The Freshwater Surf Life Saving Club can be described as an Inter-War Mediterranean style building of rendered masonry construction. The subject site features substantial landscaping and a paved driveway. Primary entry to the building is from the north at the junction of the original clubhouse building and later 1980s addition. The building has undergone some alterations and additions. The original clubhouse building located on the eastern portion of the site has a modified Dutch gable roof with shallow eaves, and a concrete tile roof. The building comprises rendered facades of masonry construction, characterised by an asymmetrical form and arched openings. The tower structure on the building's southeast elevation has a landmark presence through its scale, decorative rendering and simple hipped roof, characteristic of the building's Interwar Mediterranean design. The tower's location to the left of the front balcony area contributes to the building's asymmetrical form.

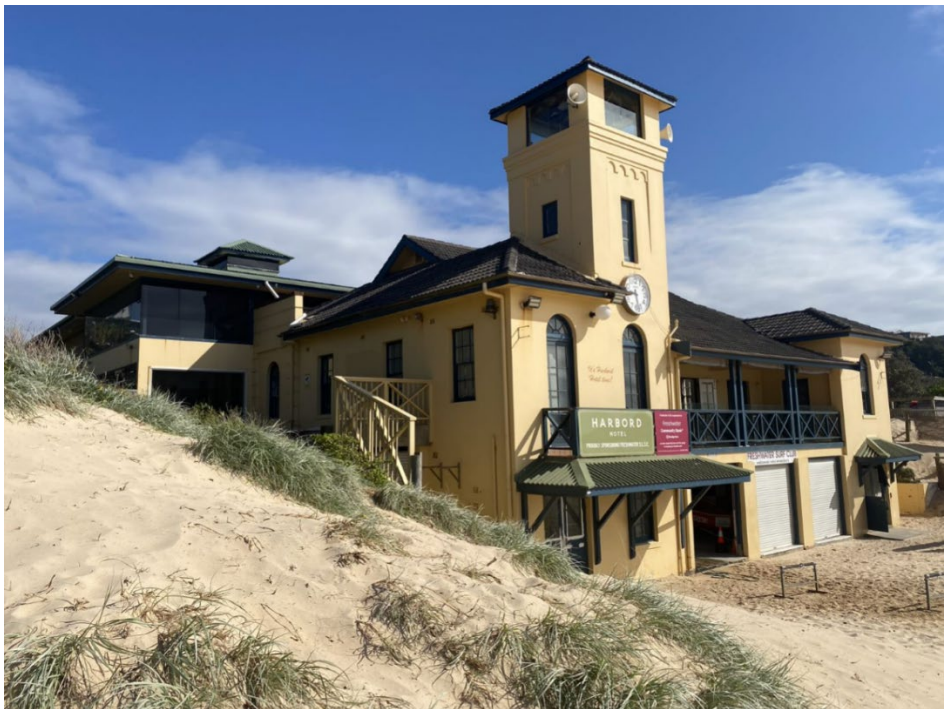
Figure 22: Southwest corner of the Freshwater SLSC (Source: NBRS, 1 February 2023)

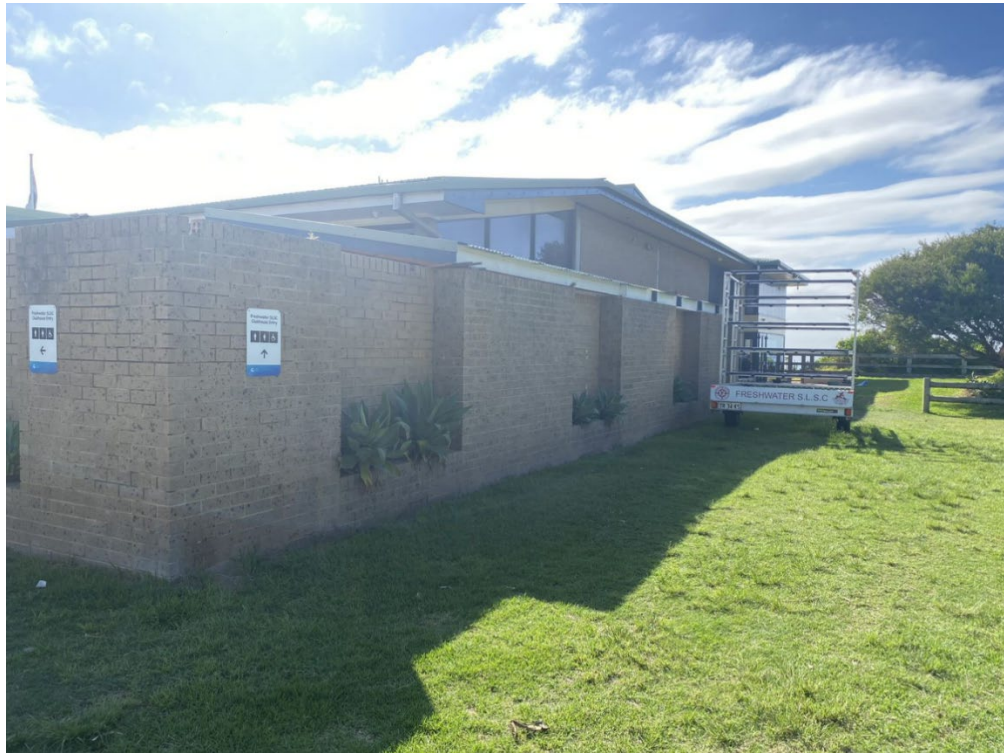
Figure 23: Southwest elevation of the Freshwater SLSC rear addition (Source: NBRS, 1 February 2023)

The rear extension to the original clubhouse building was constructed in 1988 and can be described as a stylistically simple, three-storey building of brick construction (including basement level). The building has a modified gable roof or combination roof with corrugated roof sheeting and glazed shutters to the northeast/southwest gables.

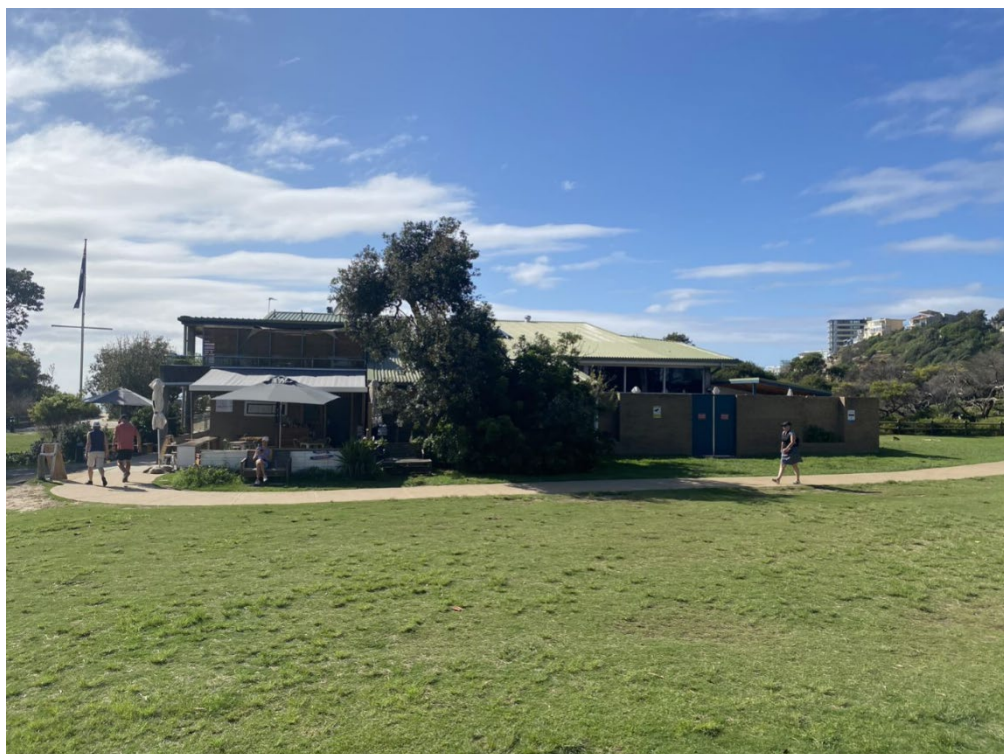
Figure 24: Northwest elevation of the rear addition of the Freshwater SLSC (Source: NBRS, 1 February 2023)

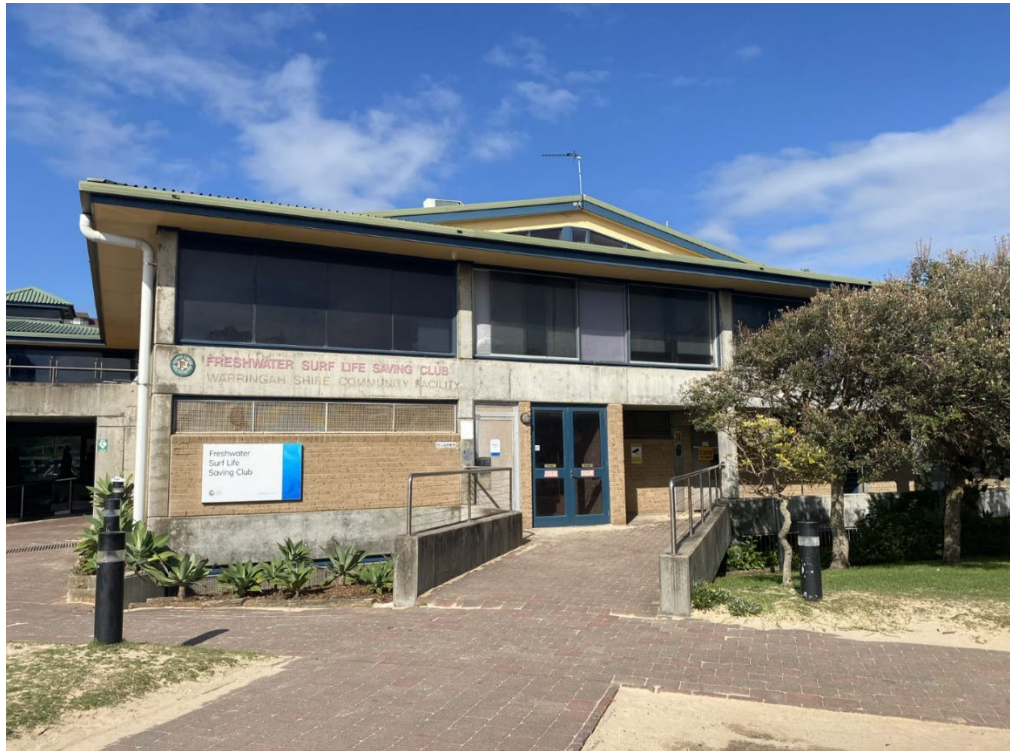
Figure 25: Northeast elevation of the rear addition of the Freshwater SLSC (Source: NBRS, 1 February 2023)

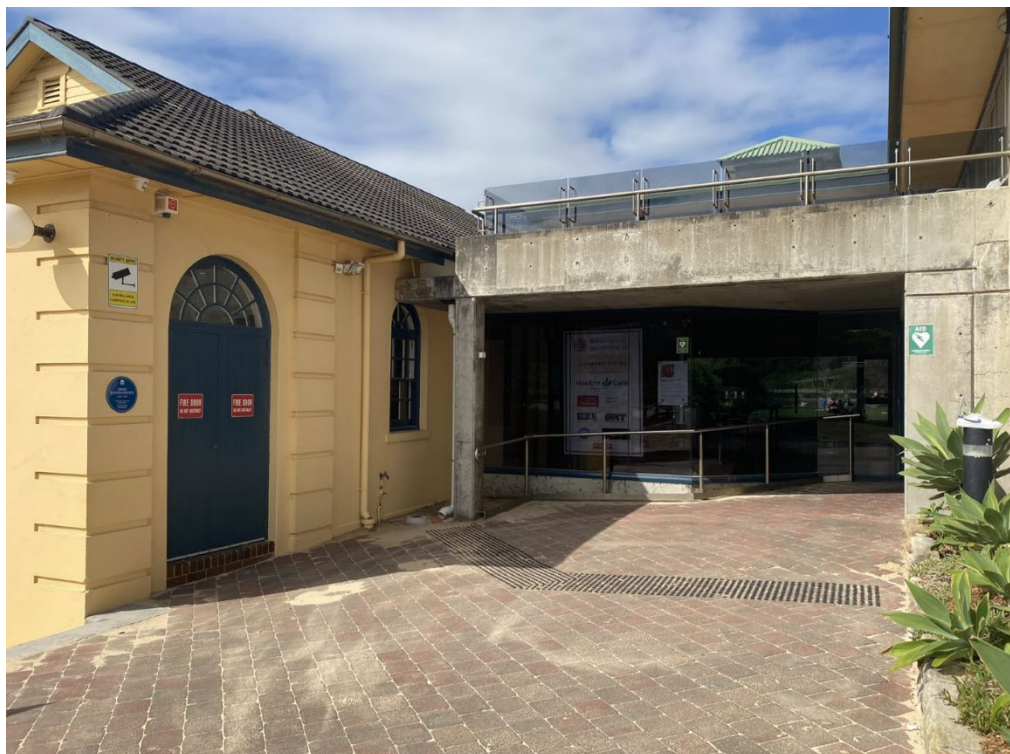
Figure 26: Northeast elevation of the subject site at the central junction between the later 1980s addition to the site (right) and the original 1930s clubhouse (left) (Source: NBRS, 1 February 2023)

The 1980s addition directly adjoins the northwest elevation of original clubhouse building through an open hallway and a later construction built in the early 2000s known as the heritage room, this contemporary structure is located on the southwest elevation of the structure, at the junction between the original clubhouse and the 1980s addition. The building currently serves as a function area / an open plan museum, displaying items of the club's long and significant history.

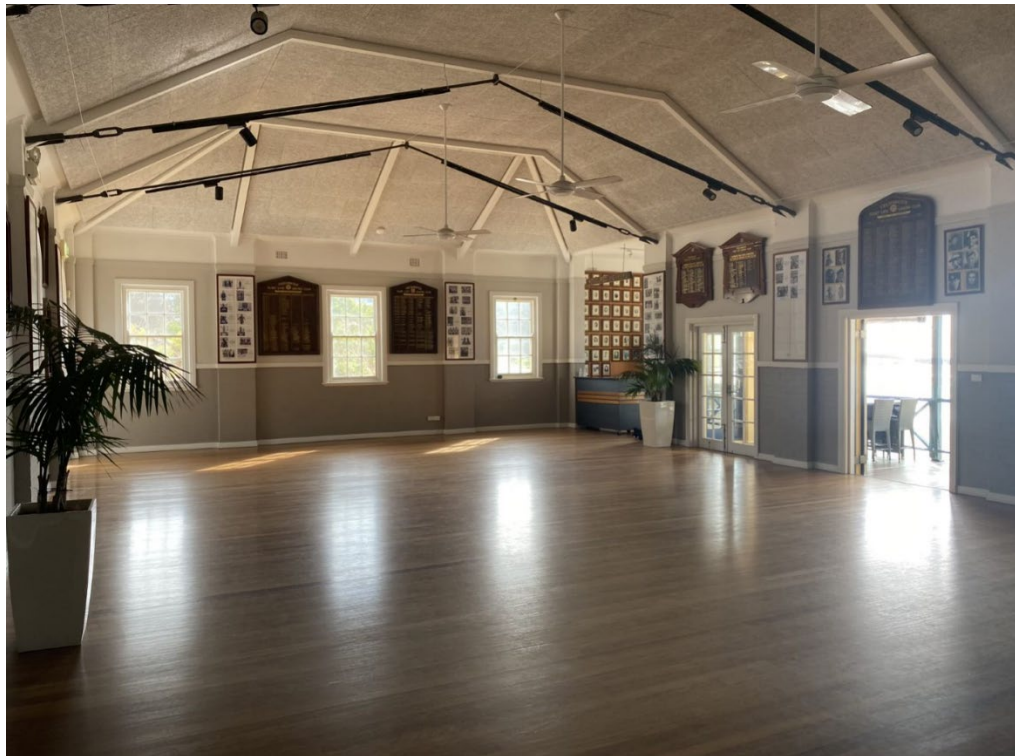
Figure 27: Interior of the surf club building (Level 2), view looking east (Source: NBRS, 1 February 2023)

The configuration of the ground floor (level two) of the clubhouse building can be described as a largely open plan hall with a small L-shaped room on the southwest side of the building, currently acting as an office and storage area. This room is separated from the main hall by a masonry partition wall, with access available internally from the southern corner of the building.

The interiors of the clubhouse are generally consistent with the general Interwar character of the building. The perimeter walls of the interior are painted brick to the dado with a rendered finish above to a picture rail. The walls are articulated by evenly spaced engaged piers that run from the timber floors to the ceiling. The ceiling is of an open configuration with metal support structures in the form of rafters and beams supporting the structure, with the assistance of bracing. The ceiling appears to be clad in contemporary sound-proof panels painted a white/grey consistent with the general aesthetic of the interiors. Natural light is provided by original eight-pane timber framed sash windows, as well as openings onto the southern balcony area. The interior features a number of pieces of memorabilia and commemorative plaques that adorn the walls and demonstrate the long history of the club.

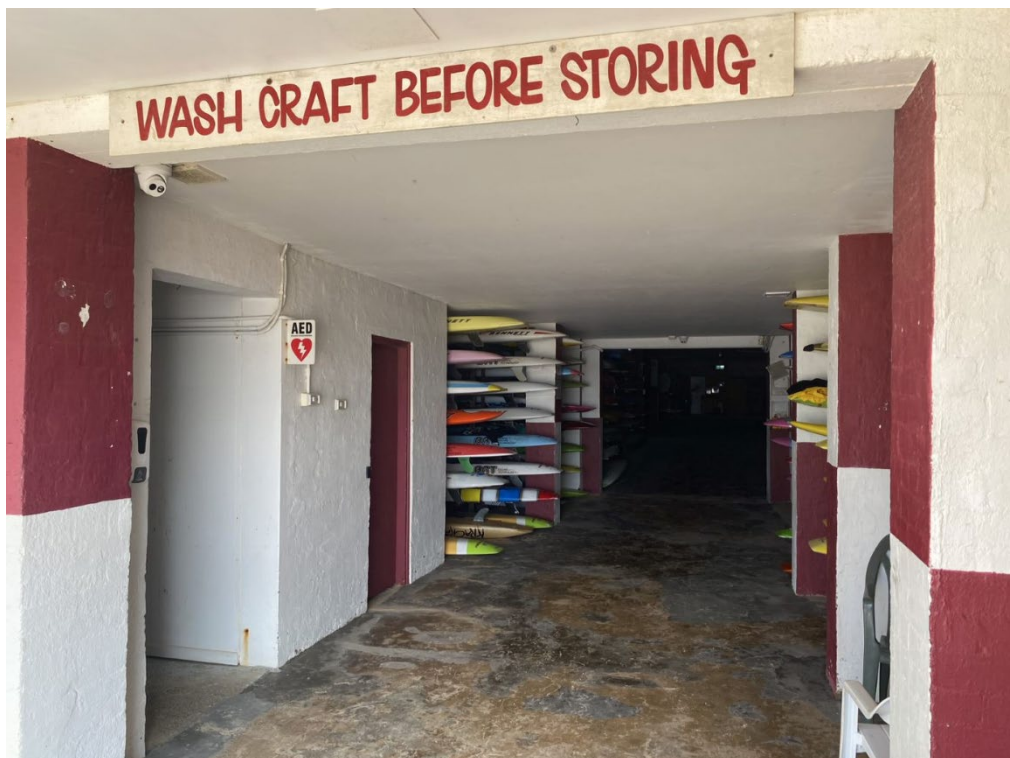
Figure 29: Basement of the original surf club building (Level 1), view looking west (Source: NBRS, 1 February 2023)

The beach level (level one) interiors of the clubhouse building have been heavily modified in order to support the functions of the surf club and their evolving needs over time. The configuration can be generally described as an open plan storage area with a link to the rear underground carpark and service rooms (patrol room, first aid rooms and storage rooms) on the north and south sides of the central storage area. The area is generally austere in design featuring painted brick walls and columns, with some later partition walls associated with the service rooms. Access is provided to the later 1980s addition through a beach access tunnel at the rear of the space.

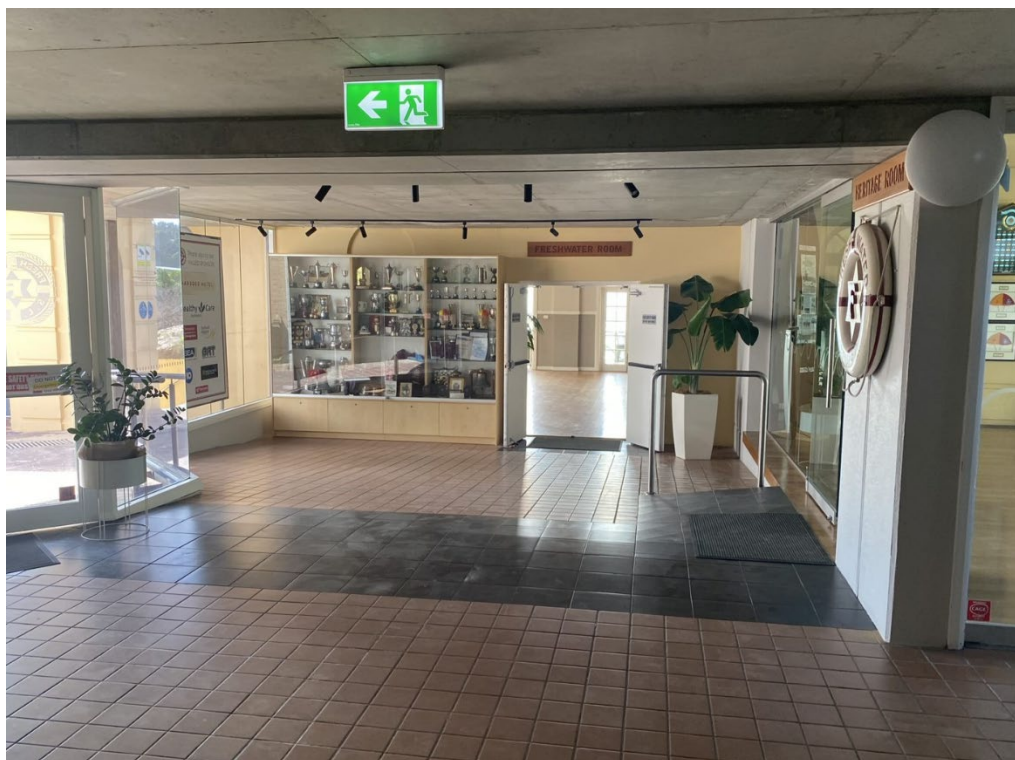
Figure 31: Interior of the junction between the original surf club building and 1980s addition, view looking southeast to the surf club building (Source: NBRS, 1 February 2023)

The new enclosed connection between the original, 1935 building and the 1986 clubhouse extension replaces the earlier glazed link and heritage room. The proposed connection has been carefully detailed to ensure the junction is sympathetic to the materials and detailing of the original building and enables reinstatement of the original door and window openings. The stylistically simple, contemporary form of the new façade and cladding incorporates both the 'Museum of Surf' connection and the 1986 clubhouse extension to ensure it presents as a single, cohesive built element that is readily discernible from the significant fabric of the local heritage item in form, materials and detailing.

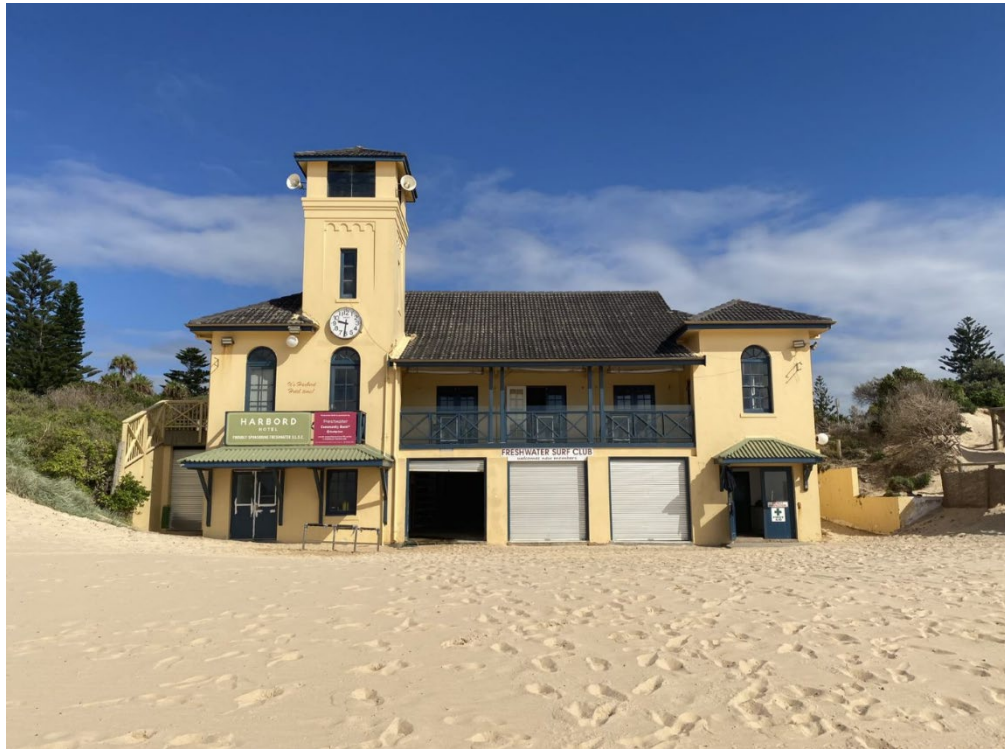
Figure 36: Front façade of the clubhouse building as seen from Freshwater Beach, view looking northwest (Source: NBRS, 1 February 2023)

Views of the site from surrounding development are available from a distance, however these views are largely obscured by the vegetation and trees along the site boundary. Primary views of the original building are from the beachfront on the east with primary views of the later addition seen from the west. Views of the site from the north and the south are obscured by vegetation and trees lining the driveway and site boundary.

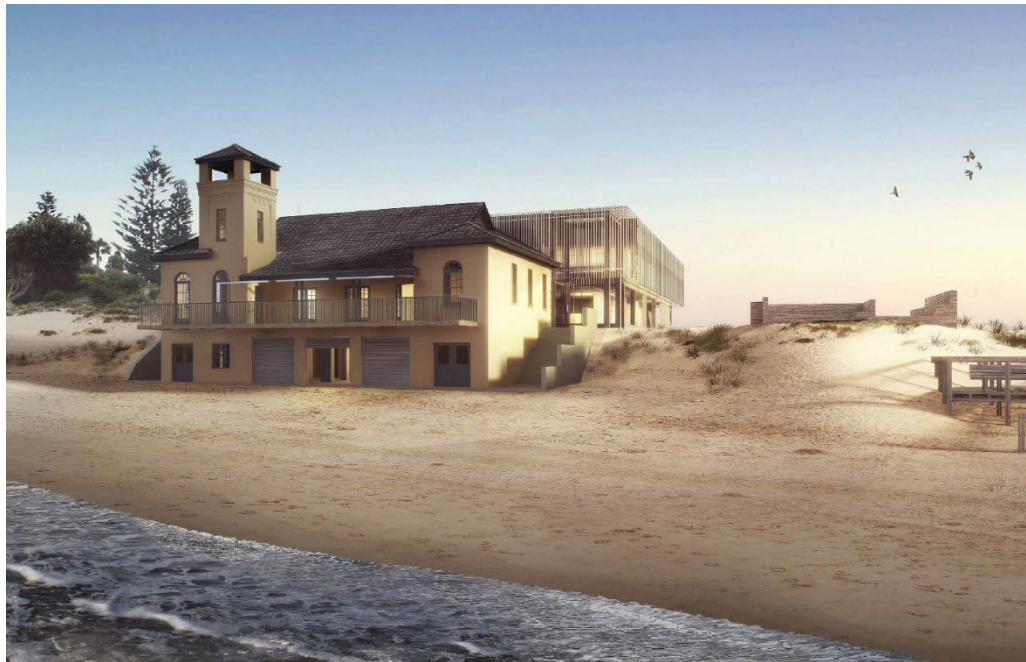
Figure 41: Photomontage of the proposed alterations and additions to Freshwater SLSC (Source: Bonus + Associates Architects, Revision A, Issued 8 May 2023)

The proposed alterations and additions to the Freshwater SLSC removes the incongruent 2009 entry and heritage room, which presently connects the original 1935 clubhouse with the 1986 extension, and replaces it with a new double-height atrium connection that shall enable users of the site to view and enjoy the original northwest façade. The new cladding and façade will unify the 1986 clubhouse extensions and the proposed additions as a cohesive and contemporary built form that enables the continued appreciation of the heritage significant 1935 clubhouse building.

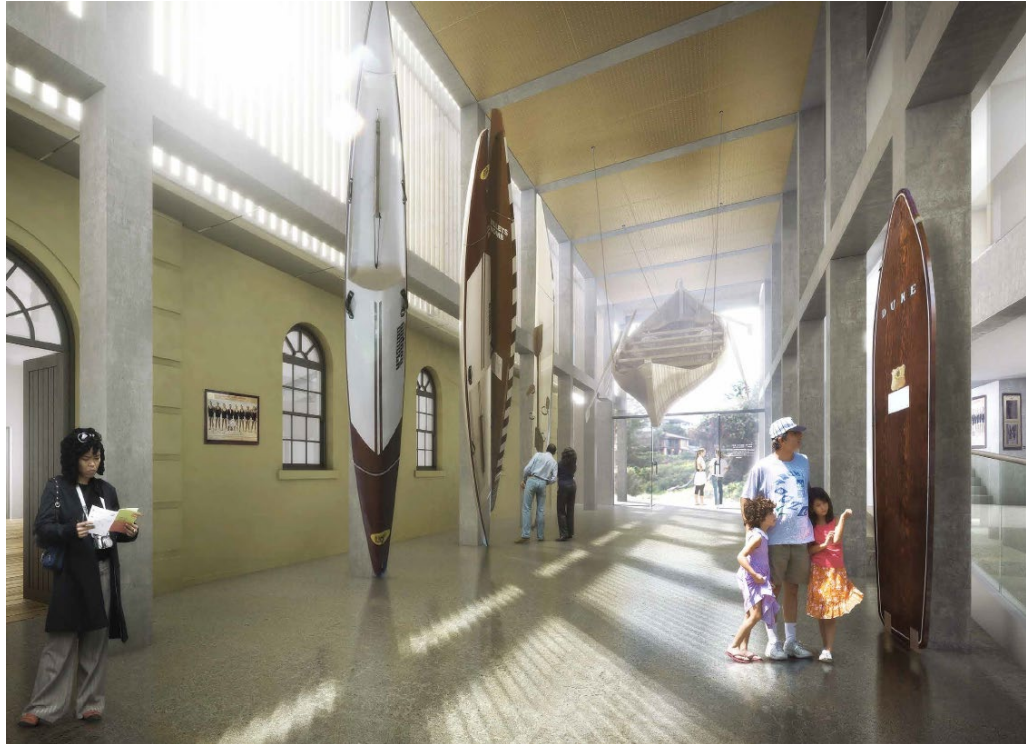
Figure 44: Photomontage of the interior of the proposed new Museum of Surf to Freshwater SLSC (Source: Bonus + Associates Architects, Revision A, Issued 8 May 2023)

- Demolition of existing structure and construction of a new infill building to provide a new club entry along with a multi-purpose hall, a double height space to be used for functions and exhibitions, including as a Museum of Surf in the northern beaches of Australia.
