Report on  
Geotechnical Investigation

Proposed Culvert Modification  
Condamine Street  
Brookvale

Prepared for  
Westfield Design and Construction Pty Ltd

Project 71015.22  
February 2014

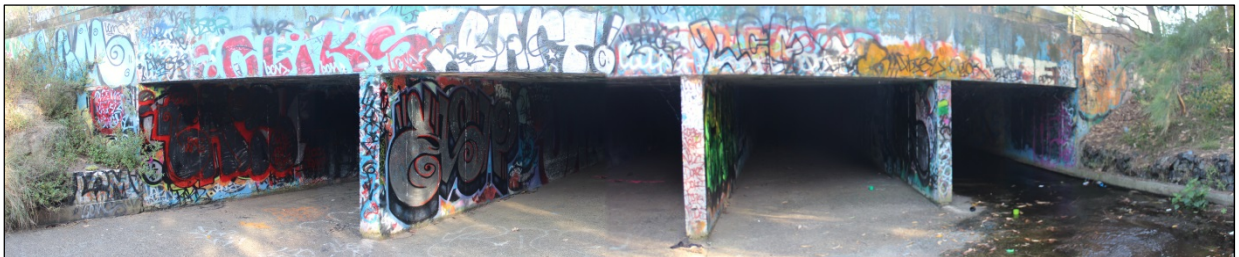
The culvert is a reinforced concrete box culvert with an approximate length of 10 m, and total width of approximately 12 m. It is divided into four separate cells, each with an internal height of 1.8 m and width of 2.8 m. The RMS drawings indicate that the culvert is divided into four sections along its length, with two central sections under Condamine Street approximately 13 m long, and two shorter sections at each end, approximately 3 m long. No foundation details are shown for the culvert, suggesting that it is founded at shallow depth. From the more recent Cardno drawings, invert levels fall from approximately RL 6.0 m at the upstream end to RL 5.5 m at the downstream concrete apron. Figure 1 shows a view of the culvert from the apron at the time of the investigation.

**Figure 1: Culvert as viewed from the downstream apron.**

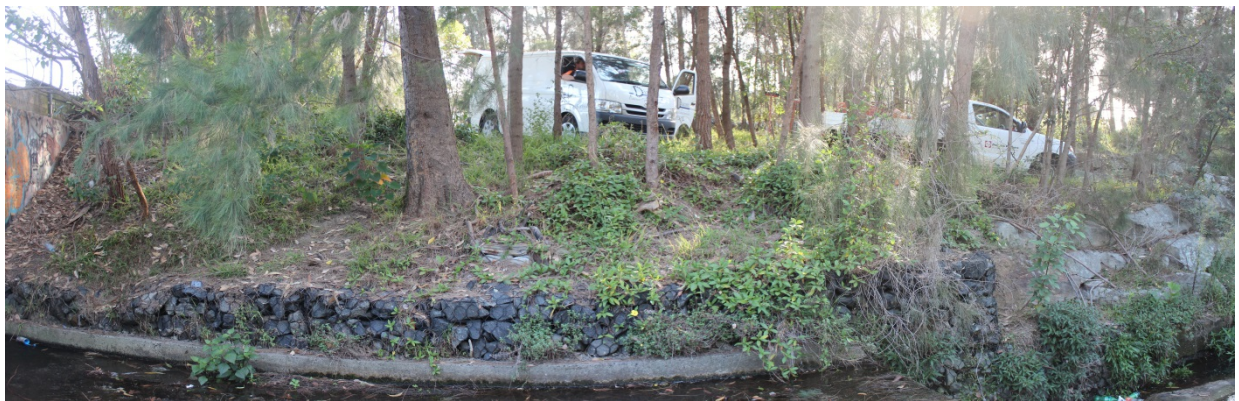
The northern slope is supported by a 600 mm high gabion retaining system wall to a distance of approximately 9.0 m from the culvert opening. Behind the gabion retaining wall, the ground slopes up at approximately 20° to at least 3 m from the apron. Slopes then locally steepen up to approximately 40° towards the access path over the culvert, or become more gently sloping towards the vehicle access road for the Brookvale Creek gross pollutant trap. The sloping ground in this area is vegetated with mature trees and some low shrubs. Topsoil is present at ground surface.

**Figure 2: Northern slope to apron**

There were no signs of existing slope instability at the northern and southern slope, with the exception of some minor creep of topsoil.

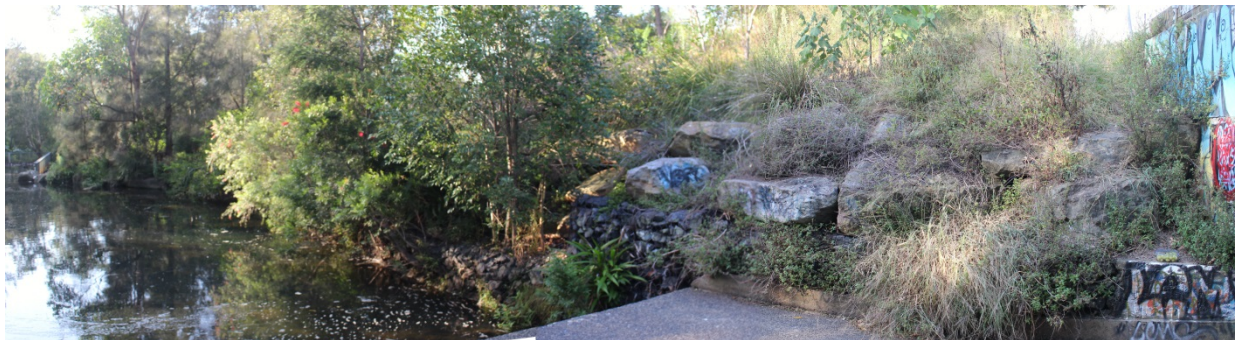
The southern slope is also supported by a 600 mm high gabion wall. The gabion retaining system is overlain by large, well-placed sandstone blocks stepping back to a height of approximately 2 m above apron level at approximately 30°. The slope then continues at approximately 20°, vegetated by grasses, low shrubs and small trees. A photograph of the southern slope is provided in Figure 3, below.

**Figure 3: Southern slope to apron**
