RESIDENTIAL DEVELOPMENT
38 UNDERCLIFF ROAD, FRESHWATER NSW

Reference: P3371_01 Rev 1

17 October 2024

Morrow Geotechnics Pty Ltd has undertaken a Geotechnical Investigation to provide geotechnical advice and recommendations for the proposed development at 38 Undercliff Road, Freshwater NSW (the site).

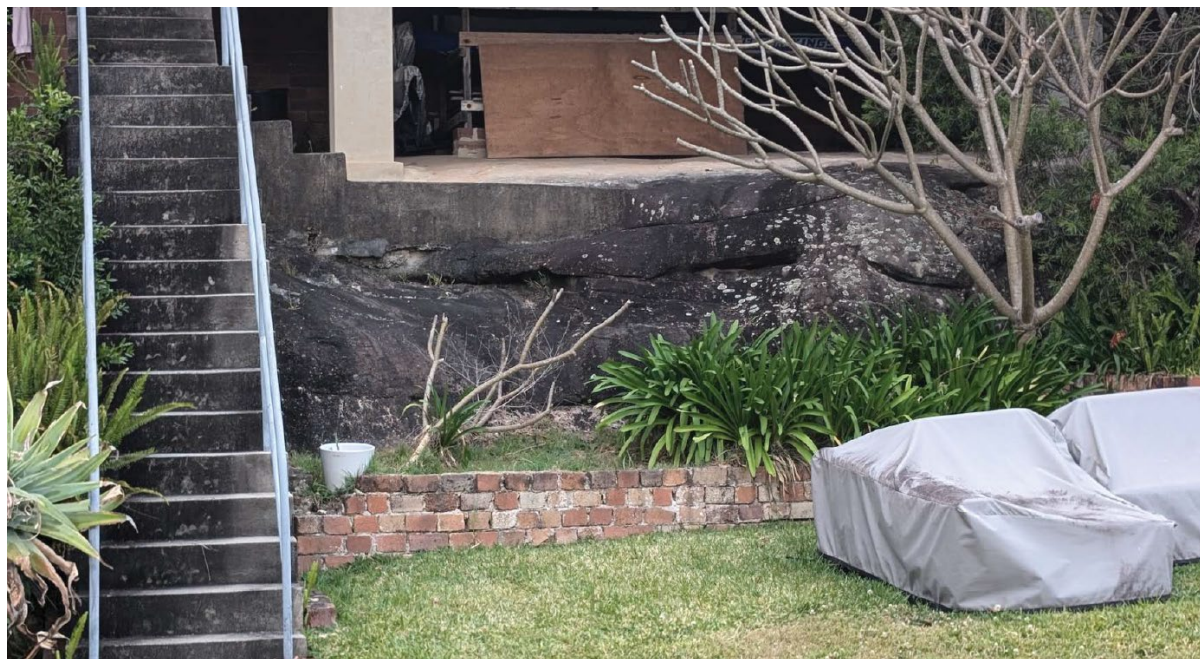
Sandstone outcrops at a cliff line approximately 1.5 m high near the centre of the site. The cliff line trends roughly east-west and comprises moderately weathered, medium strength Hawkesbury Sandstone.

**Photo 1:** Sandstone outcropping at centre of site.

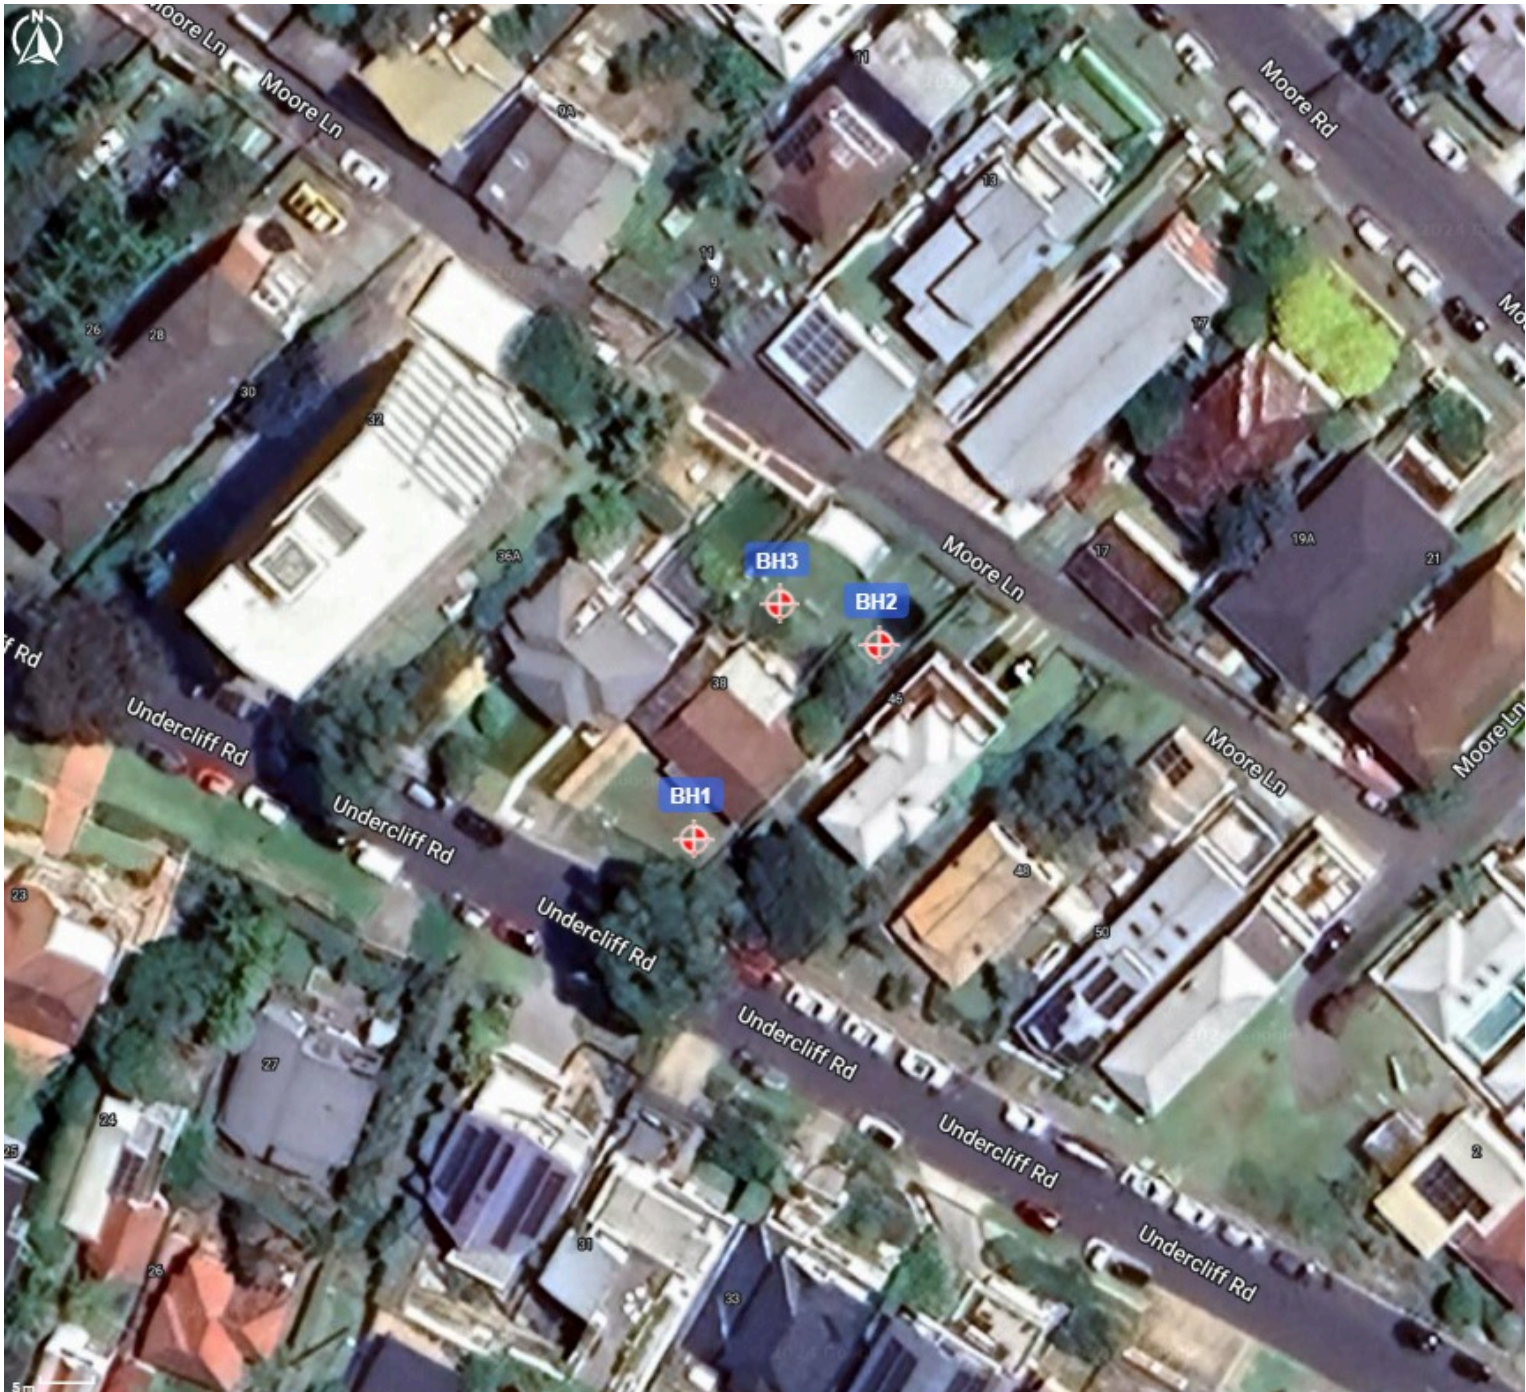
Figure:
1

Borehole locations are shown on **Figure 1** and borehole logs are presented in **Appendix A**.

Borehole Location Plan

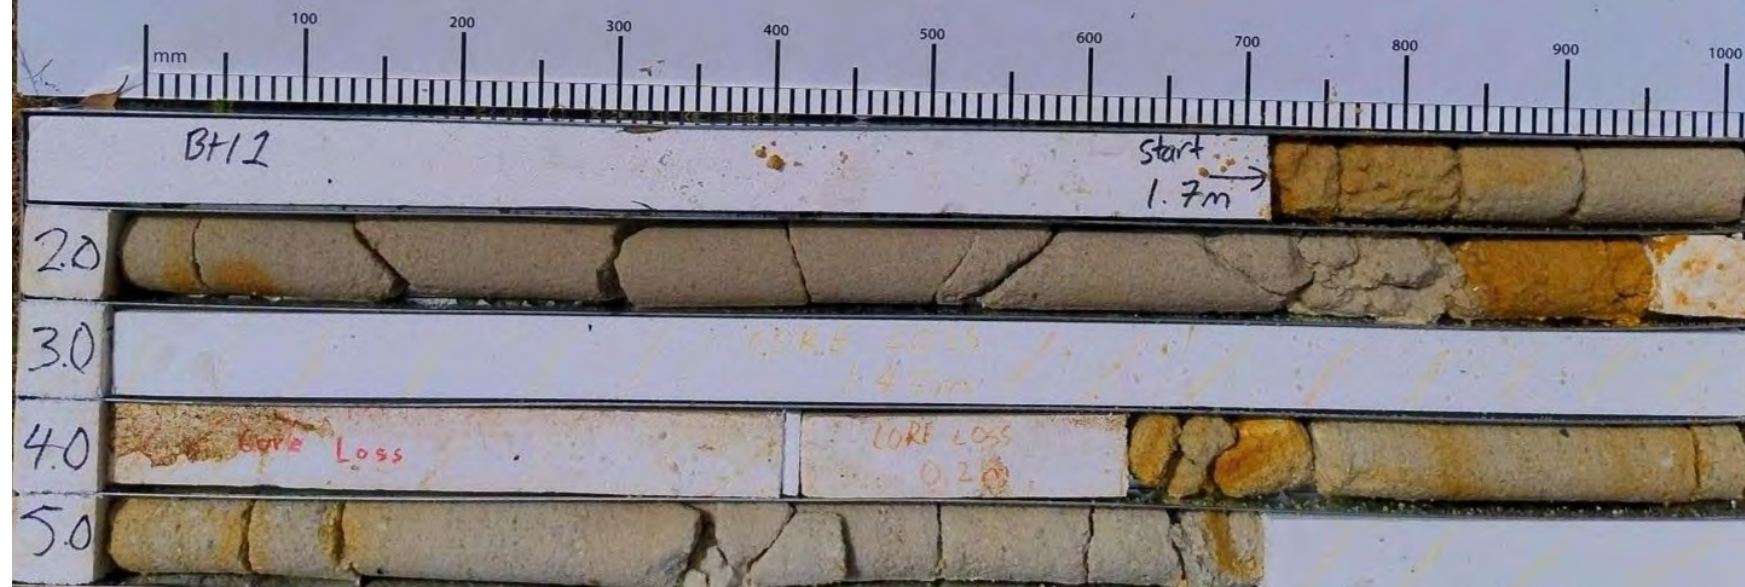
CORE TRAY NO.: 1

BOREHOLE ID: BH1

DEPTH: 1.7 - 6.0m
