PRELIMINARY ASSESSMENT: Acid Sulfate

For New House and Pool at **1005-1009 Barrenjoey Road, Palm Beach**

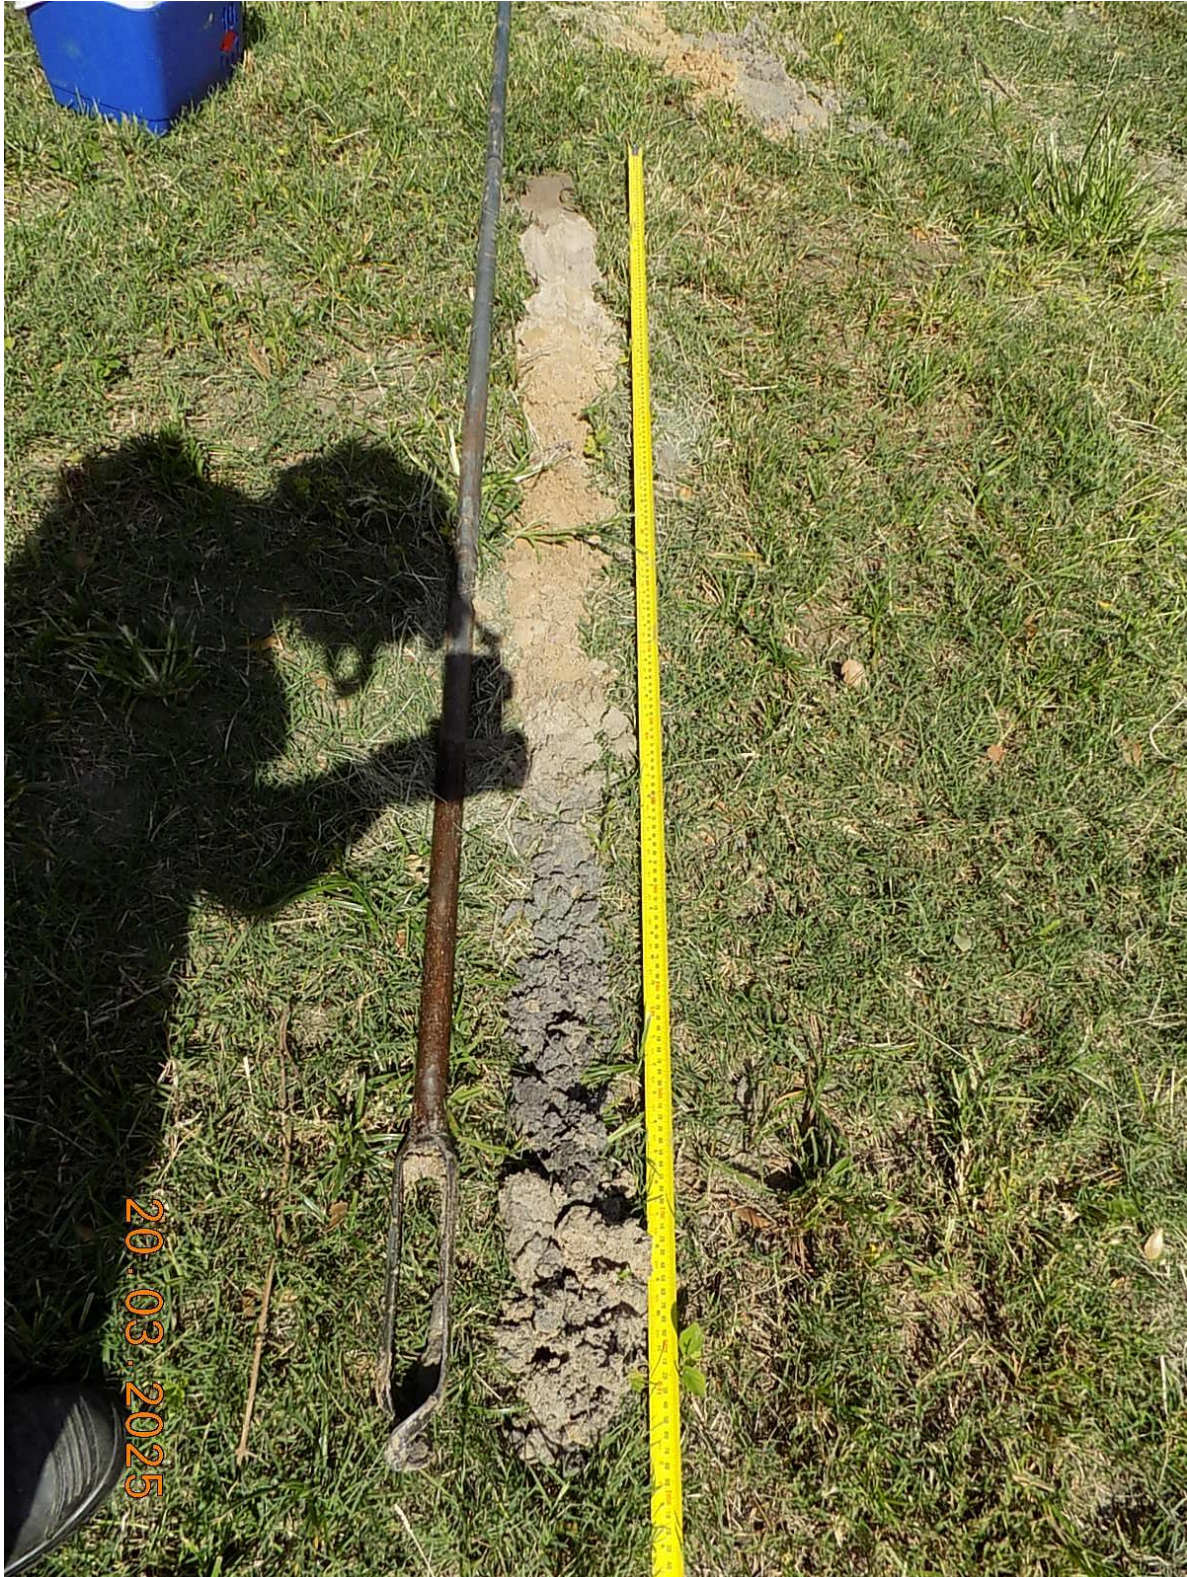
Photo 1: AH1 – Downhole is from top to bottom

AUGER HOLE 1 (~RL1.6) – AH1 (Photo 1)

Depth (m)	Material Encountered
0.0 to 0.2	TOPSOIL , silty sandy soil, brown, Dense, dry, fine to medium grained.
0.2 to 1.2	MARINE SEDIMENT , clean quartz sand, yellow, Medium Dense to Dense, dry to damp, medium grained, shell fragments throughout.
1.2 to 1.9	MARINE SEDIMENT , clean quartz sand, grey, Medium Dense, wet, medium to coarse grained, shell fragments throughout.

End of hole @ 1.9m in marine sediment. Hole collapsing due to presence of water. Water table encountered at ~1.3m.

TEST: AH1	FIELD pH & PEROXIDE RESULTS				
Sample depth (m)	pH _F	30% Peroxide reaction	pH _{FOX}	pH _F - pH _{FOX}	SS=Shell J=Jarosite R=Roots
0.1	7.7	M	7.5	0.2	<5% R
0.6	8.0	M	7.8	0.2	<5% SS
1.1	7.9	H	7.6	0.3	<5% SS
1.6	7.7	H	7.4	0.3	<5% SS
1.9	7.5	H	7.3	0.2	<5% SS

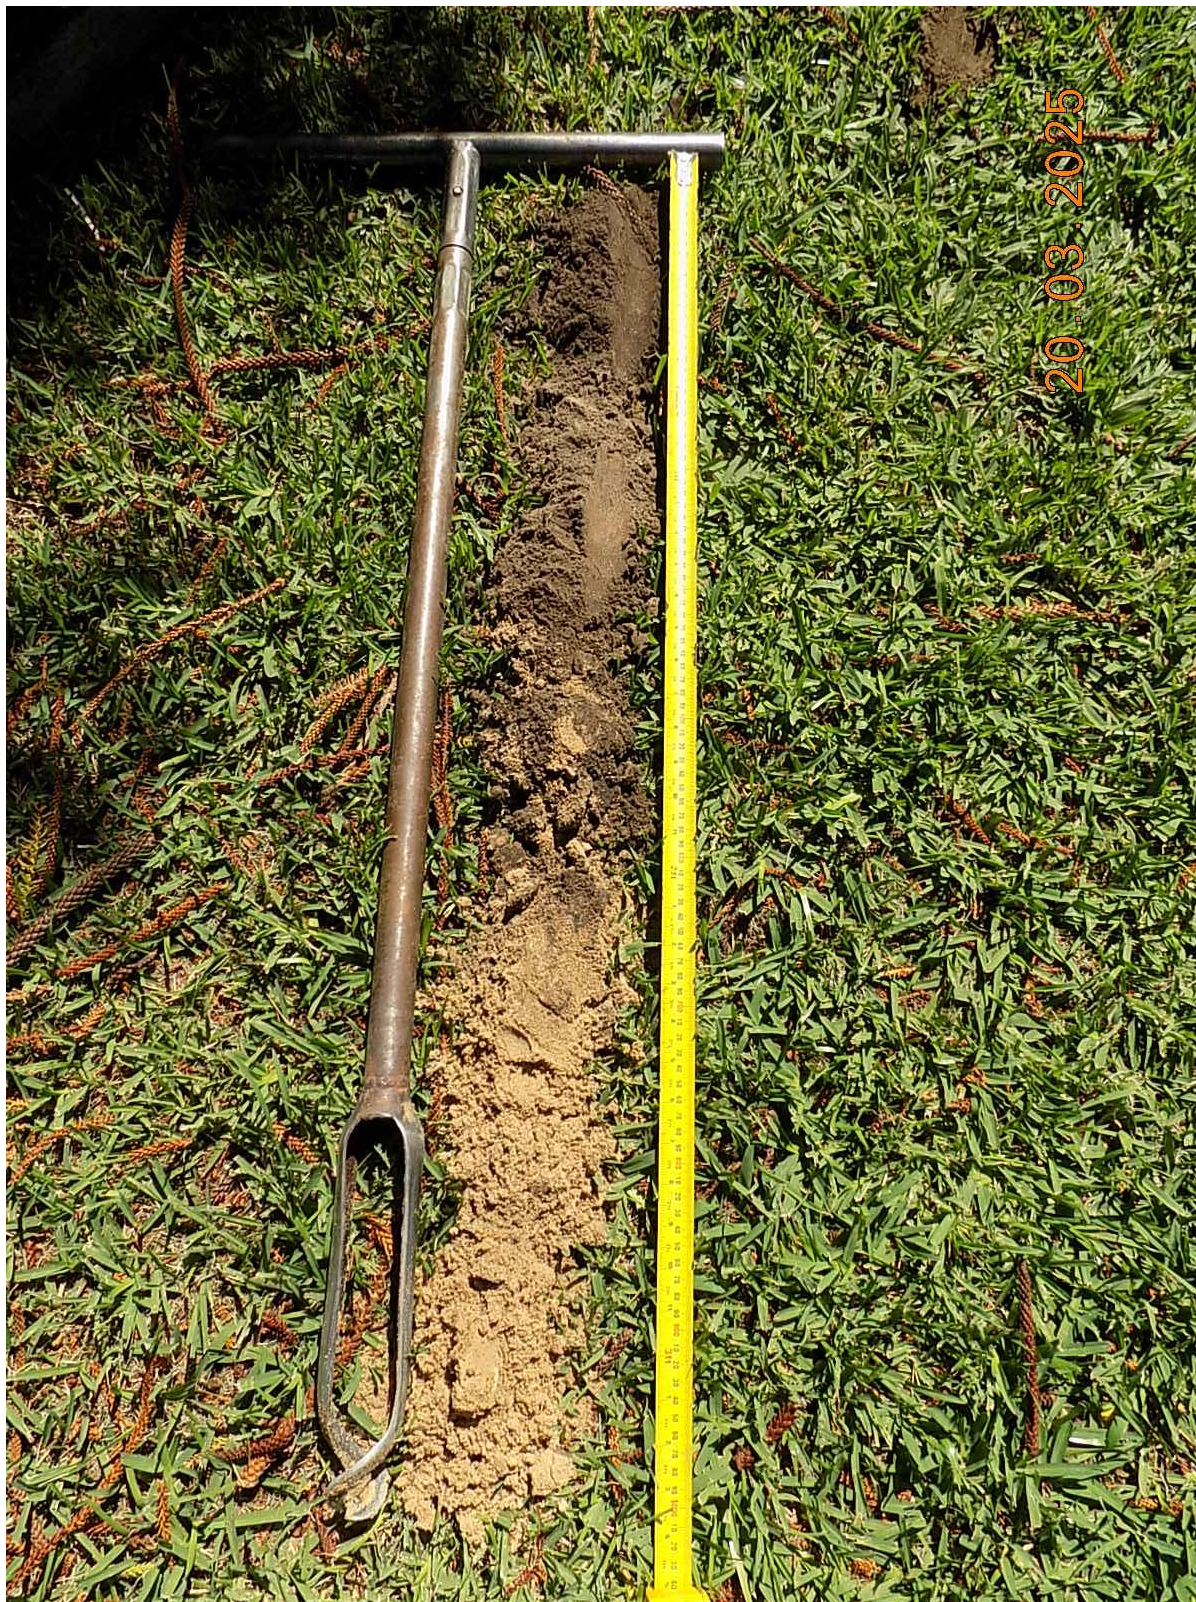
Photo 2: AH2 – Downhole is from top to bottom

AUGER HOLE 2 (~RL1.9) – AH2 (Photo 2)

Depth (m)	Material Encountered
0.0 to 0.2	FILL , sandy fill, dark brown, Medium Dense, dry, medium grained.
0.2 to 0.6	TOPSOIL , silty sandy soil, brown, Medium Dense, dry, fine to medium grained.
0.6 to 1.0	MARINE SEDIMENT , clean quartz sand, yellow, Medium Dense, dry, medium grained, shell fragments throughout.

End of Hole @ 1.0m in Marine sediment (sand). No water table encountered.

TEST: AH2	FIELD pH & PEROXIDE RESULTS				
Sample depth (m)	pH _F	30% Peroxide reaction	pH _{FOX}	pH _F - pH _{FOX}	SS=Shell J=Jarosite R=Roots
0.2	7.6	M	7.5	0.1	<5% R
0.5	7.9	M	7.9	0	-
1.0	8.3	H	8.1	0.2	<5% SS

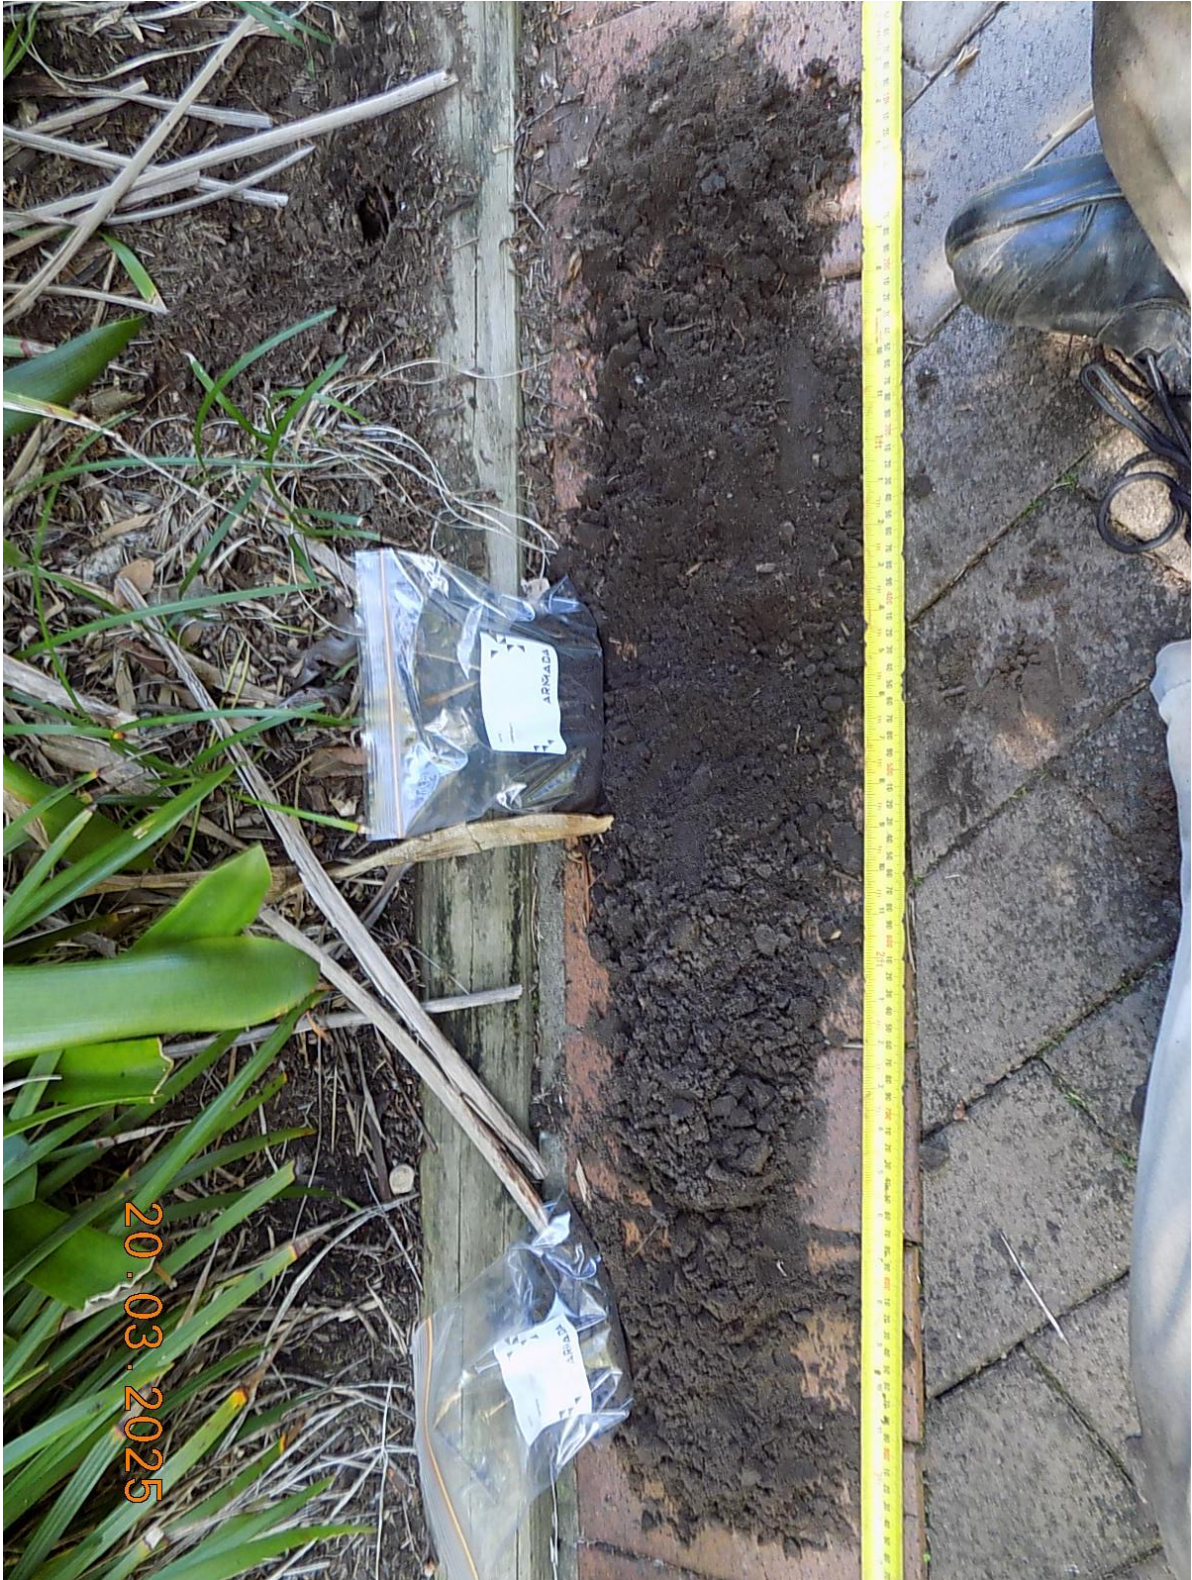
Photo 3: AH3 – Downhole is from top to bottom

AUGER HOLE 3 (~RL2.2) – AH3 (Photo 3)

Depth (m)	Material Encountered
0.0 to 0.2	FILL , sandy fill, dark brown, Very Dense, dry, medium grained.
0.2 to 0.6	TOPSOIL , sandy, dark brown, Dense, dry, fine to medium grained.
0.6 to 1.0	SANDY LOAM , dark brown, Dense, dry, fine to coarse grained.

End of Hole @ 1.0m in sandy loam. No water table encountered.

TEST: AH3	FIELD pH & PEROXIDE RESULTS				
Sample depth (m)	pH _F	30% Peroxide reaction	pH _{FOX}	pH _F - pH _{FOX}	SS=Shell J=Jarosite R=Roots
0.5	7.6	M	7.5	0.1	<5% R
1.0	7.8	M	7.5	0.3	-

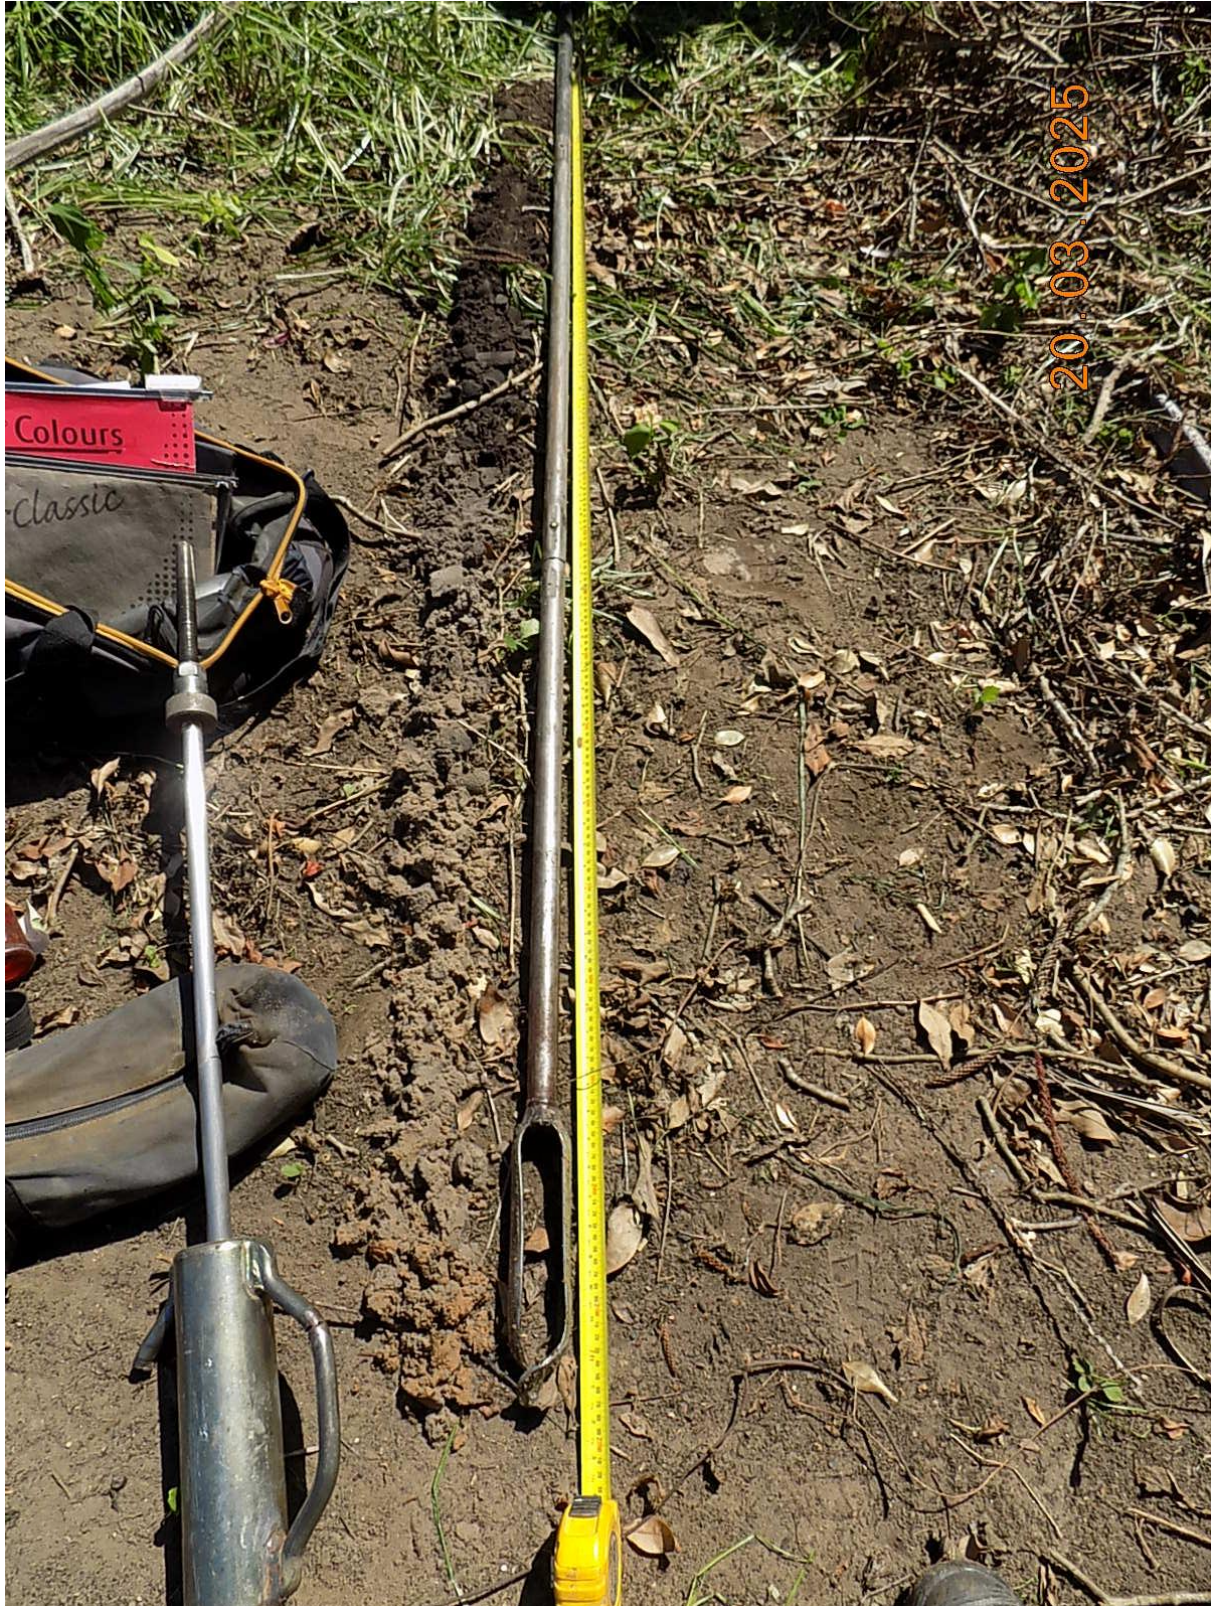
Photo 4: AH4 – Downhole is from top to bottom

AUGER HOLE 4 (~RL2.2) – AH4 (Photo 4)

Depth (m)	Material Encountered
0.0 to 0.4	FILL , sandy fill, dark brown, Very Dense, dry, medium grained.
0.4 to 0.7	TOPSOIL , sandy, dark brown, Medium Dense to Dense, dry, fine to medium grained.
0.7 to 1.1	SANDY LOAM , dark brown, Medium Dense, dry, fine to coarse grained.
1.1 to 2.1	MARINE SEDIMENT , clean quartz sand, grey to orange, Medium Dense, dry to wet, medium to coarse grained, shell fragments throughout, maroon clay flecks at base of auger.

End of Hole @ 2.1m in marine sediment. Hole collapsing due to presence of water. Water table encountered at ~1.6m.

TEST: AH4	FIELD pH & PEROXIDE RESULTS				
Sample depth (m)	pH _F	30% Peroxide reaction	pH _{FOX}	pH _F - pH _{FOX}	SS=Shell J=Jarosite R=Roots
0.2	7.1	L	7.0	0.1	<5% R
0.6	7.3	L	7.2	0.1	-
0.8	7.1	M	6.9	0.2	-
1.3	6.9	M	6.8	0.1	<5% SS
1.7	6.9	M	6.7	0.2	<5% SS
2.1	6.5	M	6.5	0	<5% SS
