Proposed Development

40 Myoora Road, Terrey
Hills, NSW

Proposed Development – 40 Myoora Road, Terrey Hills, NSW Geotechnical Investigation Report

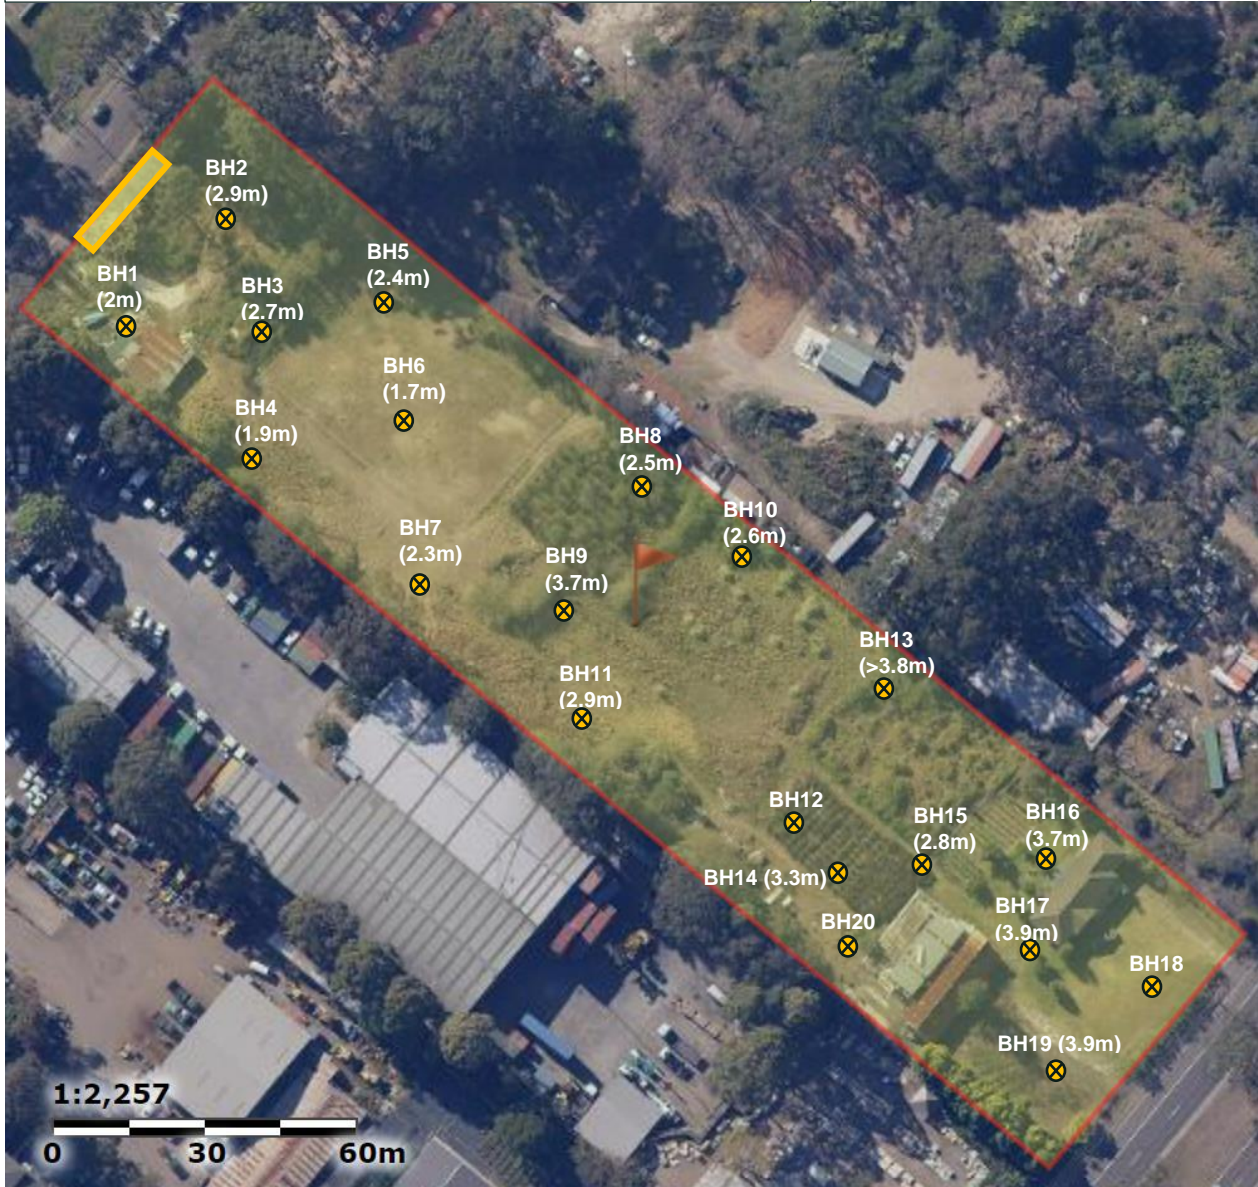
PHOTOGRAPH AND BOREHOLE LOCATIONS

Borehole Locations (depth to XW/HW Bedrock) -

Approximate Location of Unstable Batter Slope -

- The unstable slope along Myoora Road (northern boundary of the site) is to be cleared of all fallen trees and loose soil, and regraded to a suitable batter angle for a permanent slope, as recommended in Section 6.5. Any new material placed on the slope should be adequately benched into the existing slope to prevent the creation of preferential failure planes and the slope should be inspected an experienced geotechnical engineer to assess its stability prior to any filling operations. If the proposed development does not allow for less steep slopes to be incorporated in the design, additional stabilisation measures may be required. Several options are available depending on budget, time constraints, and the desired outcome. Fortify Geotech can offer potential solutions, including terracing, soil removal and recompaction, geocells or retaining walls.

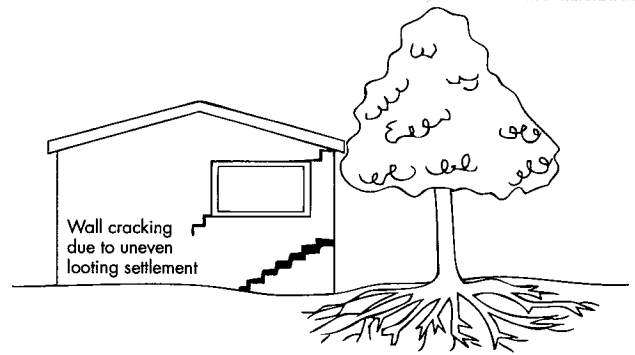
Trees can cause shrinkage and damage

As the weather pattern changes and the soil begins to dry out, the external footings will be first affected, beginning with the locations where the sun's effect is strongest. This has the effect of lowering the

external footings. The doming is accentuated and cracking reduces or disappears where it occurred because of dishing, but other cracks open up. The roof lines may become convex.
