Report Title: Geotechnical Report 35 Therry Street, Avalon
Report Date: 8/3/22

GEOTECHNICAL INVESTIGATION:

New Granny Flat at **35 Therry Street, Avalon**

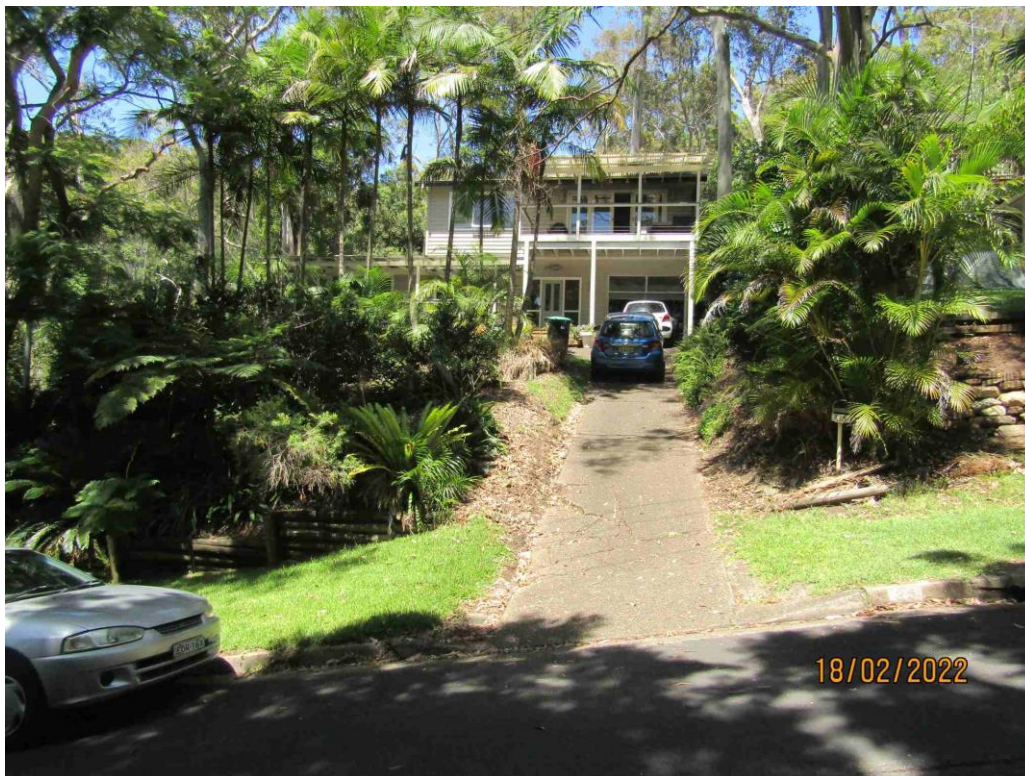
Photo 1

- 2.3** At the road frontage, a concrete driveway runs up the slope to a garage on the ground floor of the house (Photos 1 & 2). Fill provides a level platform for a garden/lawn area beside the driveway on the W neighbouring property. The fill is battered at stable angles. Fill terraces the slope and provides a level platform for a lawn and garden area on the downhill side of the house (Photos 1 & 3). The fill is supported by low timber retaining walls. The part two storey brick and timber clad house is supported by brick walls and brick piers (Photos 2 & 4). The supporting walls and piers stand vertical and show no significant signs of movement (Photo 5). Timber decks extend off the downhill and uphill sides of the house (Photos 2 & 4). A low concrete block retaining wall supports a cut on the E neighbouring property near the E common boundary. A stable concrete block retaining wall up to ~1.6m high supports

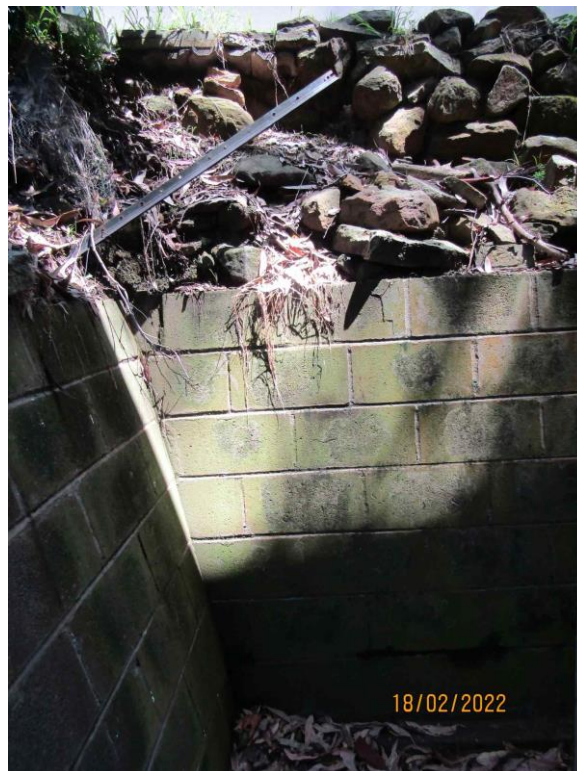
Photo 6

the cut for the house (Photos 6 & 7). Roughly placed rocks line a fill directly above the retaining wall on the W neighbouring property. See '**Section 13** Ongoing Maintenance'. Low timber retaining walls support filled lawn and garden areas on the uphill side of the house (Photo 8). No signs of slope instability were observed on the property.

The Roughly placed rocks on the W common boundary that line a fill on the W neighbouring property (Photos 6 & 7) are to be monitored by the owner on an annual basis or after heavy and prolonged rainfall, whichever occurs first. A photographic record of these inspections is to be kept. Should movement occur the fill is to be supported by an engineered retaining wall. We can carry out these inspections upon request.

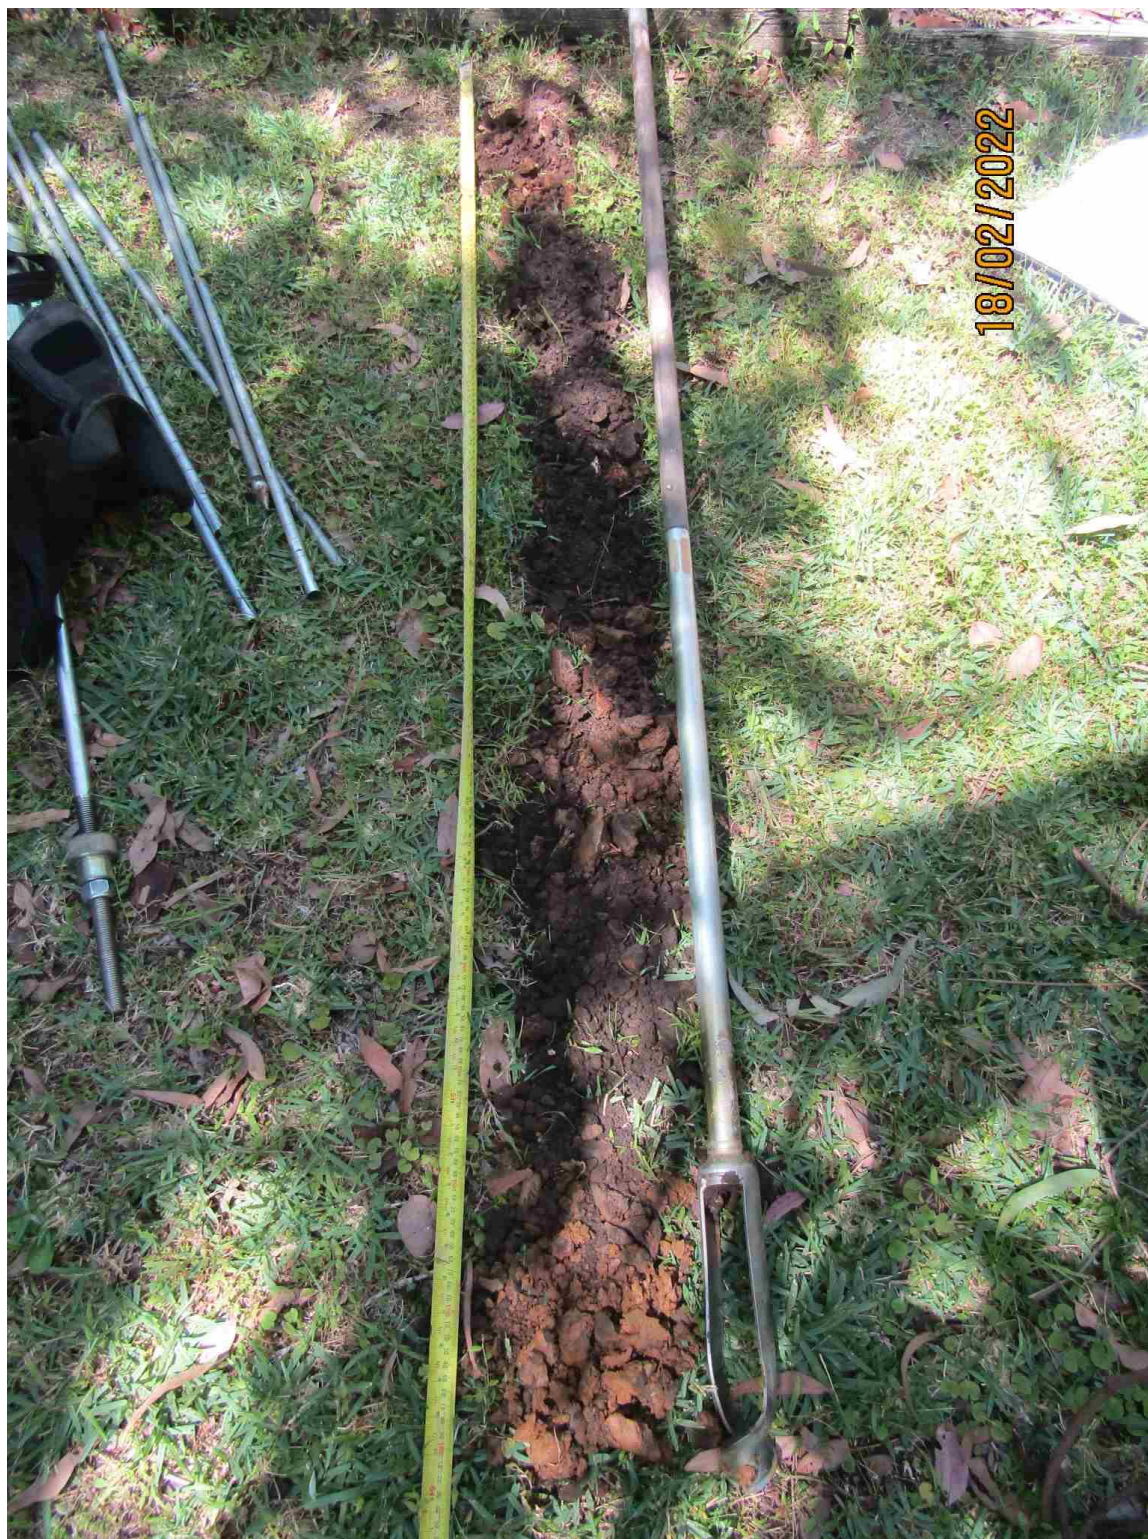
AUGER HOLE 1 (~RL25.3) – AH1 (photo 9)

Depth (m)	Material Encountered
0.0 to 1.6	FILL , sandy soil and clay, dark brown, brown orange, dry to moist, fine to medium grained.
1.6 to 1.8	CLAY , brown orange, dry to moist, stiff.

End of Hole @ 1.8m in stiff clay. No watertable encountered.

Photo 9: AH1 – Downhole is from top to bottom.
