# STATEMENT OF ENVIRONMENTAL EFFECTS

## ALTERATIONS AND ADDITIONS

114 Whale Beach Road, Whale Beach 2107  
Lot 82 DP 10782

Prepared by Amanda Elboz  
Space Landscape Designs Pty Ltd  
27<sup>th</sup> August 2020

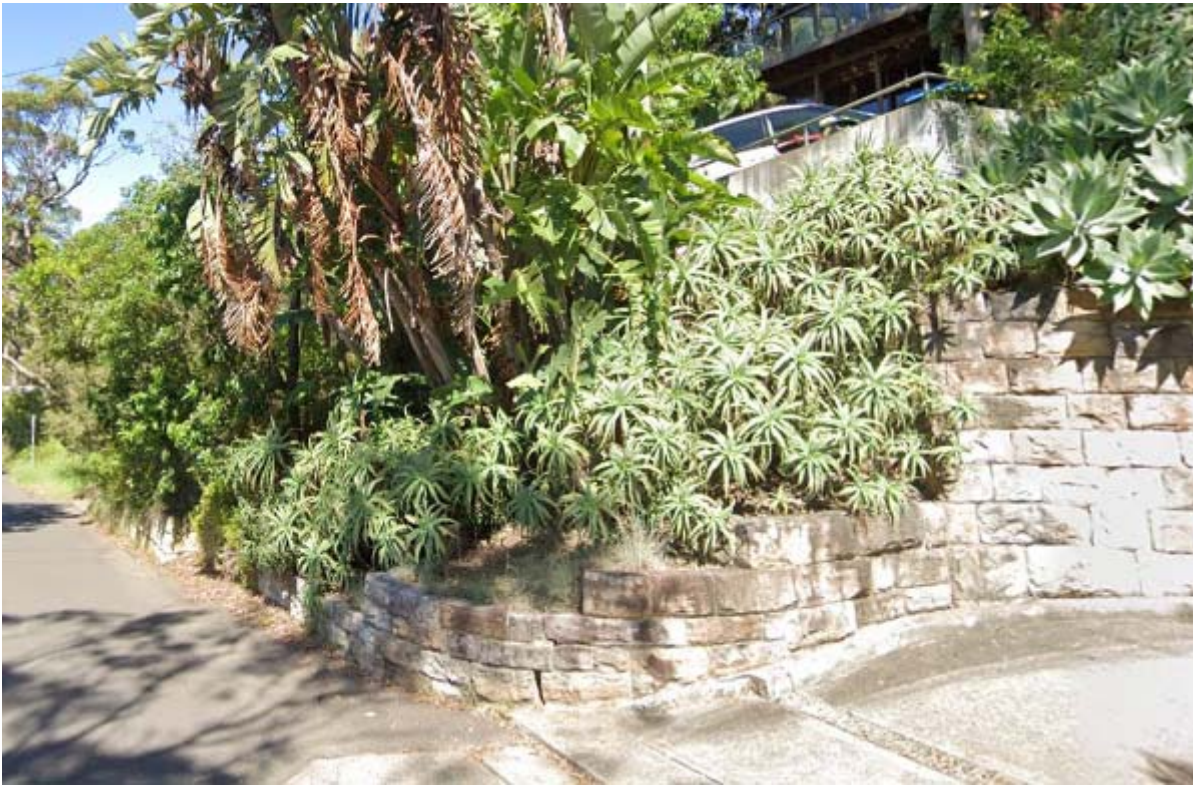
*Image 2 Existing stone retaining walls located on council verge and alongside driveways on Whale Beach Road*

The proposed retaining walls will be visible on Whale Beach Road due to part being located on the council verge. The new walls will be engineered to ensure further erosion and landslip does not occur onto the road. The lower wall will be clad in stone to blend in with the natural environment and enhance the existing streetscape. It is compatible with other existing retaining walls located on the street verge along Whale Beach Road. (Refer to Image 2)

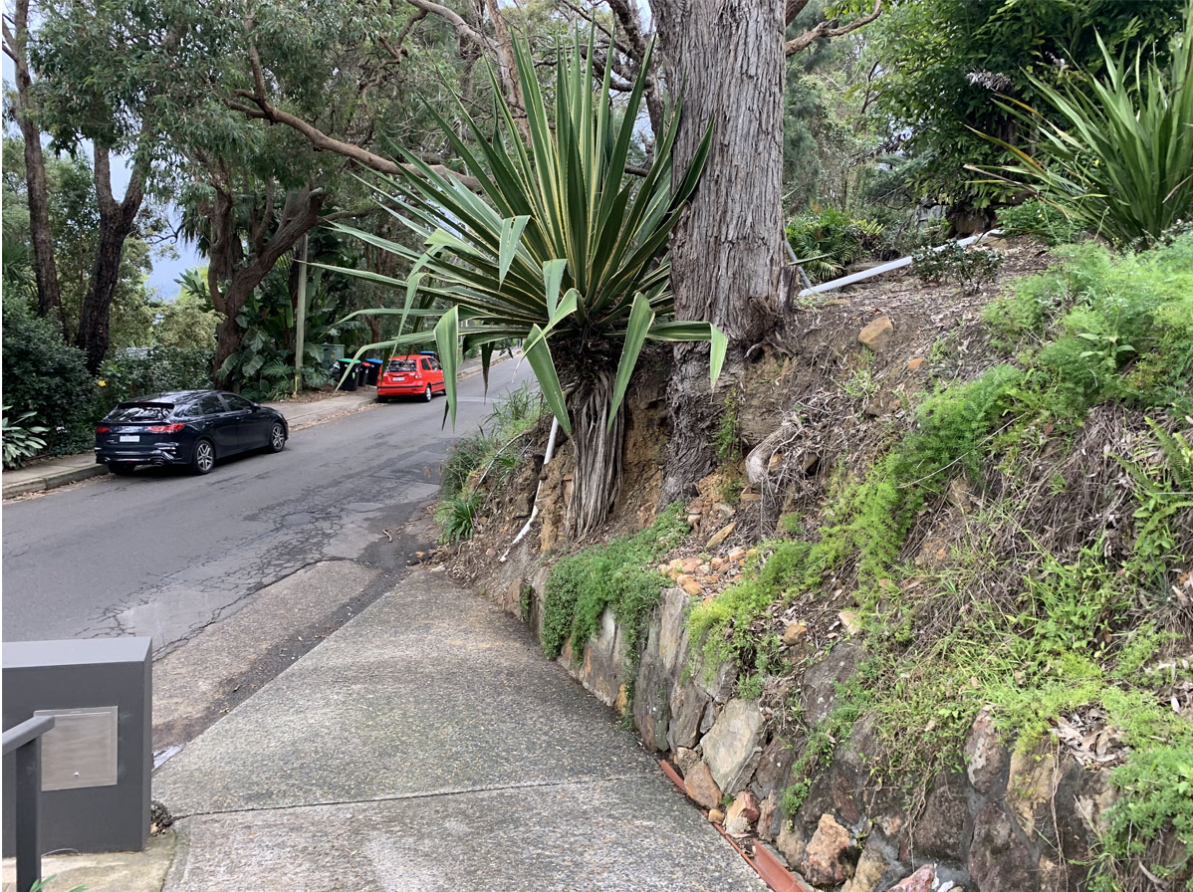
*Image 3 Showing existing failing stone wall to be replaced and tree to be removed*

The proposal seeks approval to replace an existing stone retaining wall that is in poor condition. A portion of the wall has partially collapsed with the roots of an *Angophora floribunda* exposed. As the bank is very steep, another retaining wall is proposed to create a tiered garden and keep the height of the lower wall as low as possible. As part of these works it is proposed to slightly widened the concrete driveway to enable better access into the driveway from Whale Beach Road.

The proposal has been designed to improve the safety and amenity of the existing site. The failing stone wall will be replaced with engineered walls that will prevent future landslip and erosion of the embankment. New native planting will soften the walls and improve the existing streetscape.

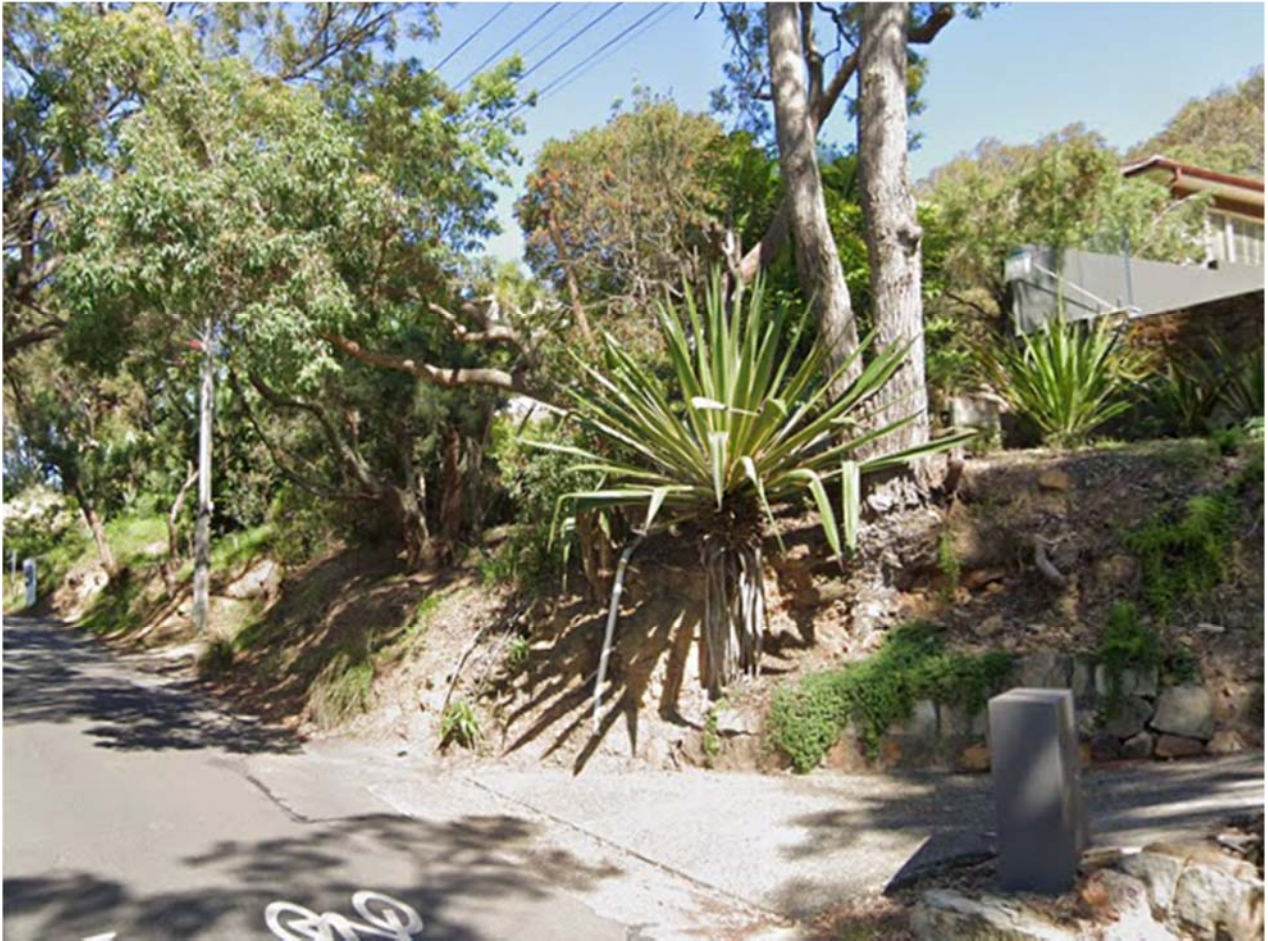
*Image 4 Showing existing failing stone wall and tree with exposed roots*

The development requires the removal of 4 trees. One tree is dead with the other three trees being identified by the Arborist Report as being lower value category Z retention value. One of the trees has visible roots with the others being required to be removed due to construction of the new walls.
