## **32 The Strand, Whale Beach**

### Geotechnical Comments for Section 4.55.

## **GEOTECHNICAL INVESTIGATION:**

New House at **32 The Strand, Whale Beach.**

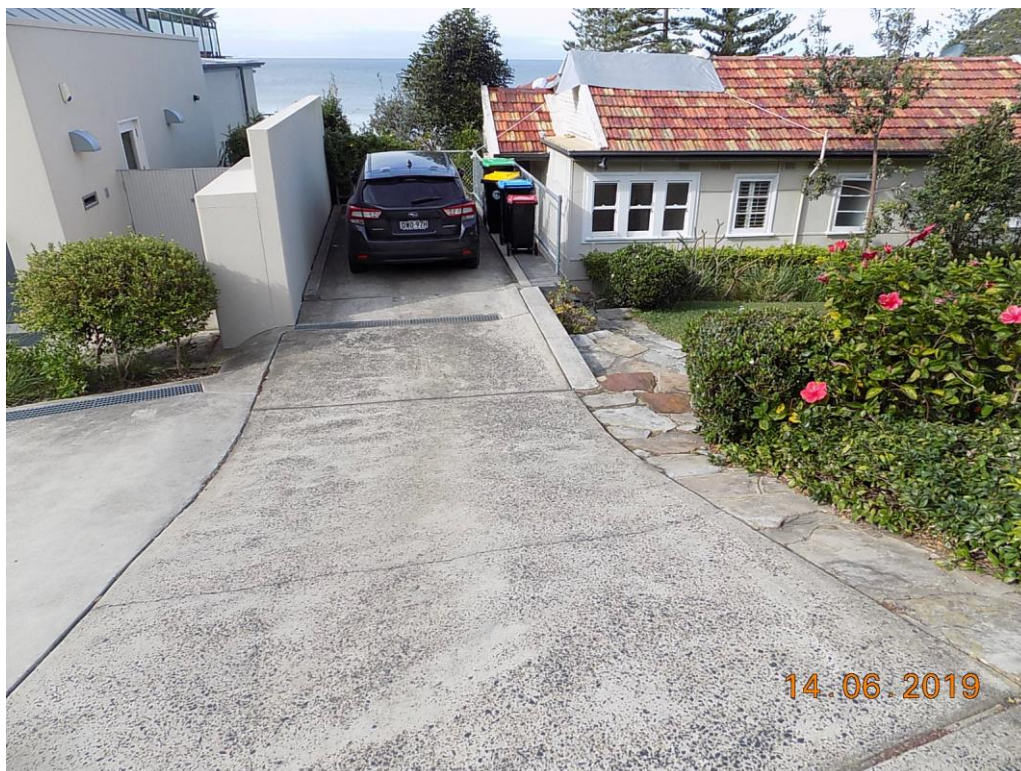
Photo 1

- 2.3** At the road frontage to Whale Beach Road, a concrete driveway runs to a concrete parking area on the uphill side of the property (Photo 1). Between the road frontage and the house is a gently sloping lawn (Photo 2). A gently sloping lawn-

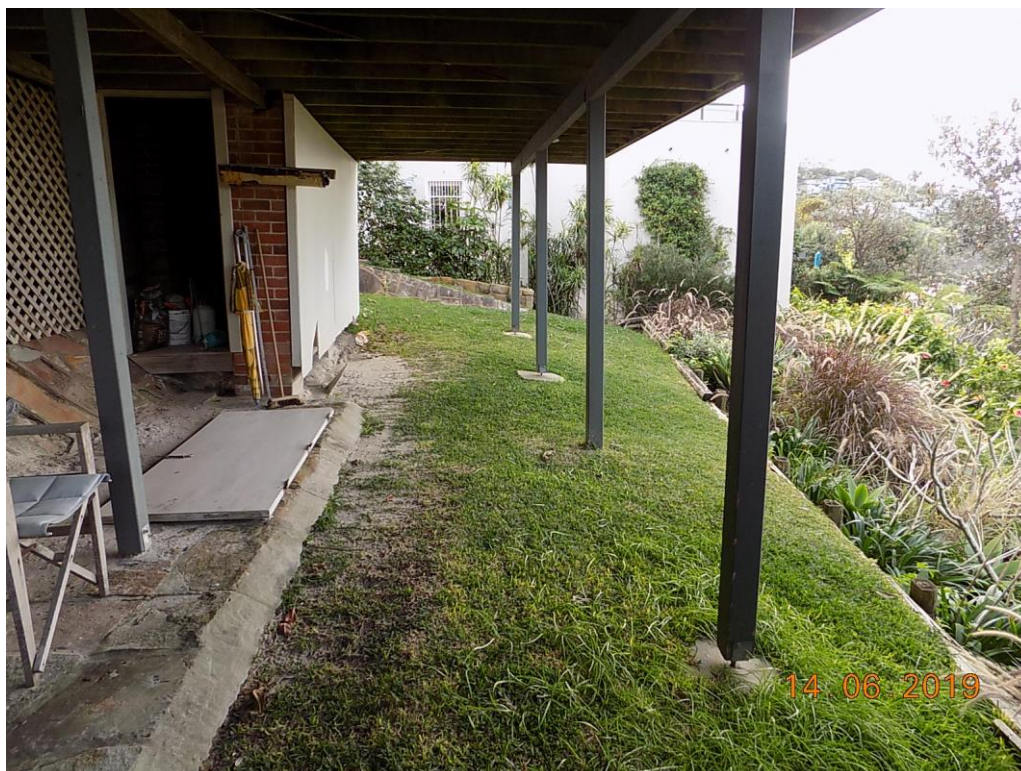
Photo 3

covered fill extends off the downhill side of the house and is supported by a timber retaining wall (Photo 3). The slope below the wall is terraced with a series of similar walls (Photo 4). The house (Photo 5) and all retaining walls will be demolished and the site will be cleared as part of the proposed works. Competent Medium Strength Sandstone bedrock outcrops near the toe of the slope (Photo 6). A near-level lawn extends from the toe of the slope to the road frontage with The Strand with the beach beyond (Photo 7).

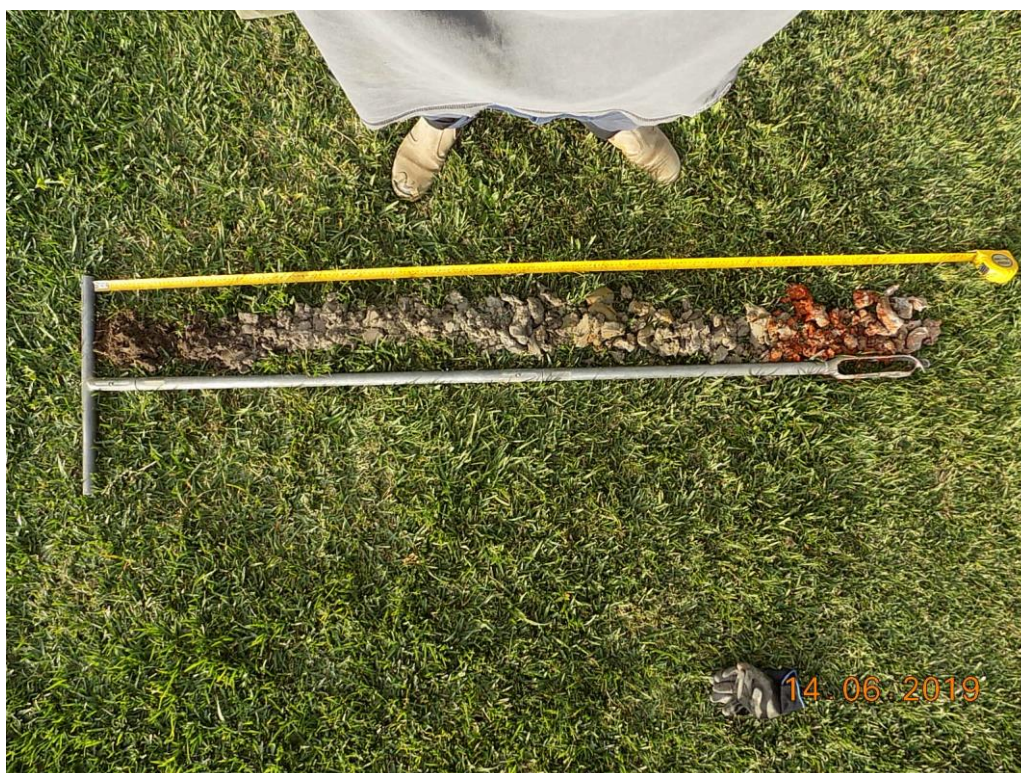
## AUGER HOLE 1 (~RL18.0) – AH1 (Photo 8)

Depth (m)	Material Encountered
0.0 to 0.2	<b>TOPSOIL</b> , sandy soil, dark brown, loose, dry, fine to medium grained with fine trace organic matter.
0.2 to 0.7	<b>SAND</b> , grey, loose to medium dense, damp, coarse grained.
0.7 to 0.9	<b>SAND</b> , grey, loose, wet, coarse grained.
0.9 to 1.5	<b>SANDY CLAY</b> , grey and mottled brown, stiff to hard, damp, fine grained.
1.5 to 1.8	<b>SANDY CLAY</b> , weathered shale, red and mottled grey, stiff to hard, dry, fine grained.
1.8 to 1.9	<b>CLAY</b> , weathered shale, grey and mottled maroon, very stiff to hard, dry, fine grained.

End of hole @ 1.9m in weathered shale. No watertable encountered.

Photo 8: AH1 – Downhole is from left to right.

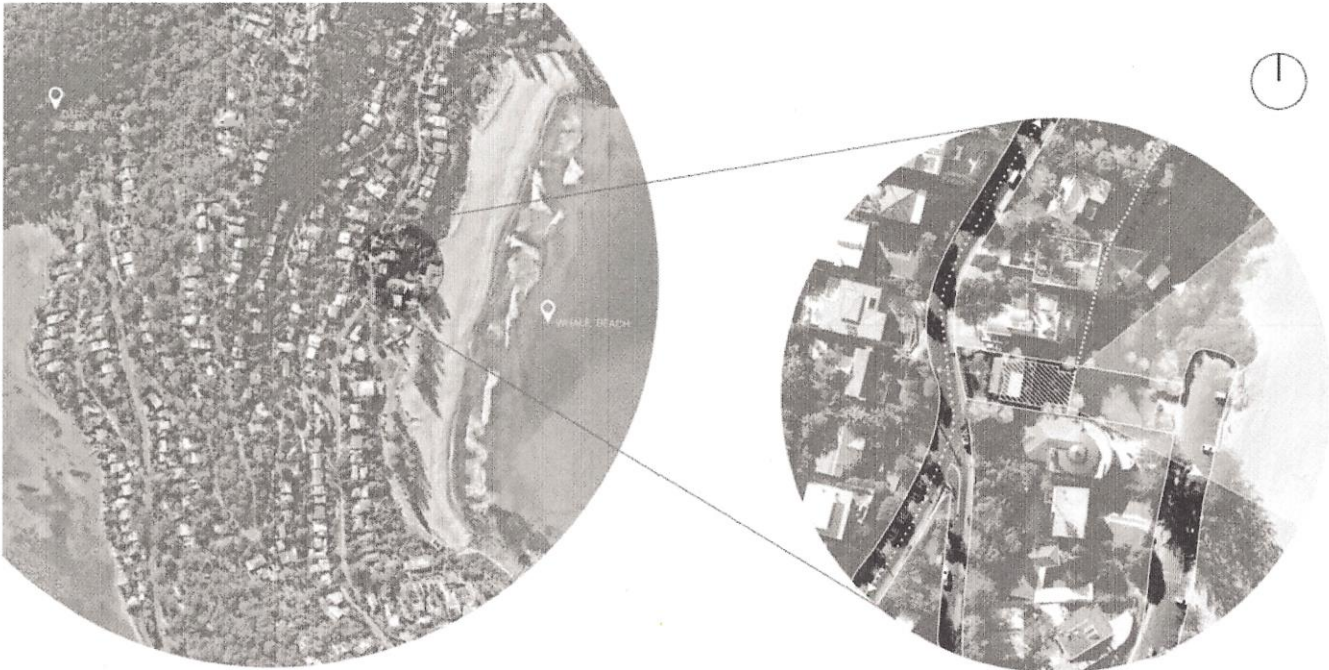
SITE PLAN – showing test locations

One auger hole was put down to identify the soil materials. Seven Dynamic Cone Penetrometer (DCP) tests were put down to determine the relative density of the overlying soil and the depth to weathered rock. The locations of the tests are shown on the site plan. It should be noted that a level of caution should be applied when interpreting DCP test results. The test will not pass through hard buried objects so in some instances it can be difficult to determine whether refusal has occurred on an obstruction in the profile or on the natural rock surface. This is not expected to be an issue for the testing on this site and the results are as follows:
