## **PRELIMINARY ASSESSMENT: Acid Sulfate**

New House, Pool and Boatshed at **1744 Pittwater Road, Bayview**

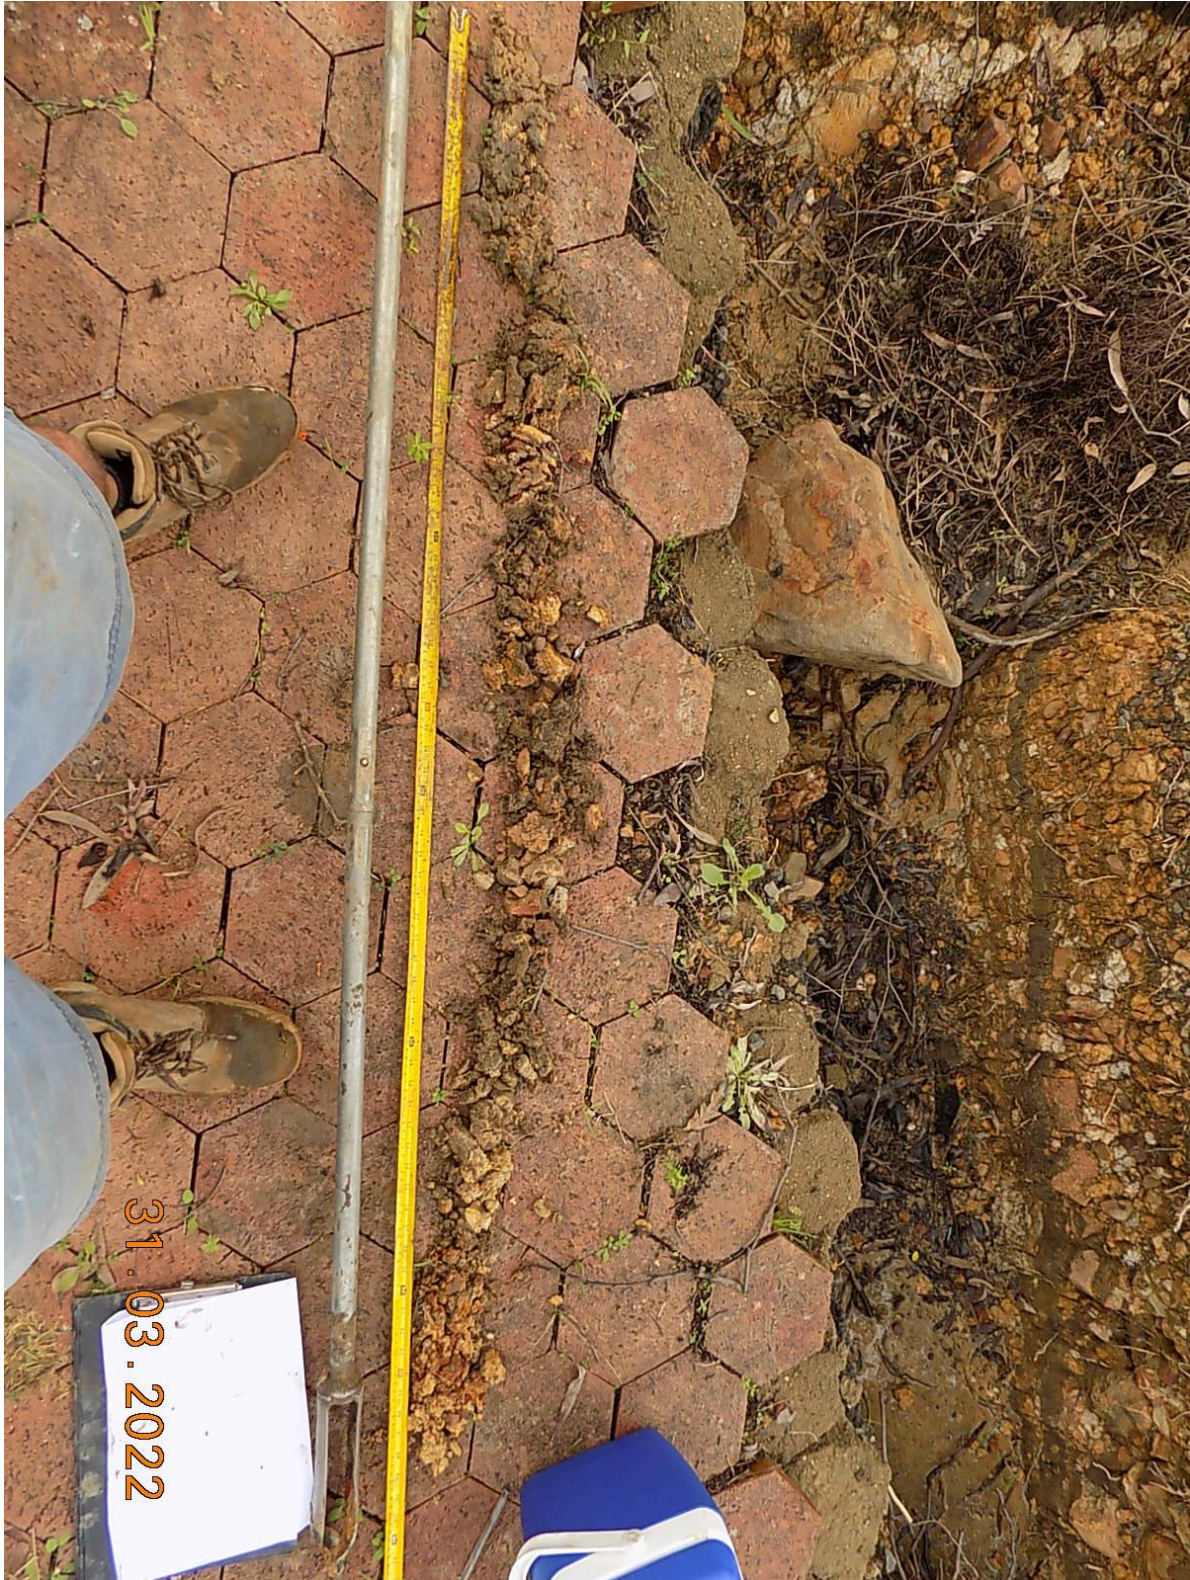
Depth (m)	Material Encountered
0.0 to 0.4	<b>FILL</b> , brown, red, yellow, sand and clay intermixed, loose, damp, fine to coarse grained.
0.4 to 0.6	<b>CLAY</b> , maroon, yellow, laminate fragments.
0.6 to 0.9	<b>CLAY</b> , yellow, brown, fine grained, dry.
0.9 to 1.4	<b>CLAY</b> , white, grey, red, dry, fine to medium grained.
1.4 to 1.7	<b>CLAY</b> , orange, red, mottled clay, derived from Extremely Low Strength Shale, damp.

End of Test @ 1.7m in clay. No watertable encountered.

Photo 1: AH2 – Downhole is from top to bottom.

TEST: AH2	FIELD pH & PEROXIDE RESULTS				
Sample depth (m)	pH <sub>F</sub>	30% Peroxide reaction	pH <sub>FOX</sub>	pH <sub>F</sub> - pH <sub>FOX</sub>	SS=Shell J=Jarosite R=Roots
0.3	6.8	-	6.5	0.3	R
0.8	7.6	-	7.3	0.3	-
1.4	7.6	-	7.6	0.0	-
1.7	7.7	-	7.5	0.2	-
