# **Heritage Impact Statement**

Brookvale Public School

2-8 Old Pittwater Road, Brookvale

April 2019

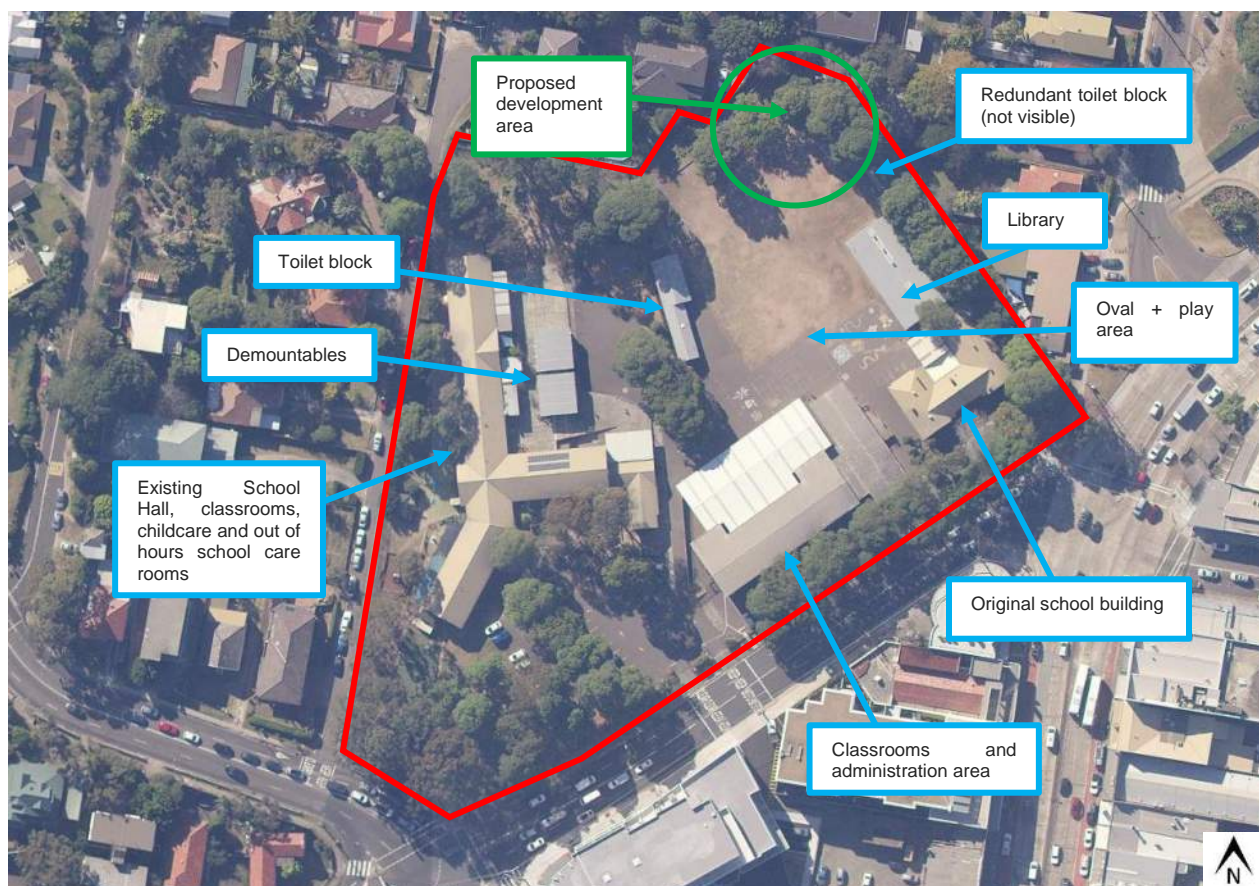
Figure 13: Aerial view showing the various built elements present on the site. (Source: SIX Maps accessed 27 March 2019)

Located on the site are a number of buildings associated with school activities including the following (Figure 13):

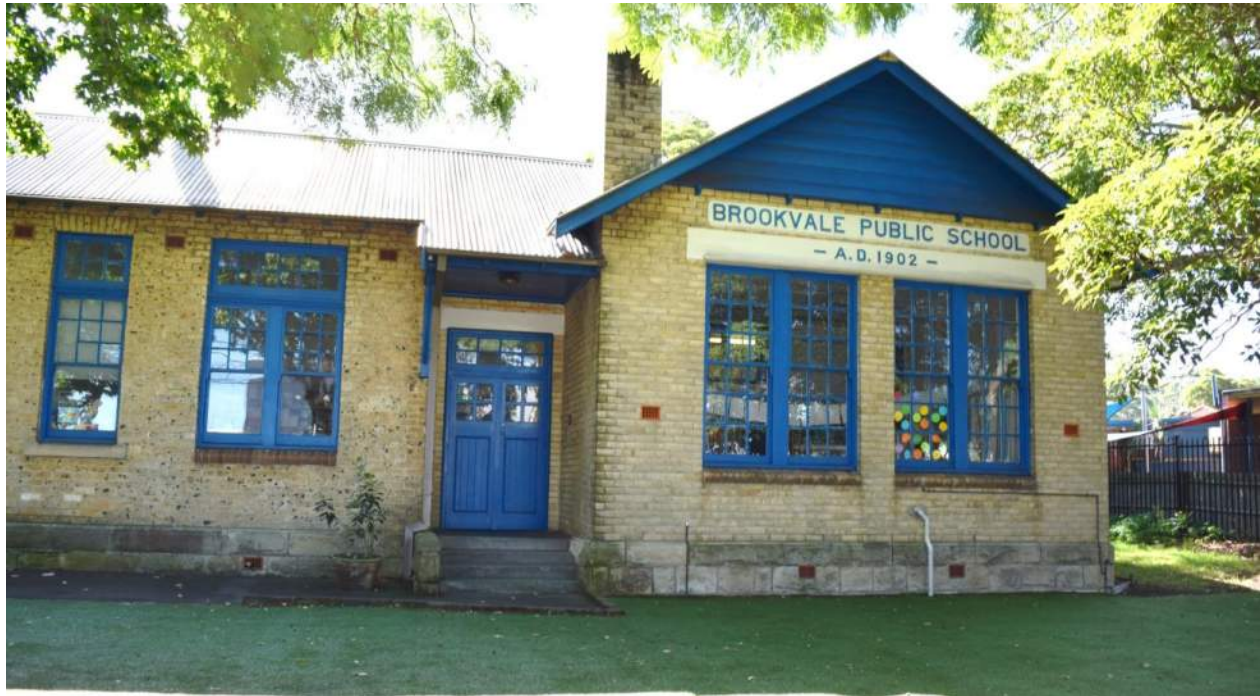
Figure 14: The south eastern elevation of the original school building showing the facebrick and sandstone construction, gable end and bay window.

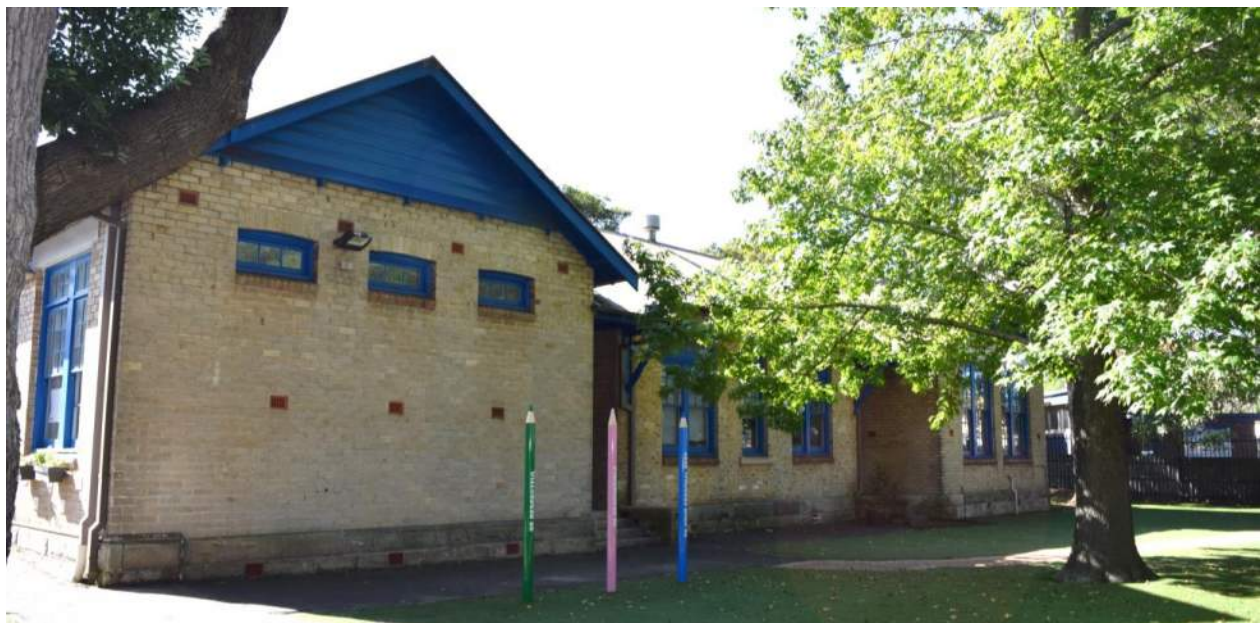
Figure 15: The south western corner of the south eastern elevation features another gable end, however, this gable end features three small windows rather than the large expansive windows seen in the south eastern bay.

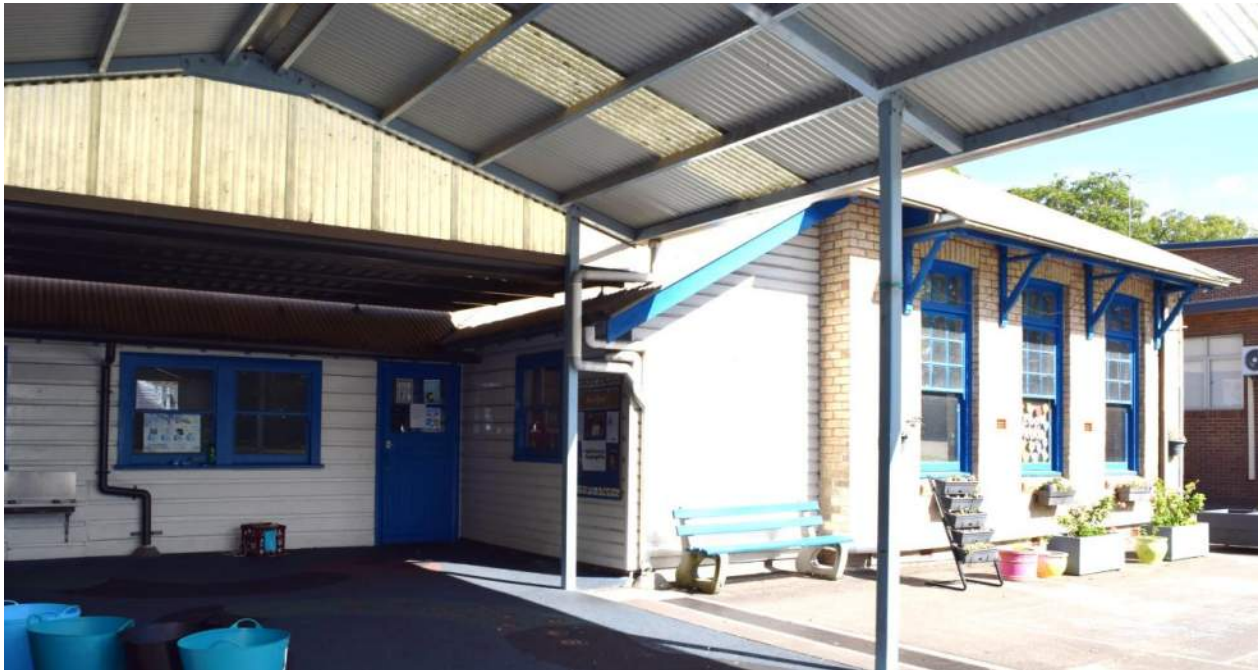
Figure 16: Rear view of the original school building and central weatherboard wing addition. Note the rear also features a shaded structure that continues north towards the library building.

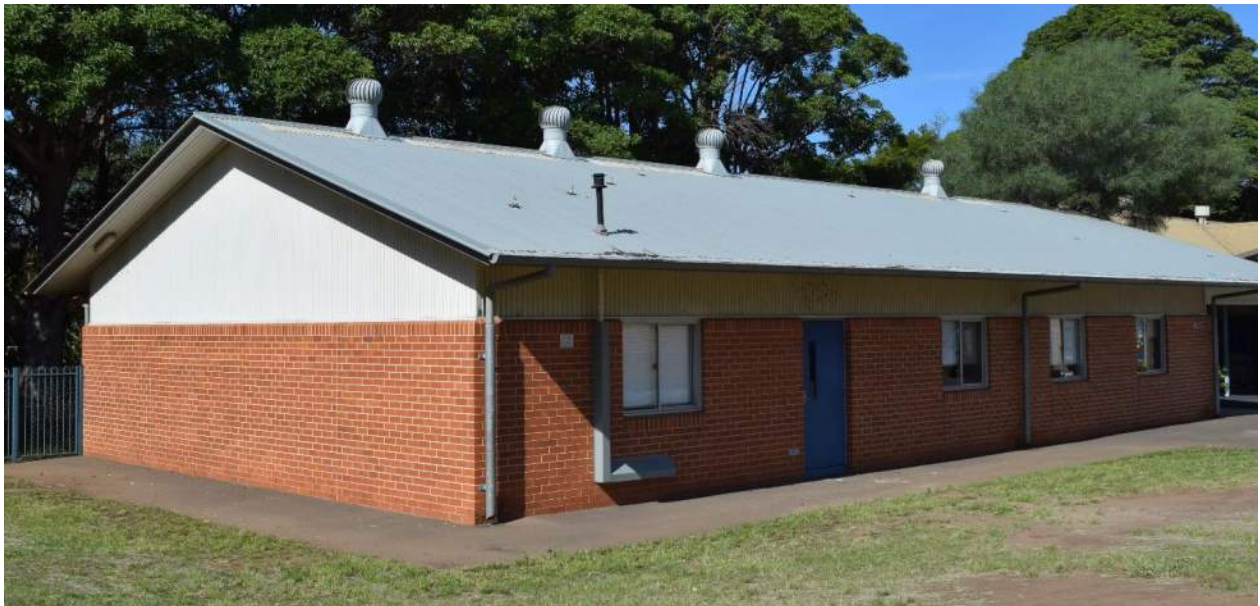
Figure 17: The library building, located directly east of the toilet block and proposed site for the new school hall. This building features a gabled roof, facebrick and timber panelling to the gable ends and underneath the roof eaves.

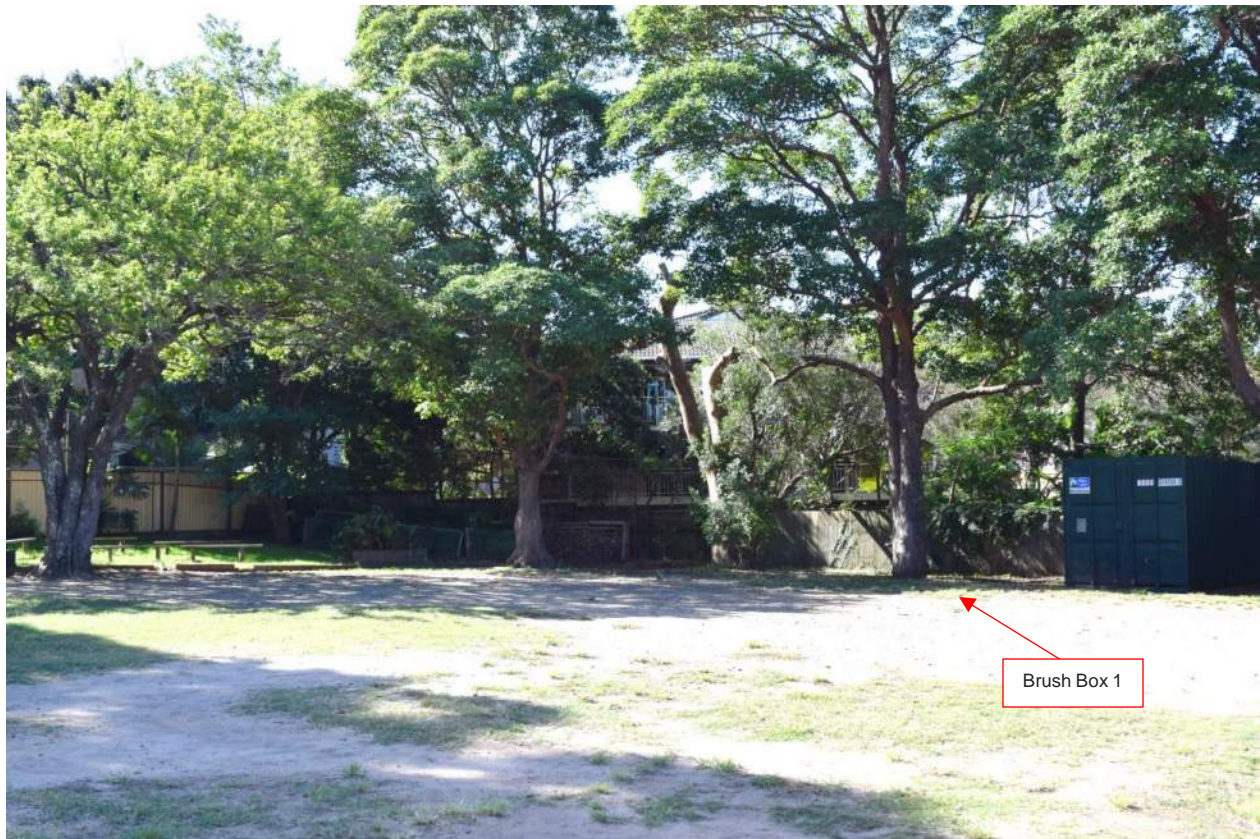
*Figure 22: Looking north east towards the proposed site for the new school hall. Note the presence of various trees, including two mature Brush Box trees, located along the perimeter.*

The proposed site for the construction of the new school hall is located within the north eastern corner of the site, as indicated in Figure 22. The site predominately consists of landscape elements, owing to its location directly adjacent to the school oval. Landscape features present include grass and various trees situated along the perimeter towards the school's boundary fence. Two mature Brush Box trees, in particular, are present and thought to be associated with the early development of the school, possibly having been planted by students as indicated in the history of the site included in Appendix A (Figure 22).

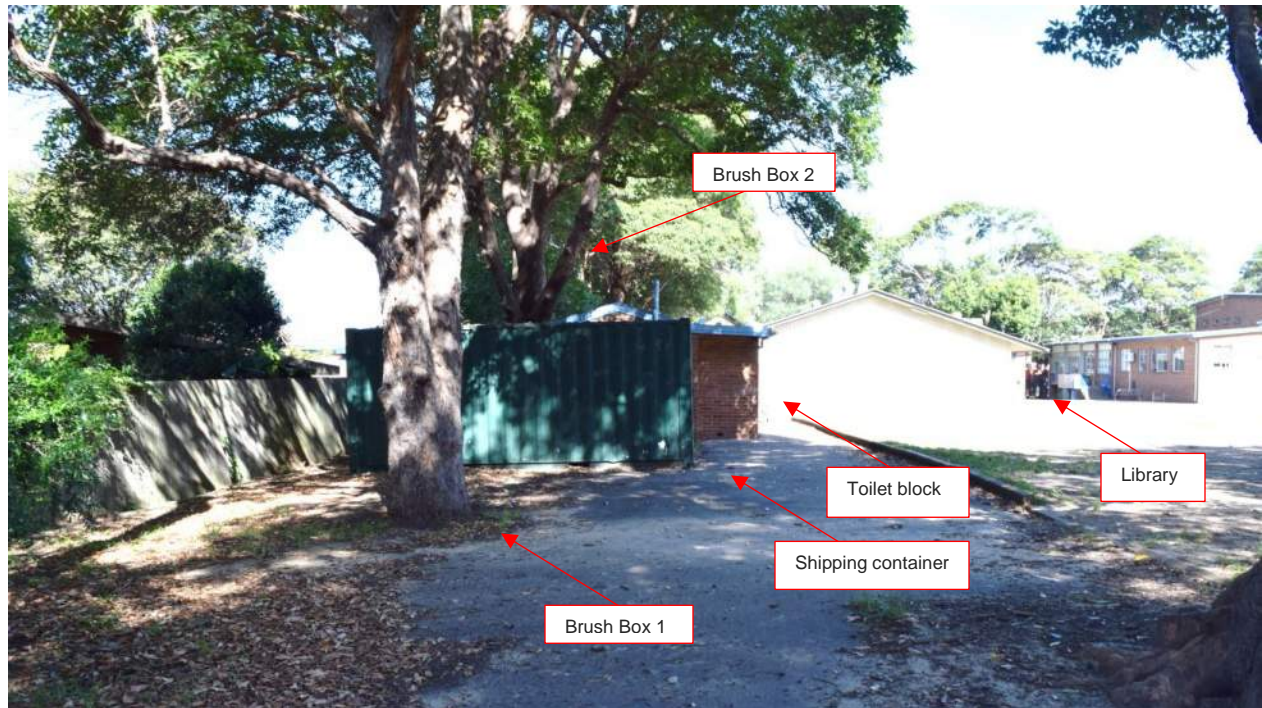
Figure 23: Looking south east from with the proposed area for the new school hall, towards the shipping container, toilet block and library.

The toilet block located within the eastern section of the proposed site was constructed in the late 20th century and consists of a single storey rectangular shaped facebrick structure with a gable roof of corrugated metal. Two entrances to the toilet block are located on the south western façade for the men's and women's facilities (Figure 26 and Figure 27). Access to the south eastern and north eastern facades is limited by a metal fence. To the north west of the toilet block is a shipping container, the contents of which are unknown (Figure 23 and Figure 24).

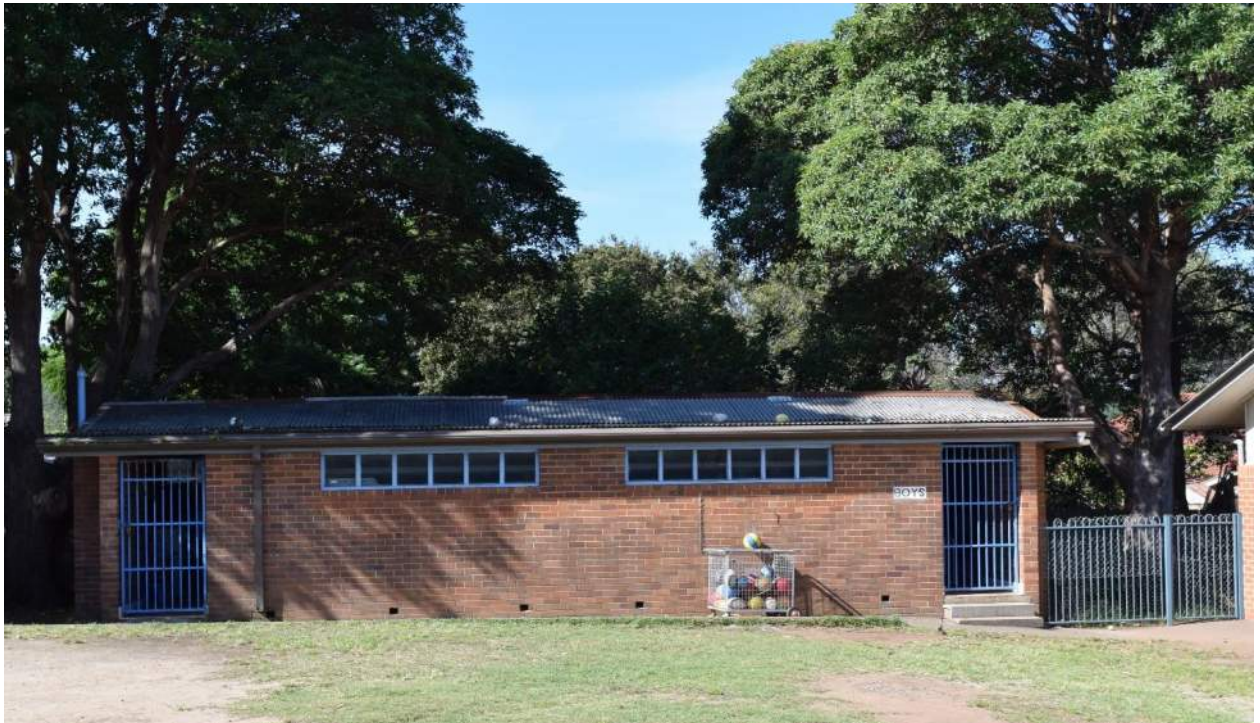
Figure 26: South western elevation of the existing toilet block showing the two entrances to the men's and women's facilities. The south eastern elevation has been fenced off, as evident to the right.

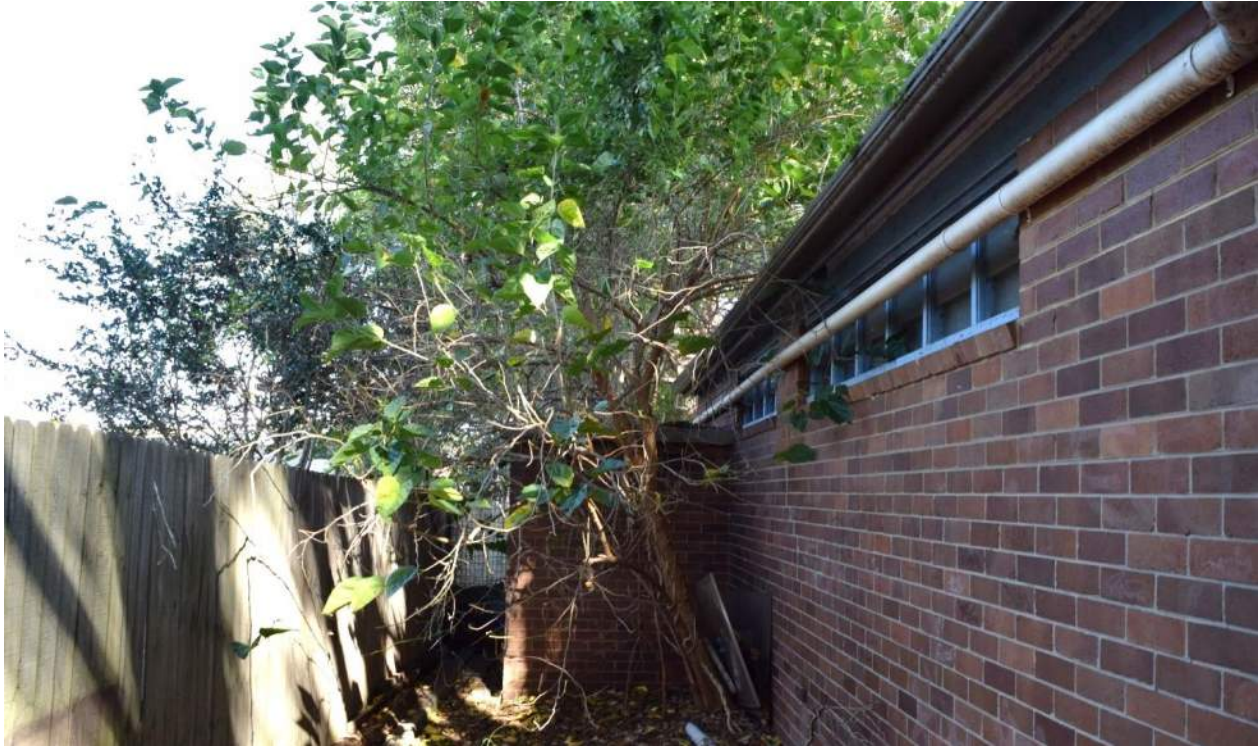
Figure 27: The north eastern elevation of the existing toilet block. Note the presence of vegetation adjacent to this elevation and the timber school boundary fence, visible to the left.

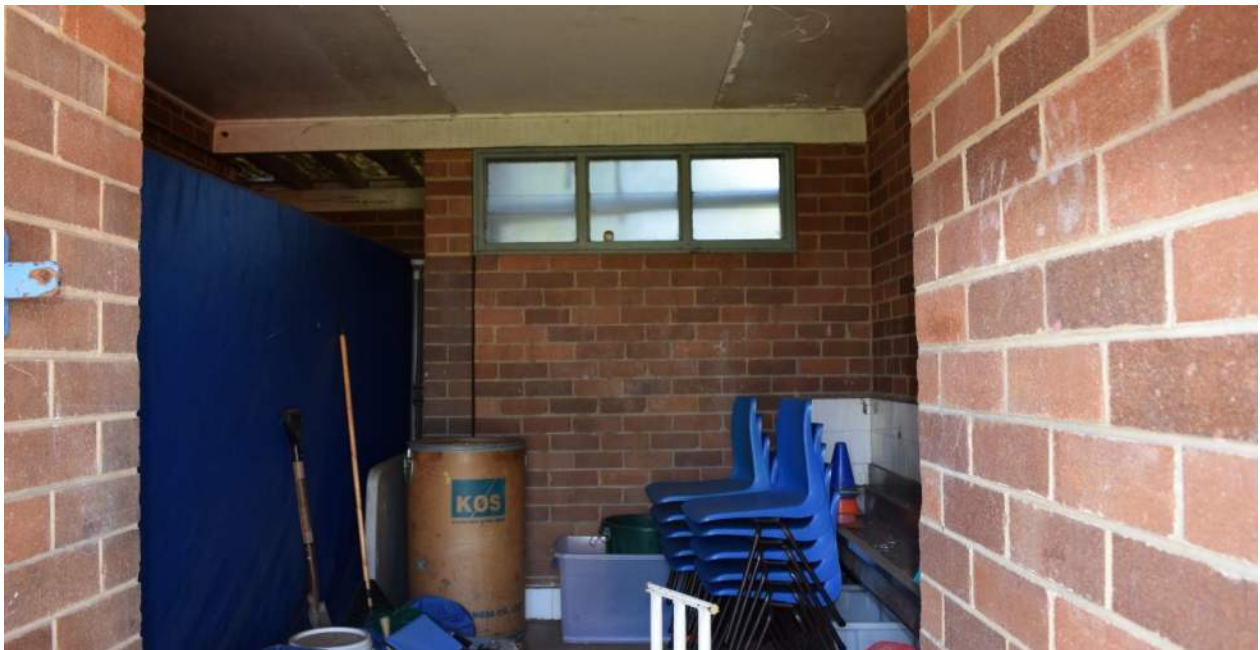
Figure 28: Interior of the toilet block from the south eastern entrance. The interior is currently used for storage purposes.

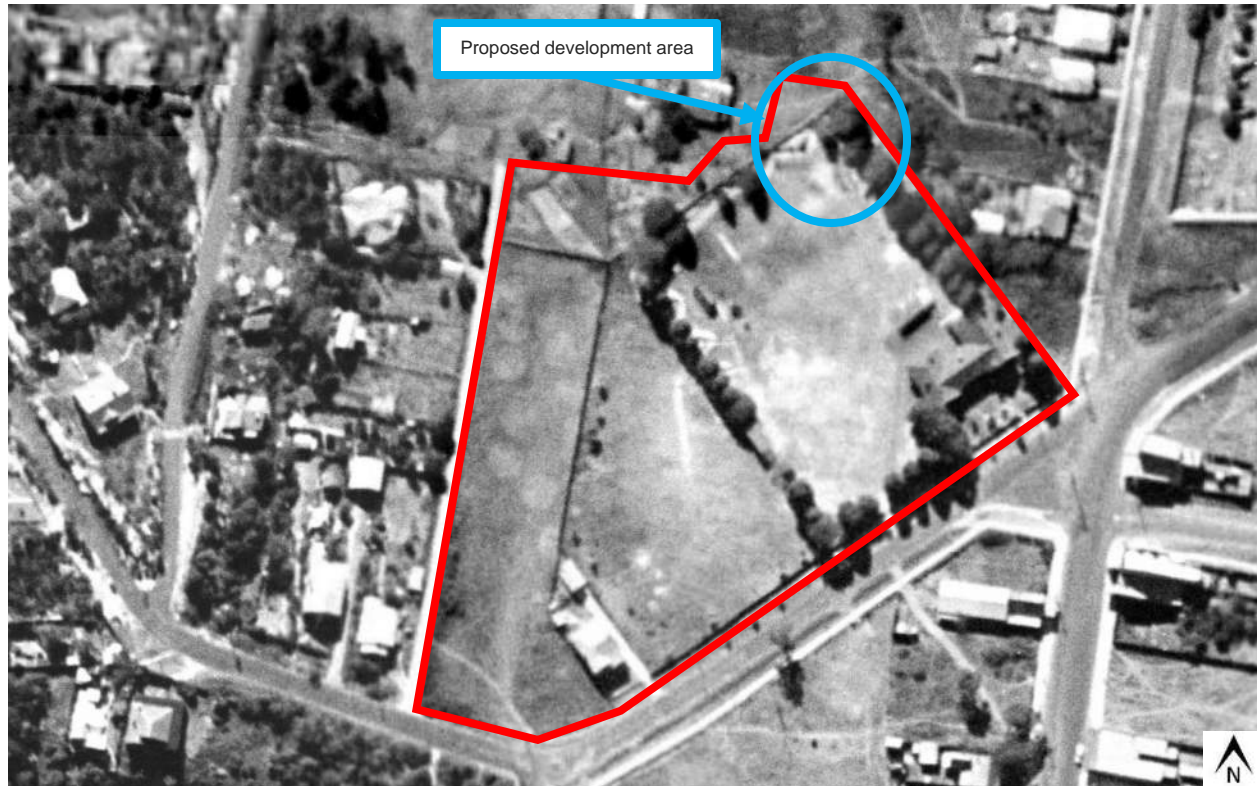
*Figure 30: 1943 aerial showing the presence of various trees along the perimeter of the original school site, and the original school building. The proposed development area is circled blue. (Source: SIX Maps accessed 28 March 2019)*

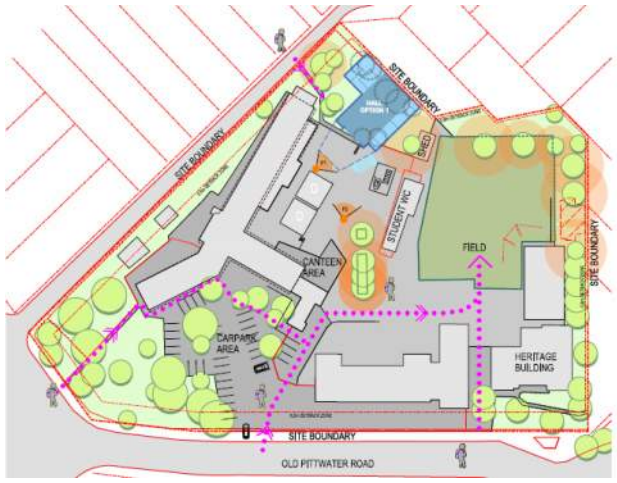
Option # and identified pros and cons	Image
<p><b>Option 1 (blue colour footprint):</b></p> <p><b>Pros:</b></p> <ul style="list-style-type: none"> <li>Doesn't interfere with existing green play space;</li> <li>Located away from the original school building.</li> </ul> <p><b>Cons:</b></p> <ul style="list-style-type: none"> <li>Will result in the removal of 7 trees;</li> <li>Difficulties in construction due to proximity with other buildings;</li> <li>Remote from core school activities;</li> <li>Requires relocation of existing play equipment;</li> <li>Doesn't comply with Dept. of Education Educational Facilities Standards and Guidelines;</li> <li>Considered unfavourable by school staff and the P &amp; C Committee.</li> </ul>

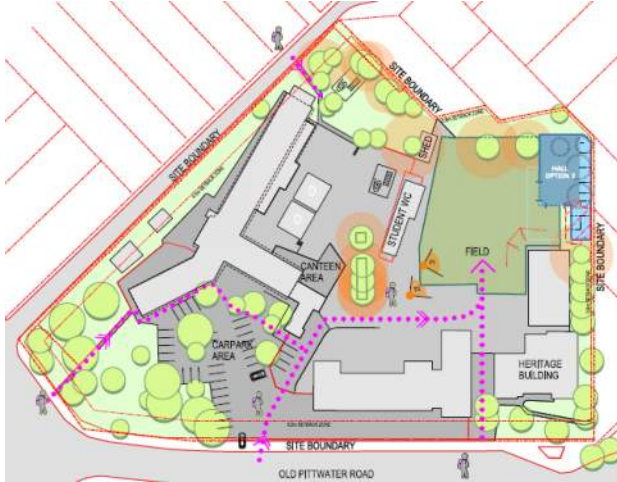
<p><b>Option 2 (blue colour footprint):</b></p> <p><b>Pros:</b></p> <ul style="list-style-type: none"> <li>Located away from the original school building;</li> <li>Will have a minimal impact on the green open place area;</li> <li>Proposed building location continues along perimeter built form of the site along eastern boundary;</li> <li>Connected with school activities physically, socially and visually;</li> <li>Will enhance the school's delivery of the curriculum and potential for extended community uses;</li> <li>Preferred option by staff and the P &amp; C Committee;</li> <li>Maximises the opportunities of the 'Share our Space' initiative promote by the NSW Department of Education.</li> </ul> <p><b>Cons:</b></p>

Option # and identified pros and cons	Image
<p>Will result in the loss of 2 mature QLD Brush box trees, 1 standard QLD Brush box tree and 1 dead tree.</p>	
<p><b>Option 3 (blue colour footprint):</b></p> <p><b>Pros:</b></p> <ul style="list-style-type: none"> <li>Doesn't interfere with green play space.</li> </ul> <p><b>Cons:</b></p> <ul style="list-style-type: none"> <li>Will result in the removal of 3 trees;</li> <li>Remote from school activities, not physically, socially, visually connected to the school;</li> <li>Corner of the site prone to vehicle incidents. Considered by the school to be unsafe. Children not allowed to use this area presently;</li> <li>Potential safety concerns by mixing school access and traffic;</li> <li>Not potential for connectivity to an open play field.</li> </ul>

### 5.1.1. Discussion of preferred Option 2

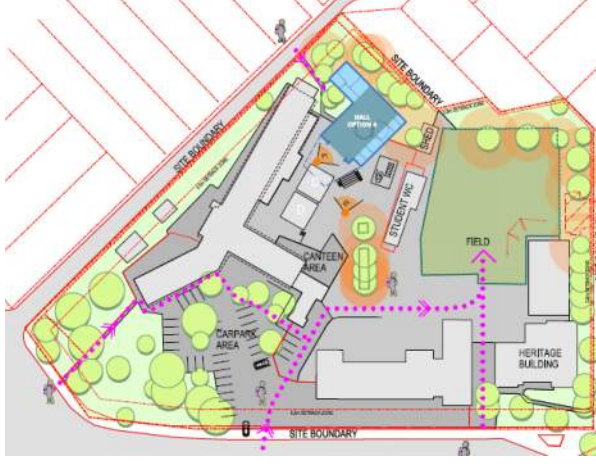
<p><b>Option 4 (blue colour footprint):</b></p> <p><b>Pros:</b></p> <ul style="list-style-type: none"> <li>Doesn't interfere with green play space.</li> </ul> <p><b>Cons:</b></p> <ul style="list-style-type: none"> <li>Remote from school activities. Not physically, socially or visually connected to school;</li> <li>Doesn't comply with the Department of Education EP &amp; G relationship to core facilities;</li> <li>Cannot safely build too close to existing building;</li> <li>Will disrupt the running of the school during construction;</li> <li>The out of hours school care and the demountable buildings will need to be relocated for duration of construction. Demountable buildings would need permanent relocation;</li> <li>2 trees removed;</li> <li>Takes up small but important active playground space;</li> </ul>

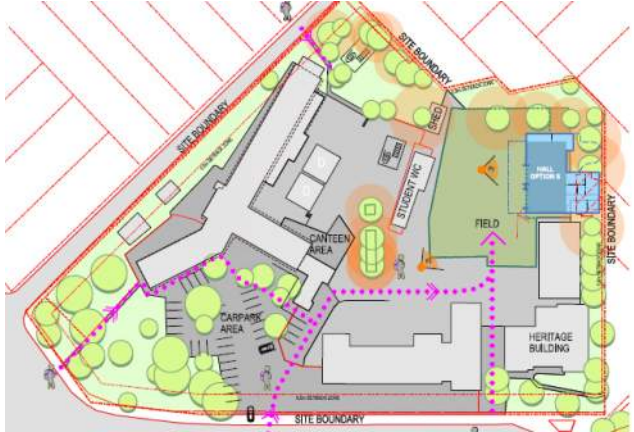
Option # and identified pros and cons	Image
<ul style="list-style-type: none"> <li>Existing play equipment would need to be relocated;</li> <li>Concerns of no line of sight to rear are behind proposed hall. Doesn't adhere to Crime Prevention Through Environmental Design principles</li> </ul>	
<p><b>Option 5 (blue colour footprint):</b></p> <p><b>Pros:</b></p> <ul style="list-style-type: none"> <li>Connected with school activities. Physically, socially, visually connected to the school;</li> <li>Retain existing trees;</li> <li>Scope for larger audiences to bleed into green space.</li> </ul> <p><b>Cons:</b></p> <ul style="list-style-type: none"> <li>Greatly interferes and loses function of green play space;</li> <li>Eliminates opportunity for sporting games;</li> <li>Reduced opportunity for NSW Department of Education's 'Share our Space' initiative;</li> <li>Concerns of no line of sight to rear area behind the proposed hall;</li> <li>Doesn't adhere to Crime Prevention Through Environmental Design principals;</li> <li>This option received an unfavourable response from the school staff and P &amp; C Committee.</li> </ul>

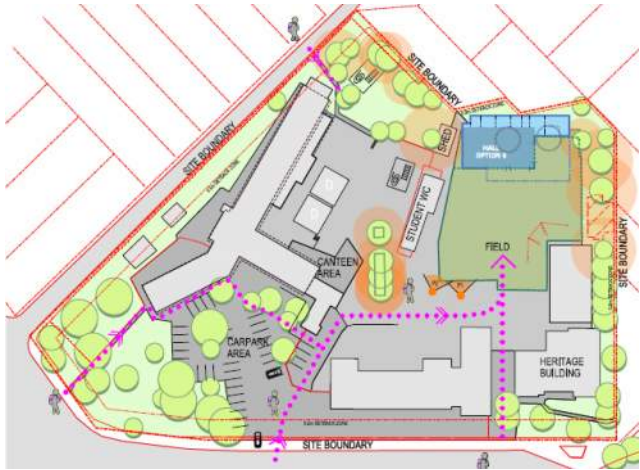
<p><b>Option 6 (blue colour footprint):</b></p> <p><b>Pros:</b></p> <ul style="list-style-type: none"> <li>Scope for larger audiences to bleed into green space;</li> <li>Connected with school activities. Physically, socially, visually connected to school.</li> </ul>

Option # and identified pros and cons	Image
<p><b>Cons:</b></p> <ul style="list-style-type: none"> <li>▪ Interferes with green play space;</li> <li>▪ Compromised shape of the green place space is not conducive to playing mini soccer and reduces usability of the field;</li> <li>▪ Not proportionally acceptable;</li> <li>▪ Two trees removed;</li> <li>▪ No significant advantages over Option 2;</li> <li>▪ Concerns of no line of sight to rear behind proposed hall. Doesn't adhere to Crime Prevention Through Environmental Design principles.</li> </ul>

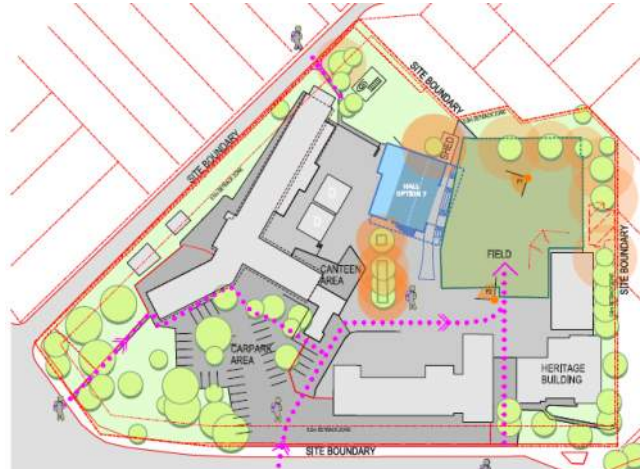
<p><b>Option 7 (blue colour footprint):</b></p> <p><b>Pros:</b></p> <ul style="list-style-type: none"> <li>▪ Doesn't interfere with green play space;</li> <li>▪ Connected with school activities. Physically, socially, visually connected to school;</li> <li>▪ Accessible and intrusive to all parts of the school;</li> <li>▪ Scope for larger audiences to bleed into the green play space.</li> </ul> <p><b>Cons:</b></p> <ul style="list-style-type: none"> <li>▪ Resource inefficiency due to demolishing and replacing existing facilities;</li> <li>▪ Play equipment needs to be relocated;</li> <li>▪ Considerable built structure divides school;</li> <li>▪ Playground supervision would need to double and line of sight is lost from one area to another;</li> <li>▪ Safety and security concerns. Toilet entrances under hall would be obscured from a distance;</li> <li>▪ Existing student toilets will need temporary relocation during construction;</li> </ul>

Option # and identified pros and cons	Image
<ul style="list-style-type: none"><li>▪ Outdoor seating area under COLA is not level with the hall prohibiting smooth flow-through between hall and green play space.</li></ul>
