Tree Consultancy

Construction Impact & Management Statement

Site:	Lot 1 in DP 1229229 145A Crescent Road NEWPORT, NSW
Client:	Jacob & Jessica Shanahan 145A Crescent Road NEWPORT, NSW 2106
Author:	Kyle A Hill Registered (Arb Aus #1884) Practising & Consulting Arborist Post Graduate Certificate in Arboriculture, Uni of Melb Diploma of Horticulture-Arboriculture TAFE, Grow SA Certificate of Horticulture, TAFE Certificate Advanced Tree Care TAFE Founder -Growing My Way Tree Services (1977) Member of International Society of Arboriculture Member of Arboriculture Australia

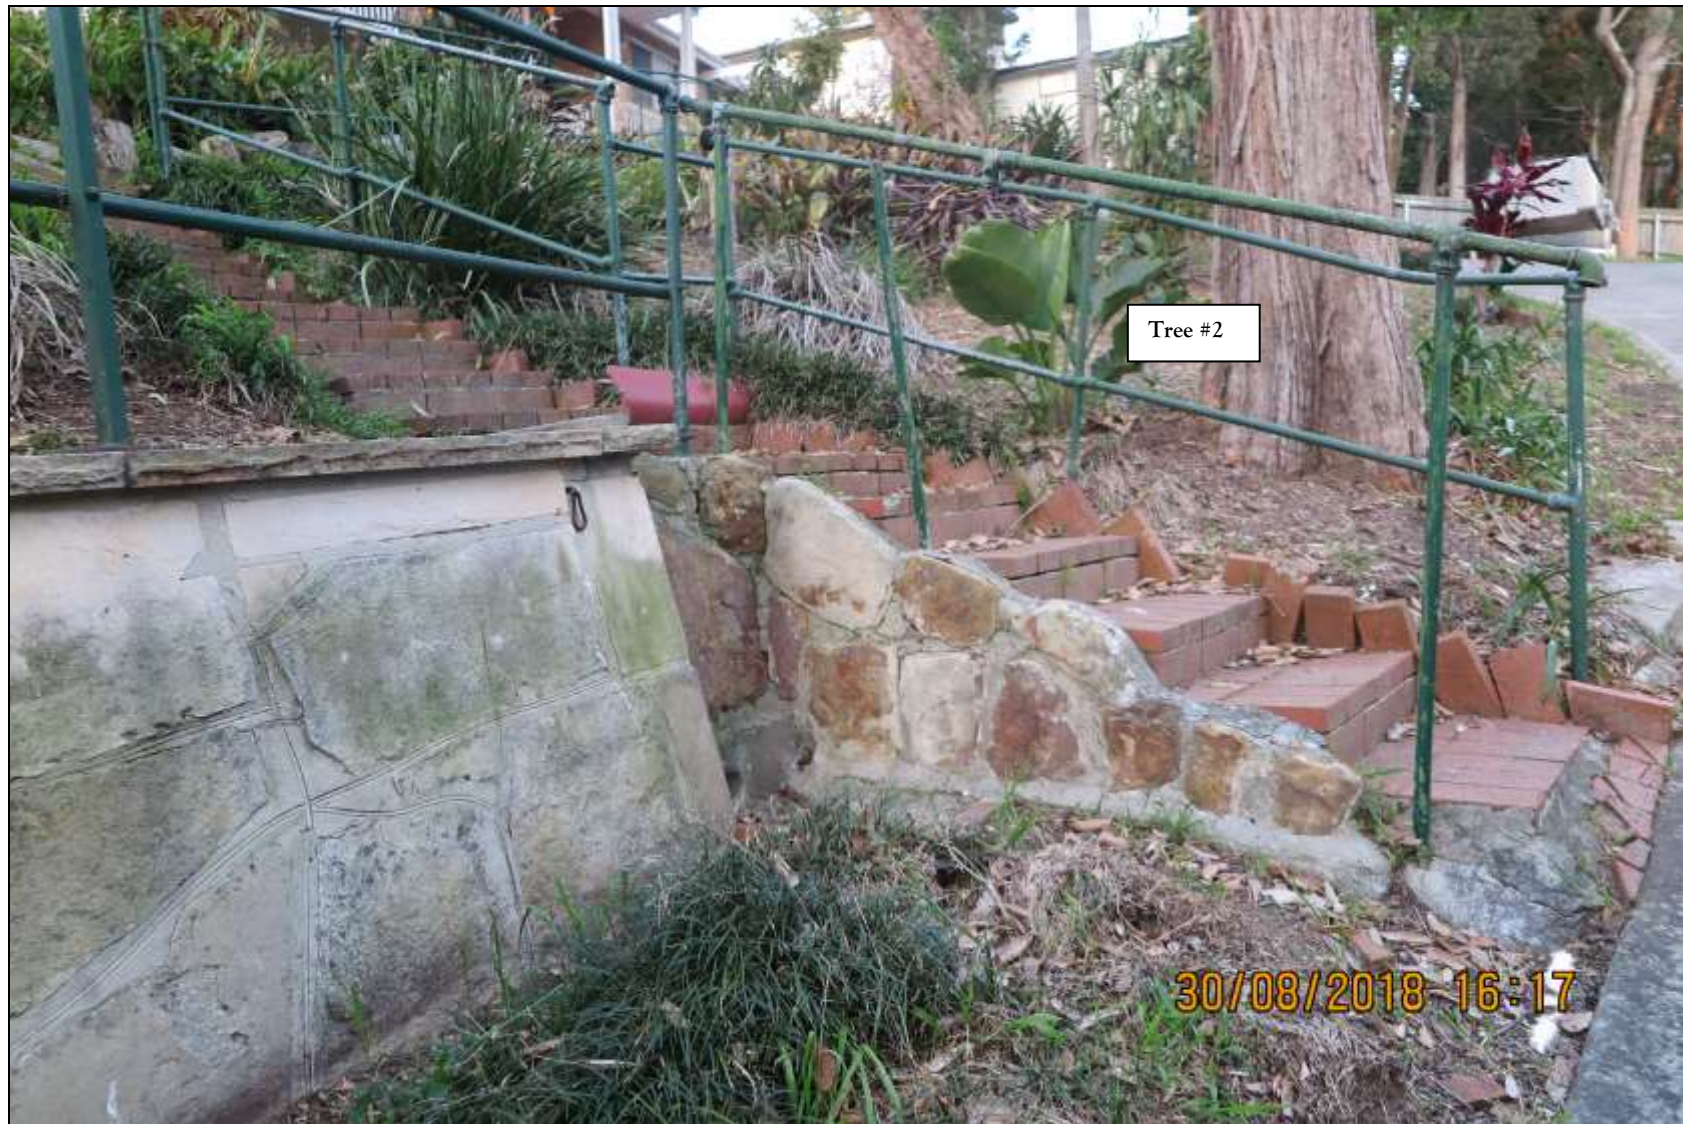
Figure 7: Above & previous page illustrates the locations of Tree #1 & Tree #2.

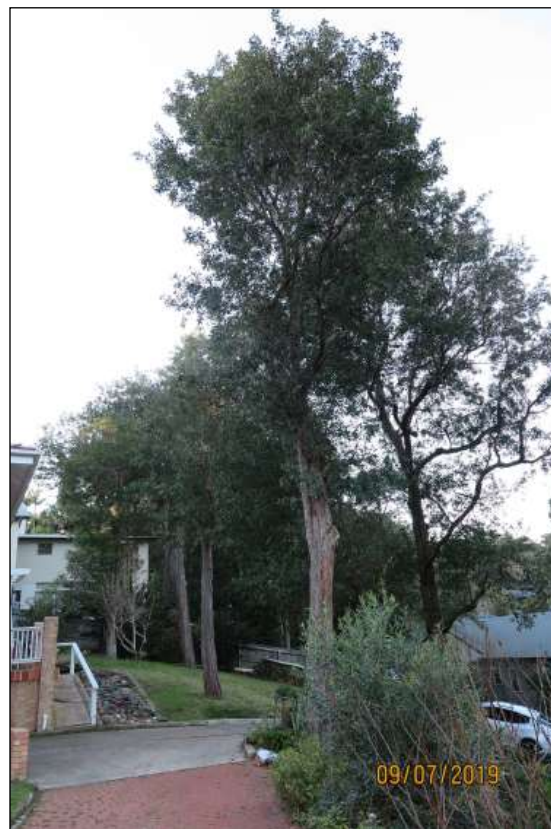
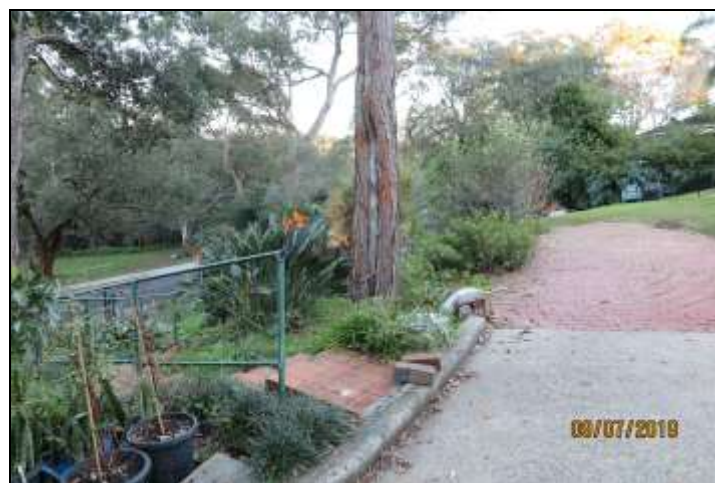
Tree #1 acknowledged as being of High Significance & High Retention value by size, species, condition or presence. (This tree was not given higher ratings as it displays compromised internal supporting wood tissue as a consequence of 'decay pathogen' (fungal) activity.) Tree #1 is acknowledged to provide 'landscape amenity but is considered to have a 'compromised' Useful Life Expectancy (from herein ULE).

Figure 8: Illustrates supporting wood tissue defects (above) & Tree #1 character (top).

Proposed works, (i.e. excavation) is whilst creating a mathematical 'major encroachment', (i.e. >10% but <20%) of its TPZ total surface area of 109.40m². is considered able to be managed in a manner whereby its ULE could reasonably be predicted to not be compromised.

No breach of the calculated SRZ radial distance (2.60m) is proposed.

Relative to protecting the tree prior to the commencement & throughout the construction phase this tree will be specified to have 'temporary metal mesh (or similar) fencing instated as close to its calculated TPZ radial distance (5.90m) as existing site features allow.

Additionally, any excavation within its 5.90m TPZ radial distance is specified to be completed manually to a depth of 1.00m (or to solid rock) along any line of excavation that breaches its TPZ radial distance.
