# rainTree consulting

## **203 BALGOWLAH ROAD - BALGOWLAH, NSW PROPOSED ADDITIONS & ALTERATIONS ARBORICULTURAL ASSESSMENT & PRUNING PLAN**

*Report ref No. RTC-15119*

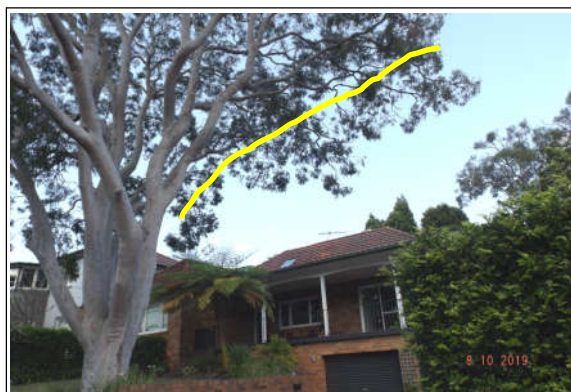
Figure 3, Showing estimated canopy loss, see Section 3 for further detail

- *Crown lifting* (Section 7.3.3) being the removal of lower branches to allow for appropriate building line clearances.
- 2.2 The proposed pruning is estimated to result in a near 12% canopy loss. Reduction pruning is required on the southern side of the canopy only where visual aesthetics and canopy balance will not be disrupted to the north when viewed from Balgowlah Street frontage. The size of branches and pruning cut locations have been provided within Section 3, where Council approval is required prior to any pruning activities being conducted.

- 2.3 Pruning works are to be conducted by a suitably qualified AQF Level 3 certified arborist in accordance with AS4373 Pruning Standards, and specifically be conducted in accordance with Safe Work Australia – Guide to managing risks of tree trimming and removal works 2016 ([www.swa.gov.au](http://www.swa.gov.au)). At the time of pruning works the certified arborist is to identify any additional pruning that removes suddenly exposed stems and pruning that maintains canopy balance and aesthetics.

- All pruning works are to be conducted with sharp disinfected pruning saws or horticultural pruning tools, ensuring clean cuts that reduced risk of infection resulting in wood rot decay.

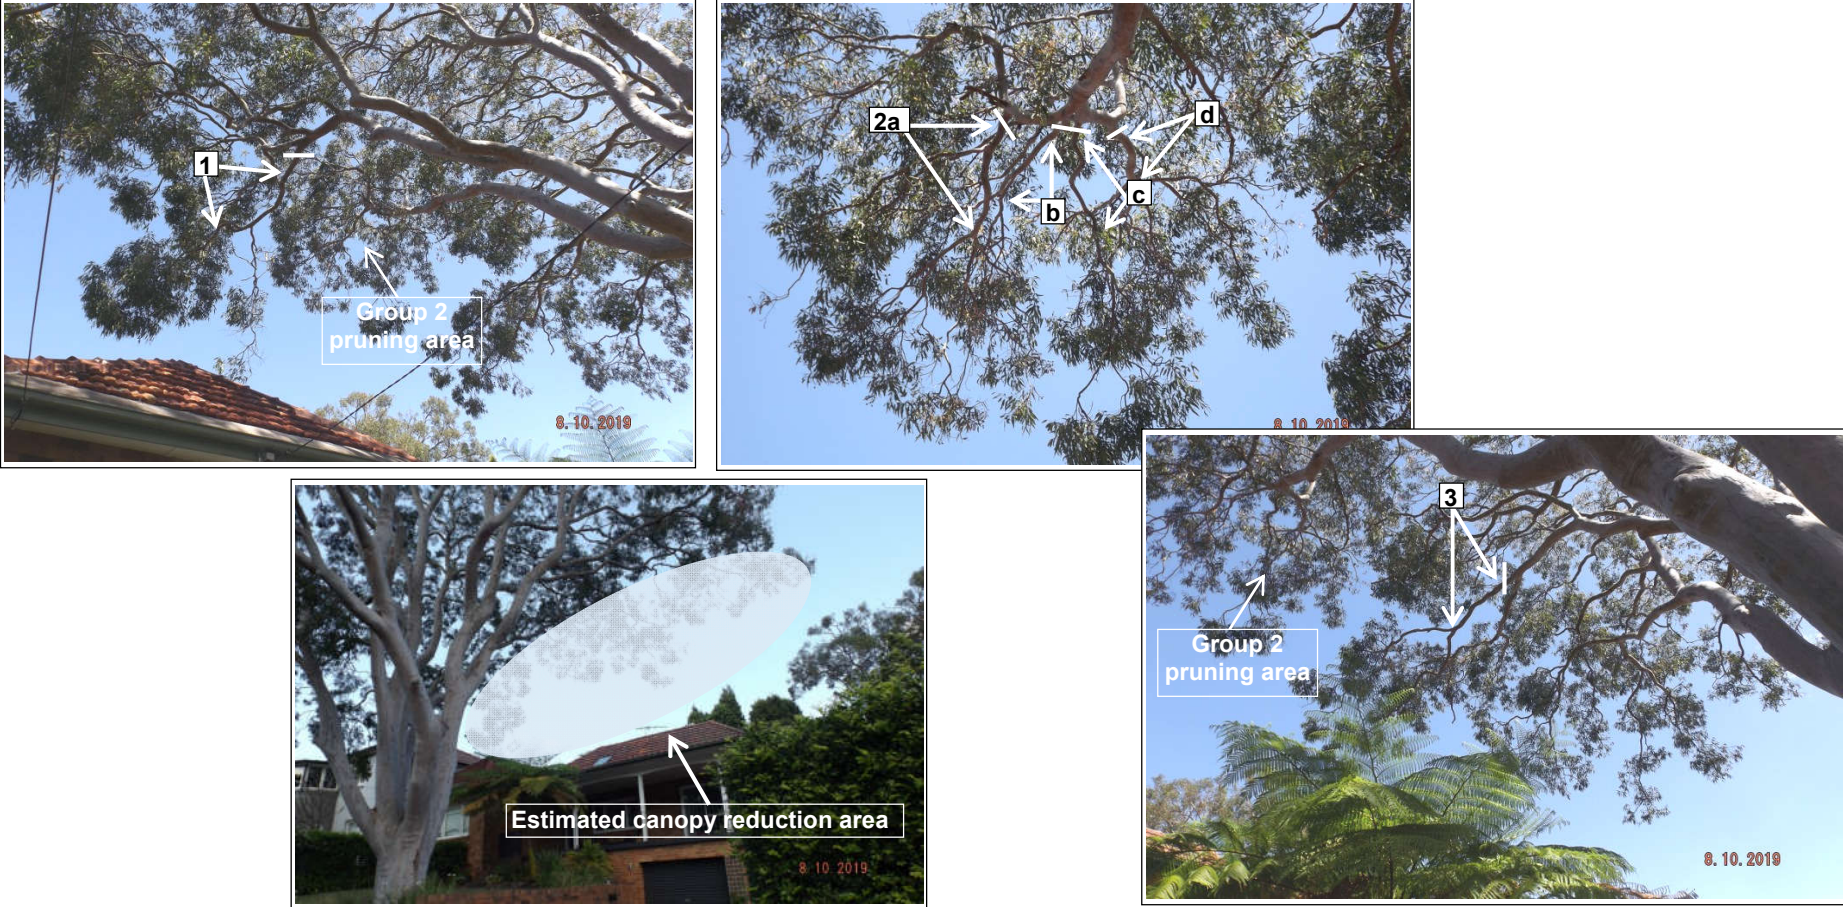
### 3 – TREE 1, PRUNING SCHEDULE

| Tree | Stem & pruning location |
|---|---|
| 1 | <p><u>RECOMMENDED PRUNING</u></p> <p>[1] = Prune out 1x stem 110mm(Ø) at 8m over roofline E side</p> <p>[2] = Prune out 4x stem 50-80mm(Ø) at 12m over central roof line (stems 2a, b, c &amp; d)</p> <p>[3] = Prune out 1x stem 110(Ø) at 9m extending to W side of centre roof line</p> <p>*Additional crown raising of low bowing stems &lt;40mm(Ø) may be required after the pruning event to maintain balance</p> |
