Arboricultural Impact Assessment

Proposed Alterations & Additions at
5 Surfview Road, Mona Vale

Date: November 2022

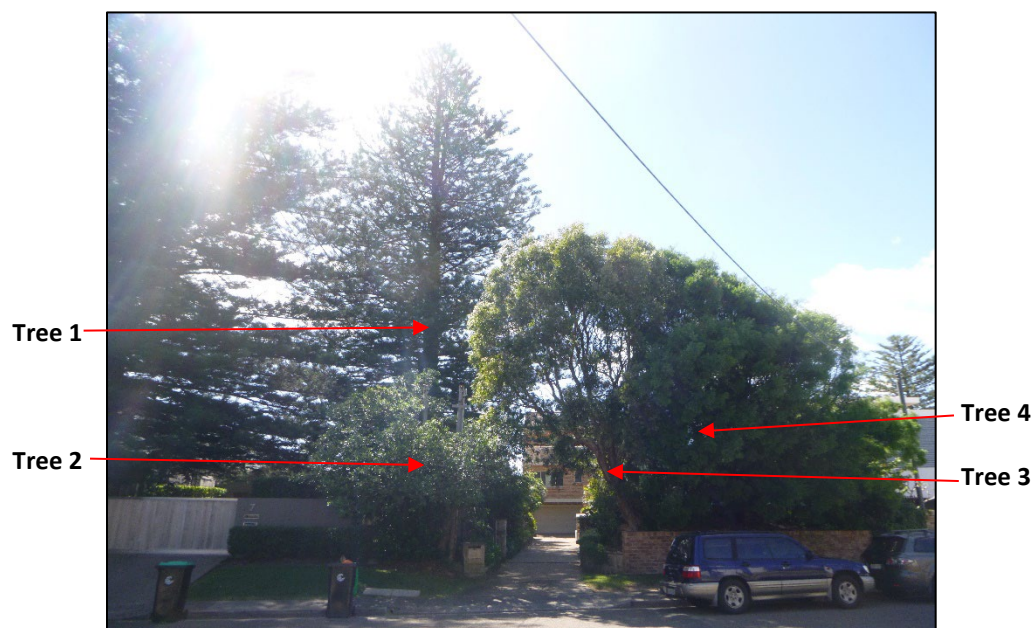
Photo A: Trees 1-4 as viewed from the street.

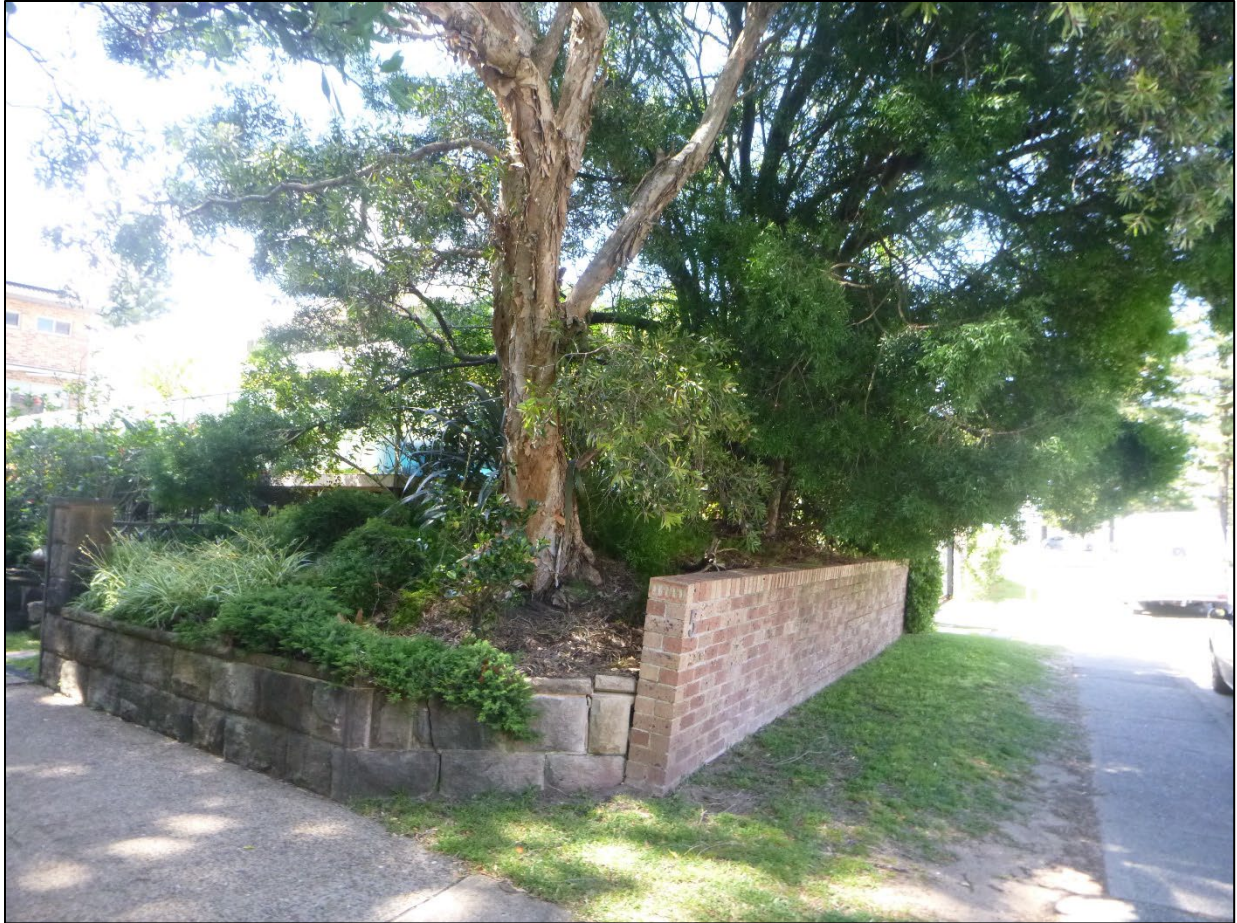
| | Species | Trunk Diameter @ 1.4m | Height | Canopy Spread Radius | Age Class | Health/ Vitality | Structural Condition | Estimated Life Expectancy | Landscape and Environmental Significance | Retention Value |
|---|---|---|---|---|---|---|---|---|--|---|
| | Comments: The front boundary wall is leaning. This is likely to be influenced by the expansion of the root plate (Photo B). | | | | | | | | | |
| | Comments: The canopy is shaped by the salt laden wind with the exposed side stunted. The existing brick wall is starting crack under pressure from the expanding root plate. | | | | | | | | | |

Photo B: Wall displacement and cracking is influenced by the root plate expansion of Trees 3 and 4.

| Tree Number/Species | Retention Value | Reason for Removal |
|---|---|---|
| 4 Broad-leaved Paperbark | Medium | Within the proposed new pedestrian access way. This tree is also contributing to the damage to the existing boundary wall (Photo B) and would need to be removed to allow wall replacement irrespective of any other proposed works. |
| 5 Yellowwood | Medium | This tree is also contributing to the damage to the existing boundary wall (Photo B) and is recommended for removal to allow wall replacement. |

Tree Removal: Trees 3 and 4 are proposed to be removed. Tree removal works should be undertaken in accordance with the WorkSafe Australia *Guide to Managing Risks of Tree Trimming & Removal Work*.

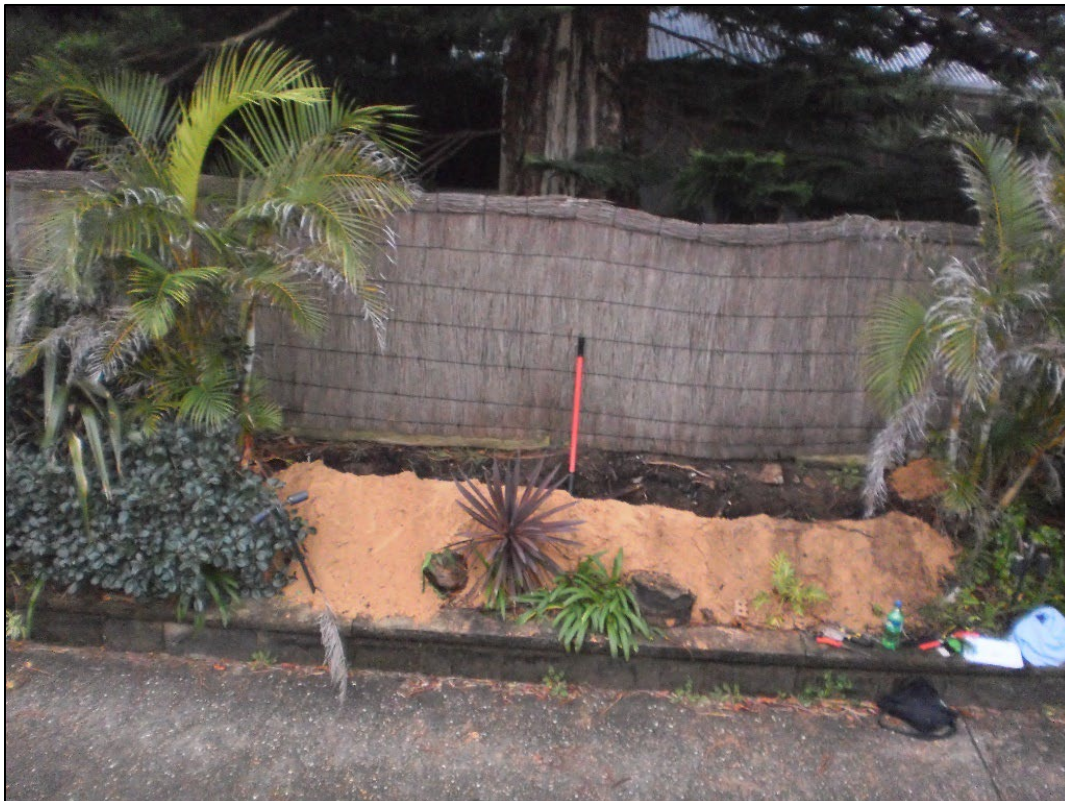
Photo C: Location of the exploratory trench.

The trench was excavated to a depth of 700mm and was 4.5m long. This depth was sufficient to expose large structural roots extending from Tree 1 across the boundary. The following table outlines the locations (chainage) size and depth of the exposed roots.

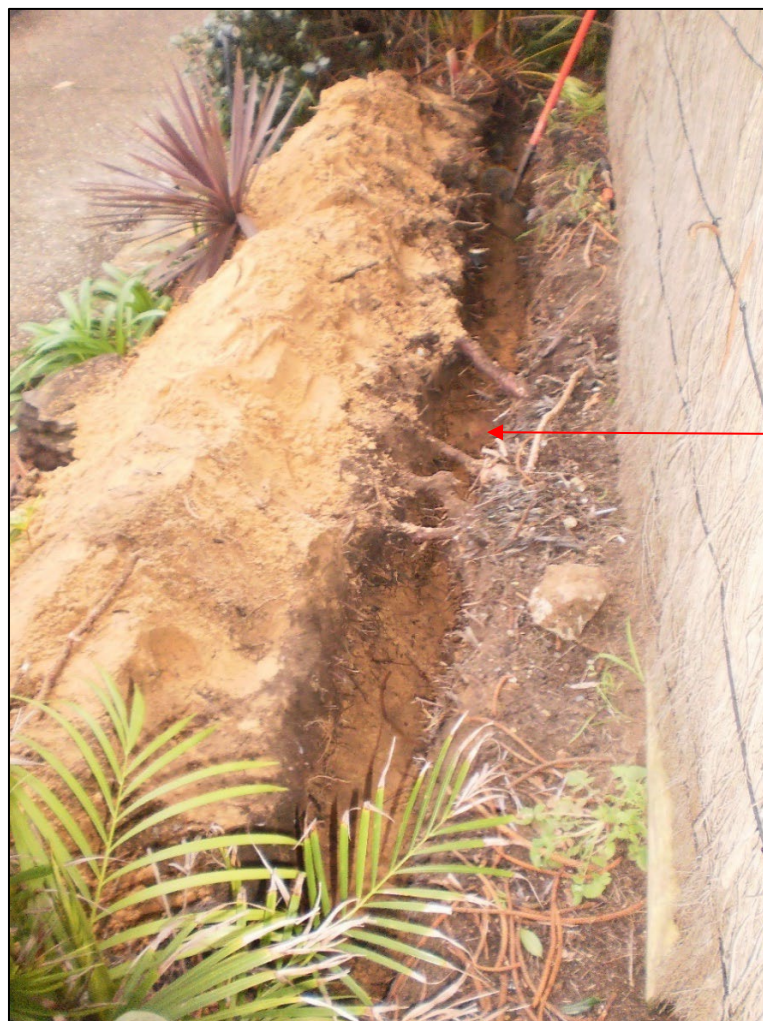
250mm diameter root

Photo D: Exploratory trench taken facing west.

The findings of the exploratory excavation was used by the Architect to ensure the design layout is clear of the structural roots.

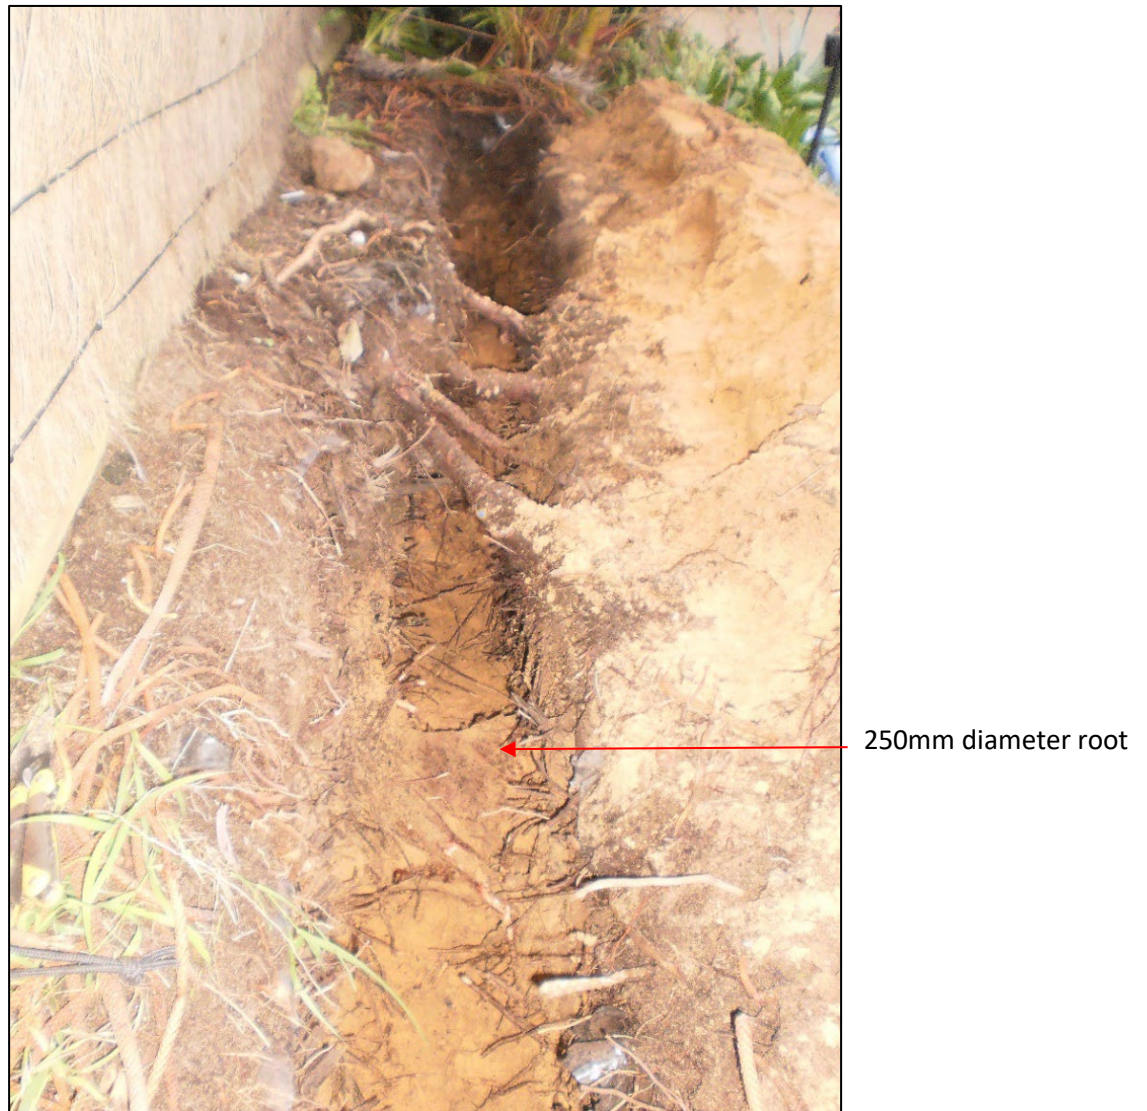
Photo E: Exploratory trench taken facing east.

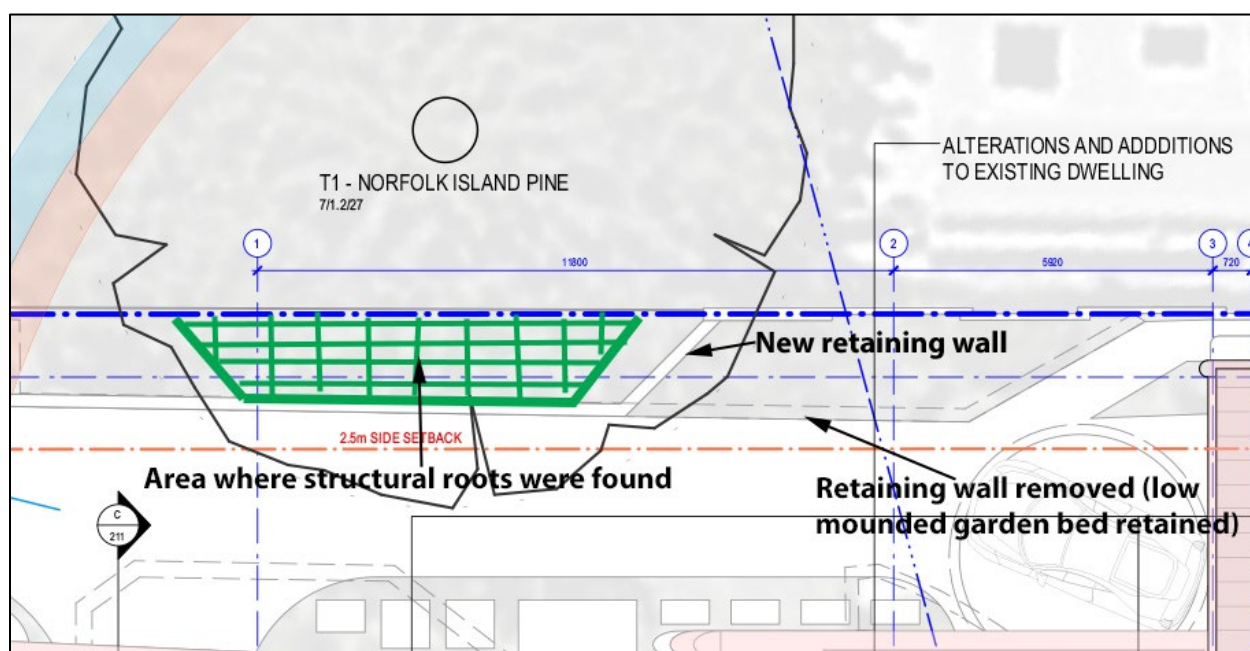
| Tree Number/Species | Retention Value | Works Proposed Within the Tree Protection Zone (TPZ) |
|---|---|--|
| 1 Norfolk Island Pine | High | <p>Removal of part of the existing garden bed retaining and construction of a new section of garden bed retaining wall is proposed within the TPZ. These works are clear the area where large structural roots were found (Figure D). Some pruning of woody transport roots and fine absorbing roots may be required. The tree is likely to tolerate this with no significant impact.</p> <p>The driveway alignment and levels will be as existing in this area with no excavation or driveway widening proposed (Figure D).</p> |

Figure D: Garden bed retaining wall works are outside of the area where large structural roots were found.

Garden bed retaining wall works: The Project Arborist should be present during garden bed grading and retaining wall construction within a 10.0m radius of Tree 1. All excavation must be undertaken using hand tools. Any exposed tree roots within the alignment of footings should be cleanly cut (using a hand saw or secateurs) before excavation continues. This process should be photographed and documented for tree protection certification purposes.
