Report Title: Geotechnical Report 16 Powderworks Road, North Narrabeen

Report Date: 16/8/19

## **GEOTECHNICAL INVESTIGATION:**

### **Alterations and Additions at 16 Powderworks Road, North Narrabeen**

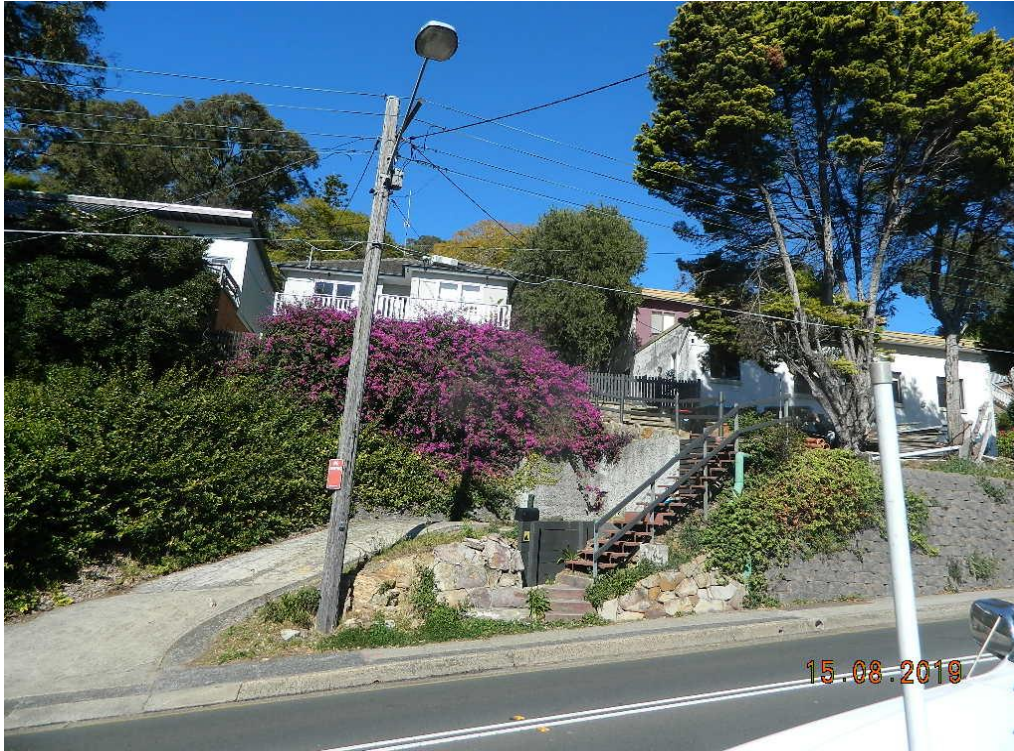
Photo 1

- 2.3** A concrete driveway runs from the road frontage to a cut car port (Photo 1). The cut is supported by a 1.8m high sprayed concrete retaining wall that appears stable and runs the width of the block across the slope (Photo 2). Timber stairs and a concrete path run around the carport and over a steep turfed slope to the downhill side of the house. The part 2 storey timber framed and fibre board clad house is supported on stable masonry piers and walls (Photo 3 & 4). Lawn extends uphill either side of the house. Above the house a stable 1.2m high sandstone block retaining wall supports a cut for the house (Photo 5). Lawn continues uphill until reaching another stable 0.8m high sandstone block retaining wall used to level the backyard (Photo 6). A timber framed and clad studio is located on the slope above the retaining wall

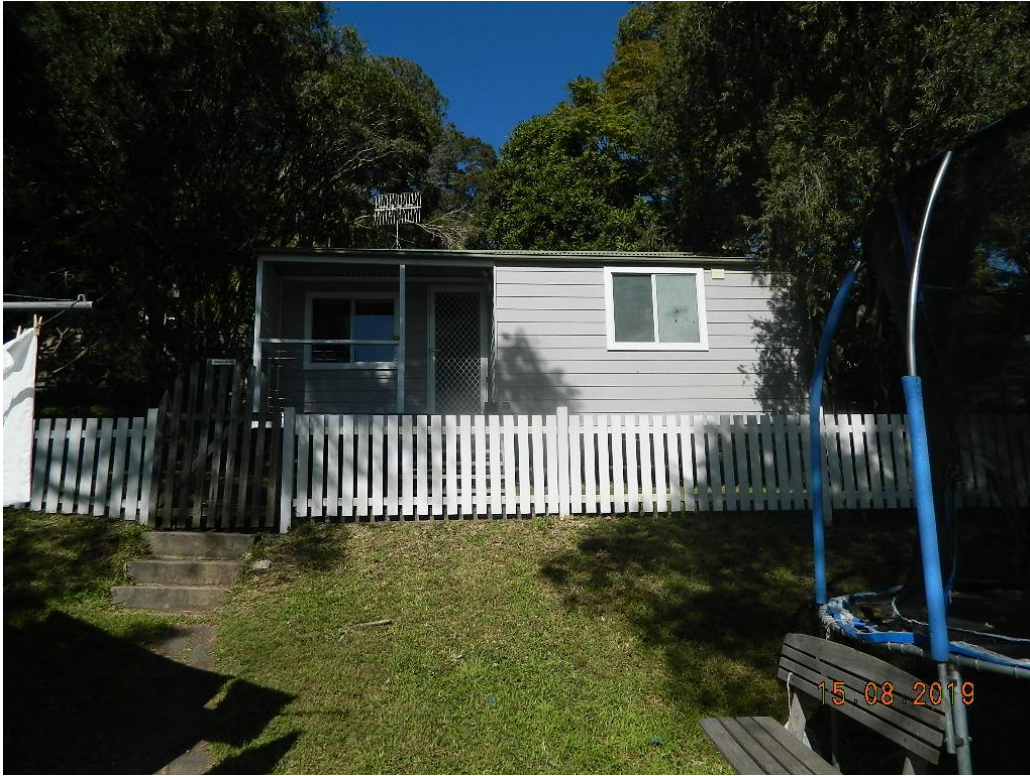
Photo 7

(Photo 7). The studio is supported on treated pine posts that stand vertical (Photo 8). An uphill extension of the secondary dwelling is proposed and construction of a new larger deck to the E of the flat. Lawn extends at moderate to steep angles to the upper common boundary above the studio.

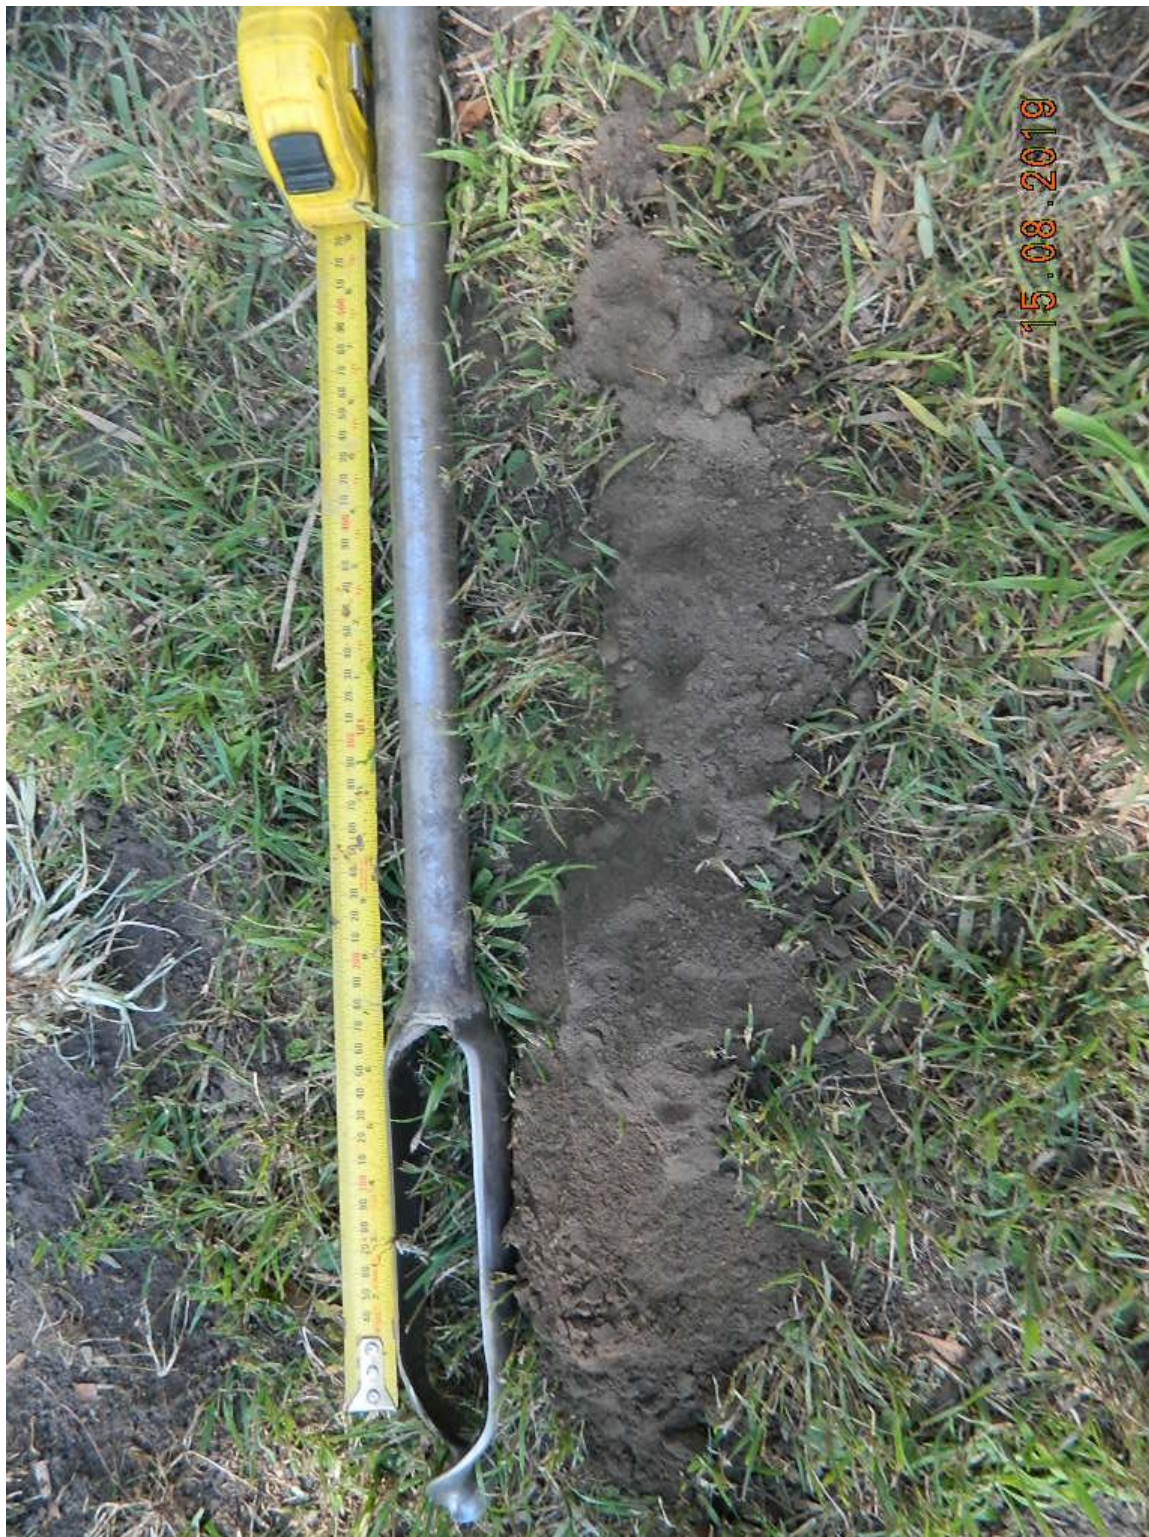
Photo 9 – AH1

#### AUGER HOLE 1 (~RL23.7) – AH1 (Photo 9)

Depth (m)	Material Encountered
0.0 to 0.5	<b>TOPSOIL</b> , sandy silt, dark brown, fine grained, medium dense.

End of test @ 0.5m. No watertable encountered.
