Report Title: RISK ANALYSIS & MANAGEMENT FOR PROPOSED NEW RESIDENCE AND GARAGE AT 143 McCARRS CREEK ROAD, CHURCH POINT – PX 00027

Job Number:
PX 00027
30th August, 2019
Page 1

**RISK MANAGEMENT
FOR
PROPOSED NEW RESIDENCE & GARAGE
AT
143 McCARRS CREEK ROAD, CHURCH POINT**

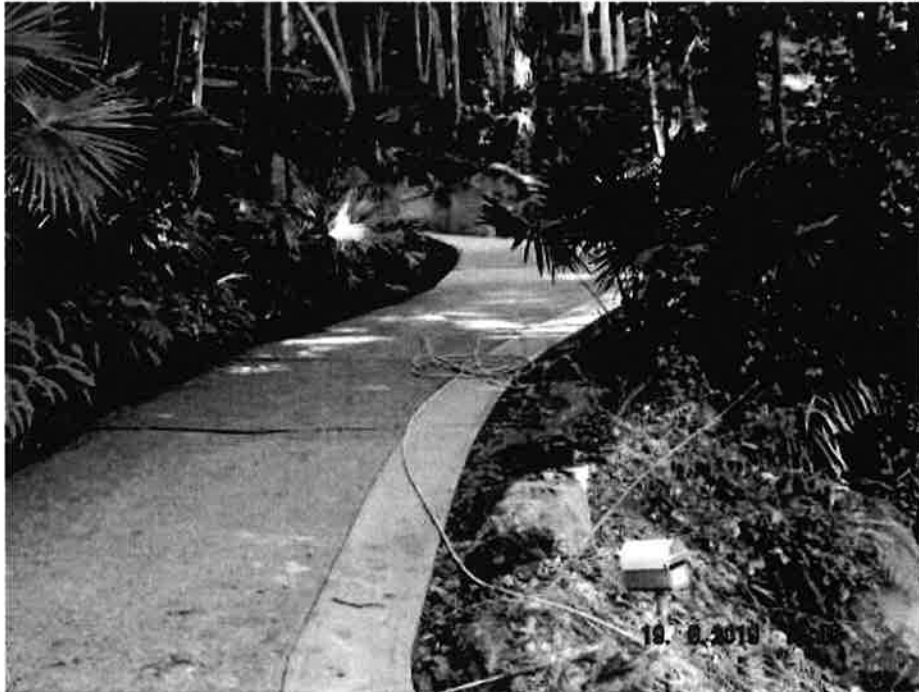
Photo 1

3.3 Access to the block is via the concrete driveway to the north of the property that provides access to 141 McCarrs Creek Road, Photo 1. From the McCarrs Creek road the steep road reserve cut batter rises to the front boundary. The cut batter is well vegetated and in some locations the exposed weathered shales of the Narrabeen Group of rocks is visible, Photo 2. There are numerous small to large trees spread over the block and medium dense undergrowth with displaced joint blocks (rock floaters) littered over the site, Photo 3. From the front boundary there is small level area where the slope rises consistently towards the rear boundary and to the first of the rock ledges, Photo 4. The second rock ledge has rock floaters on top and eroded overhangs in some locations and is approximately halfway up the property, Photos 5 & 6. The vegetated slope then continues to the rear boundary.
