**Subject: Construction Certificate J100145
Development Consent Permit 109/08
24 Montpelier Place Manly**

CONSTRUCTION CERTIFICATE
NO. J100145

24 MONTPELIER PLACE MANLY

DOUGLAS PARTNERS PTY LTD
ST. PATRICK'S ESTATE PRECINCT 2 - MANLY
BORE 201 PROJECT 28058A SEPTEMBER 1999

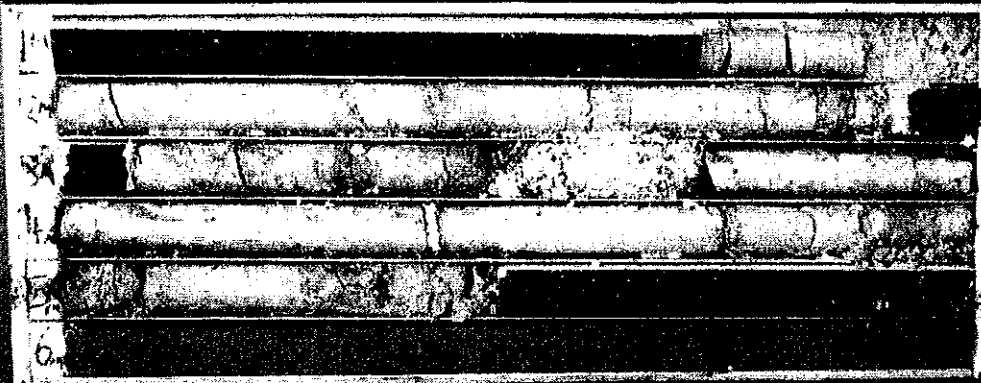
BORE 204 PROJECT 28058A SEPTEMBER 1999

1.00 - 6.00 M

| Depth (m) | Description of Strata | Graphic Log | Soil | | Rock Strength | | Sampling & In Situ Testing | | | Test Results & Comments | |
|---|--|---|---|---|---|---|---|---|---|---|---|
| 1.7 | SANDSTONE - very low to low strength, slightly weathered, fractured to slightly fractured, light yellow to off white, coarse grained sandstone | | | | | | | C | 22 | 0 | PL (A)=0.1MPa PL (A)=0.1MPa |
| 3.65 | SANDSTONE - low to medium and low strength, slightly and highly weathered, slightly fractured, off white, coarse grained gravelly sandstone | | | | | | | | | | |

RIG: SCOUT DRILLER: COOPER LOGGED: PARMAR CASING: BL TO 1.0m
 TYPE OF BORING: SFA TO 1.0m, NMLC CORING TO 6.0m
 WATER OBSERVATIONS: NO FREE GROUNDWATER OBSERVED WHILST AUGERING
 REMARKS:

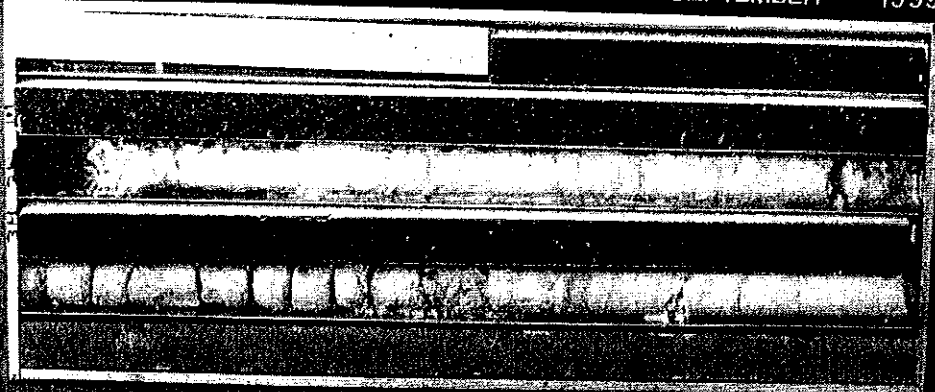
BORE 207 PROJECT 28058A SEPTEMBER 1999

0.50 - 5.00 M

| Depth (m) | Description of Strata | Graphic Log | Soil | | | | | | | | Rock Strength | | | | Sampling & In Situ Testing | | | | | | | |
|---|--|---|---|---|---|---|---|---|---|---|---|---|---|---|---|---|---|--|---|---|---|---|
| 2.0 - 2.13 | SANDSTONE - very low to low strength, slightly weathered, slightly fractured to fractured, off white, coarse grained sugary sandstone with quartz gravel | | | | | | | | | | | | | | | | | | | | | PL (A)=0.1MPa |

WATER OBSERVATIONS: NO FREE GROUNDWATER OBSERVED WHILST AUGERING

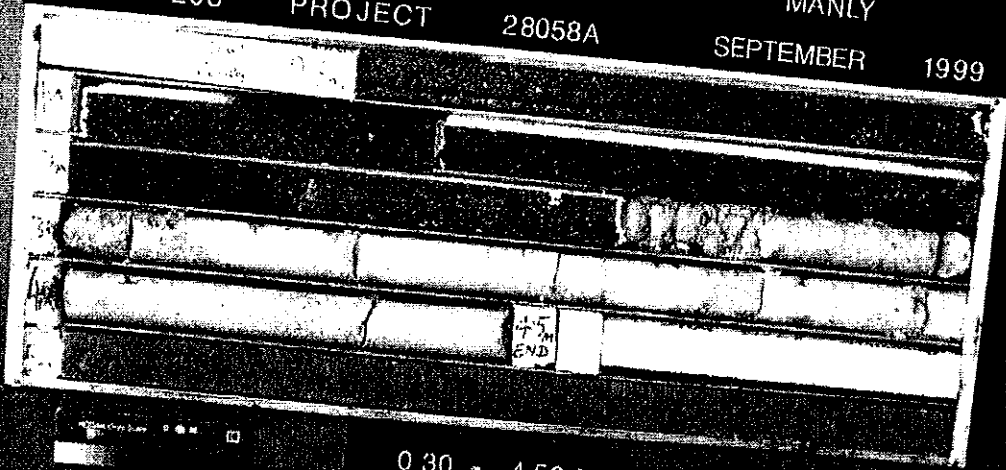
DOUGLAS PARTNERS PTY LTD
ST. PATRICK'S ESTATE PRECINCT 2 - MANLY
BORE 208 PROJECT 28058A SEPTEMBER 1999

0.30 - 4.50 M

| Depth (m) | Description of Strata | Graphic Log | Soil | | | | | | | | | | Rock Strength | | Sampling & In Situ Testing | | | | | |
|---|---|---|---|---|---|---|---|---|---|---|---|---|---|---|---|---|---|---|---|---|
| 2.55 - 2.75 | SANDSTONE - very low strength, slightly weathered, fractured, off white, coarse grained, sugary sandstone | . | | | | | | | | | | | | | | | | | | PL (A)=0.2MPa |
| 2.75 - 3.0 | SANDSTONE - low then low to medium strength, slightly weathered, slightly fractured, off white, coarse grained gravelly sandstone | . | | | | | | | | | | | | | | | C | 100 | 99 | PL (A)=0.2MPa PL (A)=0.3MPa |

RIG: SCOUT DRILLER: COOPER LOGGED: PARMAR CASING: GL TO 0.3m
 TYPE OF BORING: SFA TO 0.3m, NMLC CORING TO 4.5m
 WATER OBSERVATIONS: NO FREE GROUNDWATER OBSERVED WHILST AUGERING
 REMARKS: R = ROTARY
