## **GEOTECHNICAL INVESTIGATION:**

Alterations & Additions at **18 Francis Street, Fairlight**

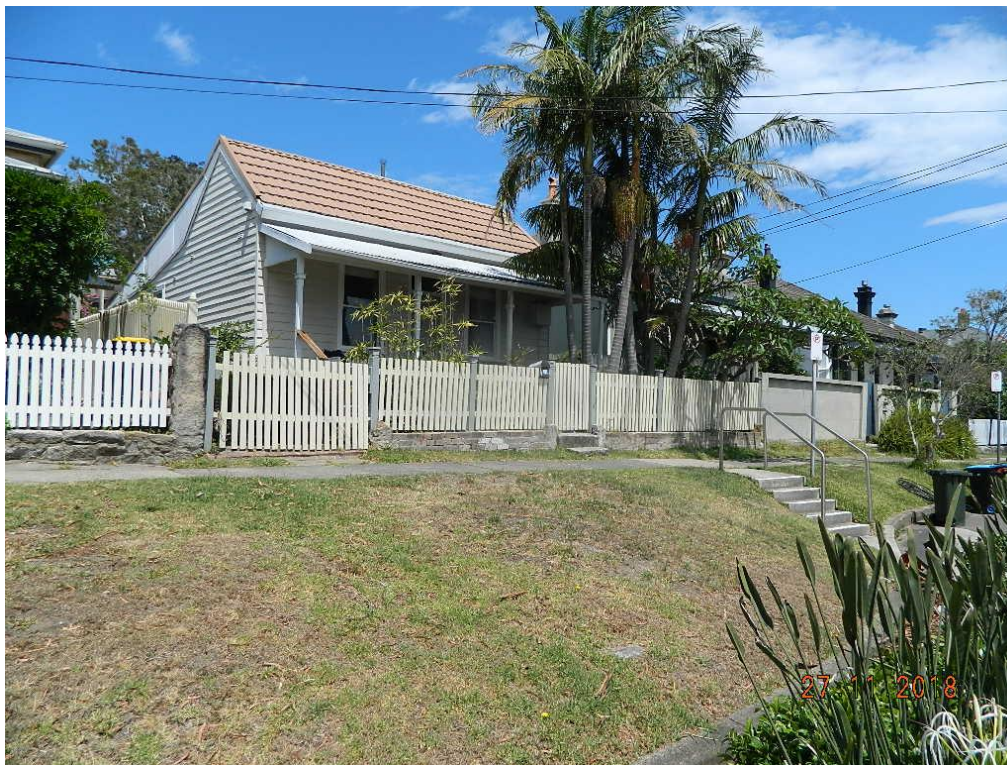
Photo 1

- 2.3** Between the road frontage and the house is a gently sloping garden area (Photo 1 & 2). The old single-storey timber framed weatherboard clad and plasterboard house is supported on sandstone block piers (Photo 3). The supporting piers stand vertical (Photo 4). A cut has been made into the slope for a paved patio that extends off the uphill side of the house (Photo 5). A stable ~0.6m rendered brick retaining wall supports the cut for the patio area. The wall will be demolished as part of the proposed works. A moderately sloping lawn area extends from the retaining wall. A covered deck is located in the NE corner of the property (Photo 6). Competent

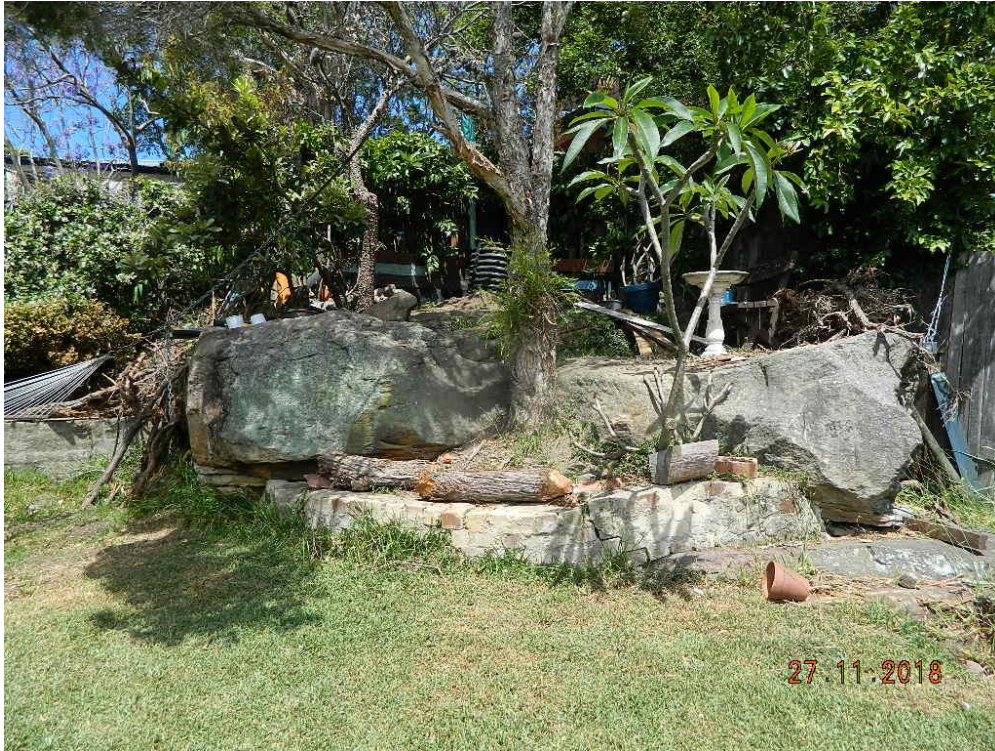
Photo 7

Medium Strength Sandstone bedrock outcrops in the SE corner of the property (Photo 7). A stable ~0.5m rendered brick retaining wall close to the uphill boundary retains a fill for a garden bed at the upper boundary (Photo 8). No significant signs of movement were observed on the property. No geotechnical hazards that could impact on the subject property were observed on the neighbouring properties as seen from the subject property and the road.

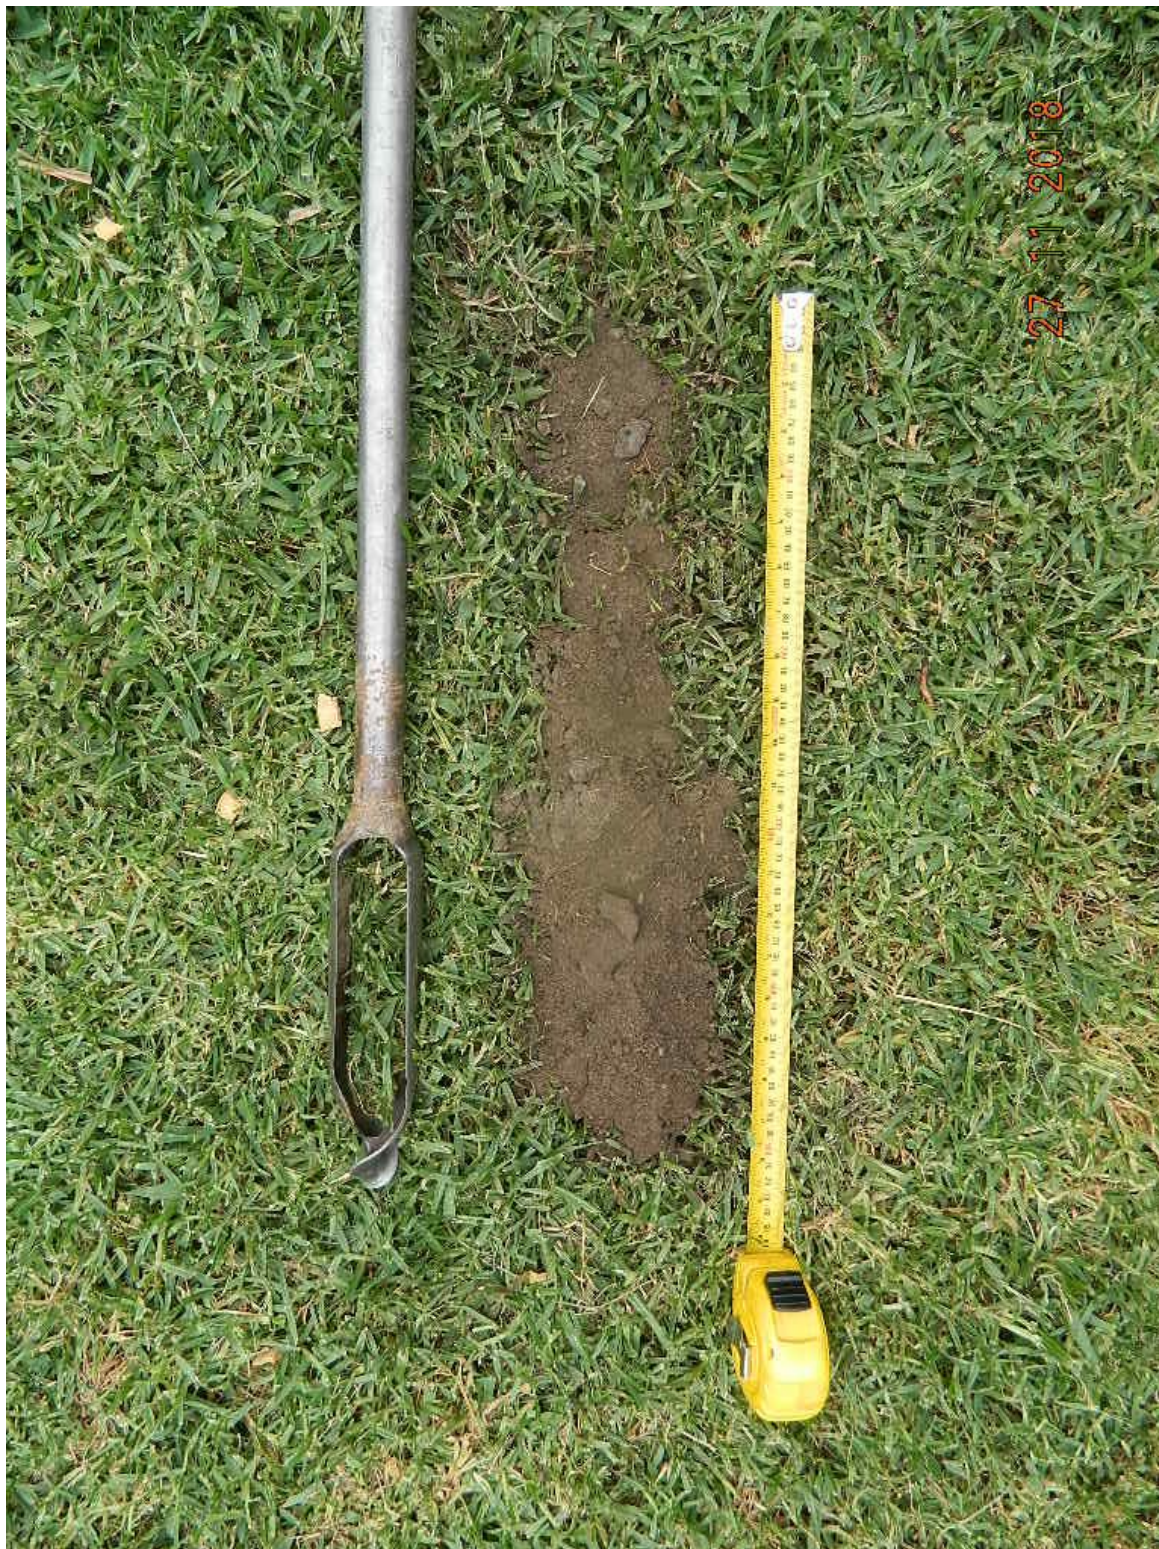
#### AUGER HOLE 1 (~RL 48.7) – AH1 (Photo 9)

Depth (m)	Material Encountered
0.0 to 0.5	<b>SANDY SOIL</b> , light brown, loose, fine to medium grained, black rock fragments, sandstone rock fragments, organic matter, dry.

Refusal @ 0.5m on hard surface. No watertable encountered.

*Photo 9 – The base of the auger is at the bottom of the picture*
