Construction Certificate Application

Type of Work: <input checked="" type="checkbox"/> Building Work
OR
<input type="checkbox"/> Subdivision Work
Description of proposal – (Provide brief, concise details):
Installation of an above ground fuel tank, decommissioning and removal of three underground tanks and associated works, including excavation and site remediation.

LOCATION OF PROPOSED ABOVE
GROUND FUEL STORAGE TANK
Refer "Attachment 2" detailed plan

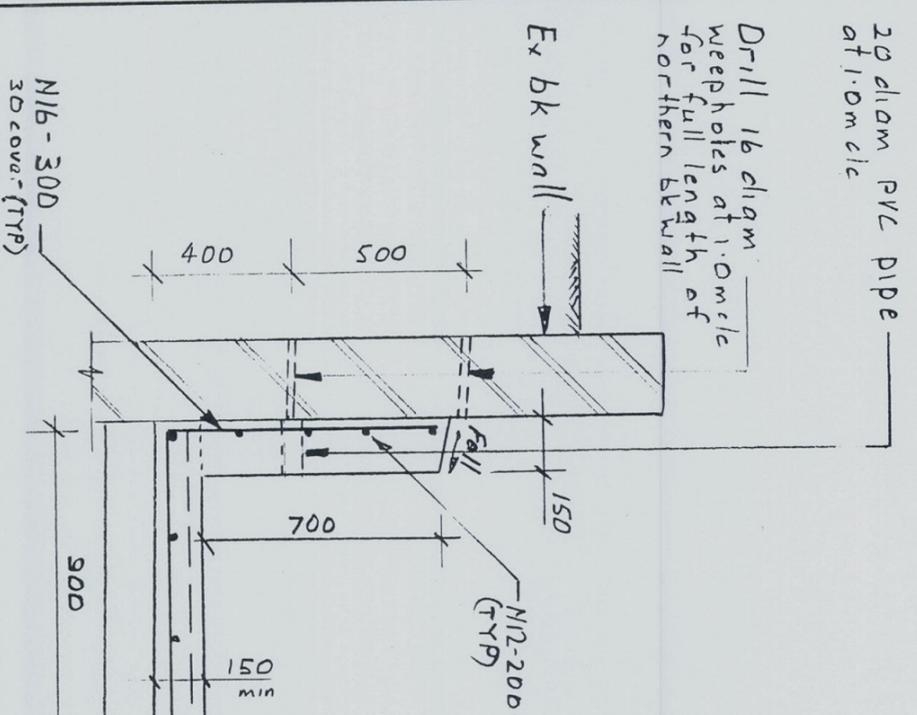
SECTION
1:20

Typical tank floor slab & ex brick wall strengthening detail

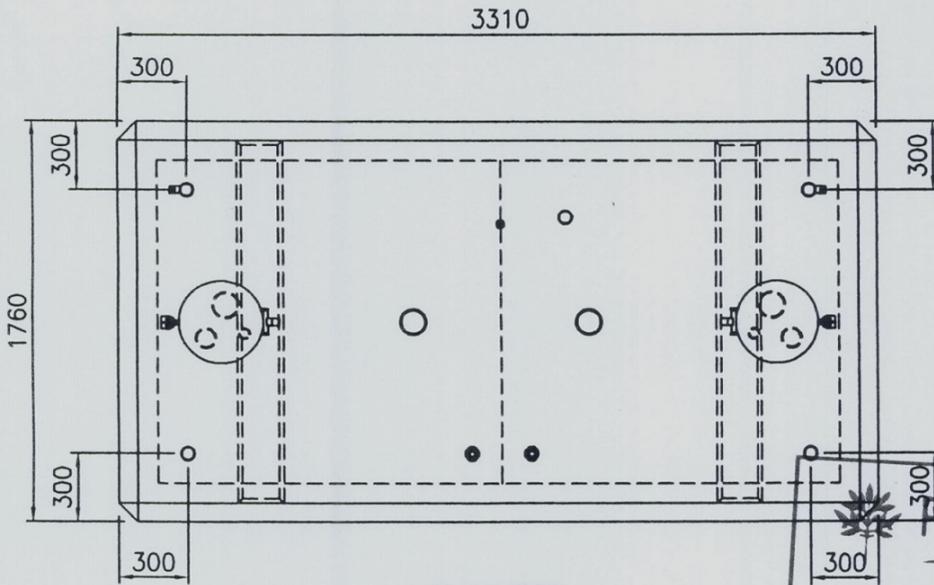
PLAN VIEW

CONVAULT

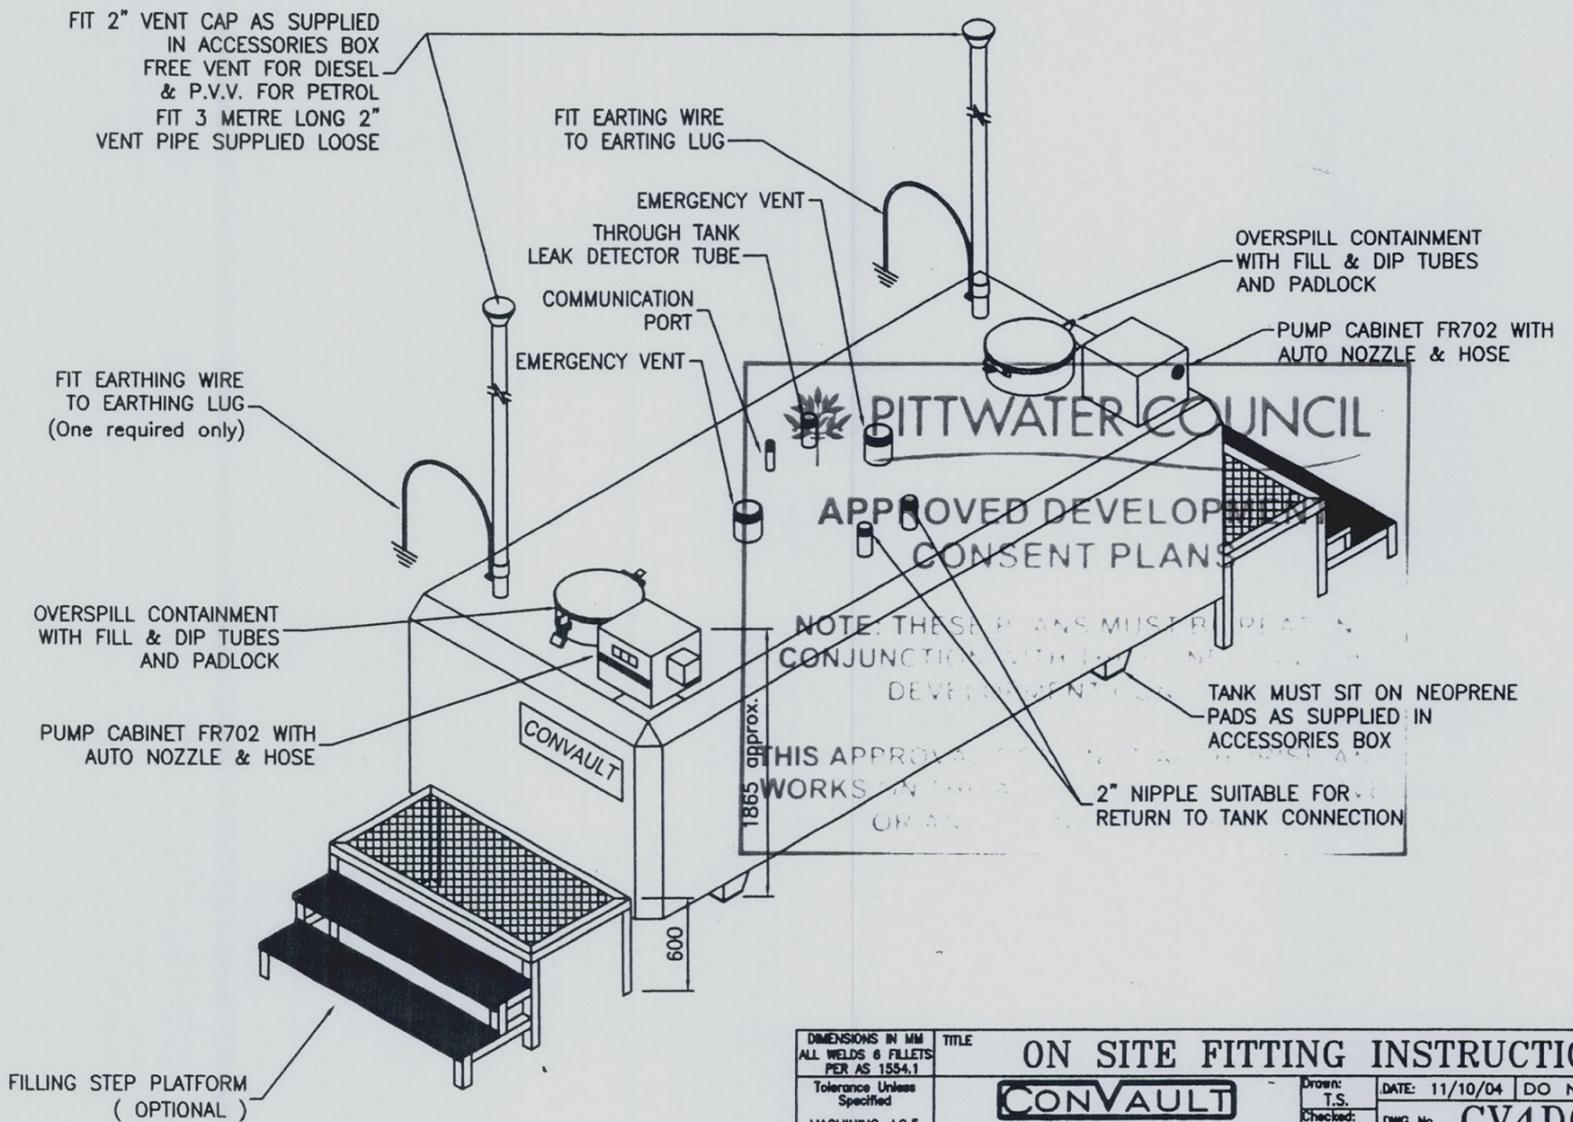
Dwg No CV4D01

ON SITE FITTING INSTRUCTIONS FOR ACCESSORIES 4000 LITRE DUAL TANK

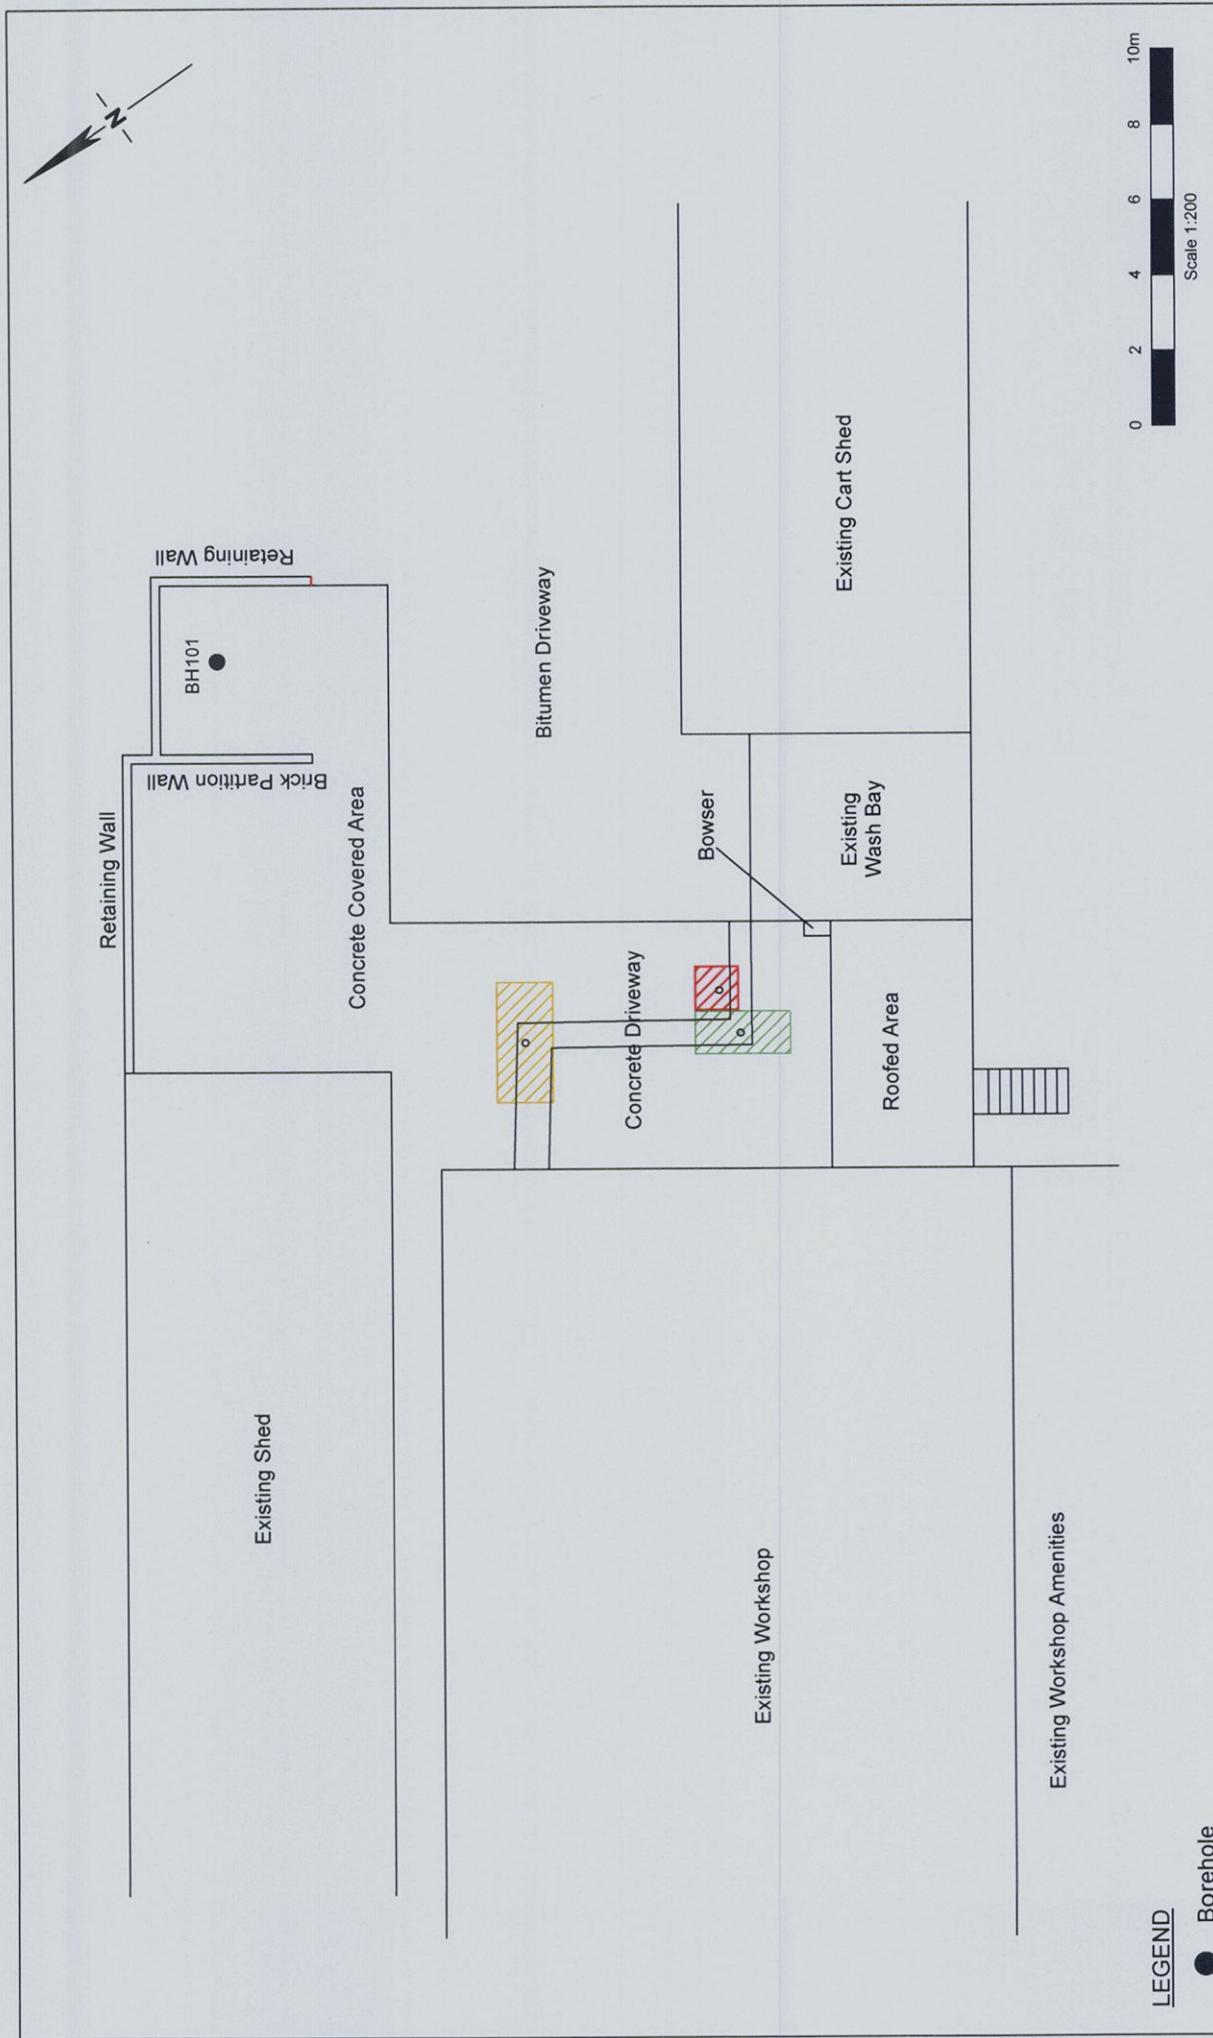
Sample Location

Further to the Preliminary Contamination Report (PCA) dated ~~23 December 2011~~, prepared by Geotechnique Pty Ltd (Geotechnique) for the above site (indicated on Figure 1 below) and as requested, one additional soil sample was recovered from the area proposed for installation of above-ground fuel storage tank (AFST) as indicated on Drawing No 12593/2-AA1 in Attachment A.

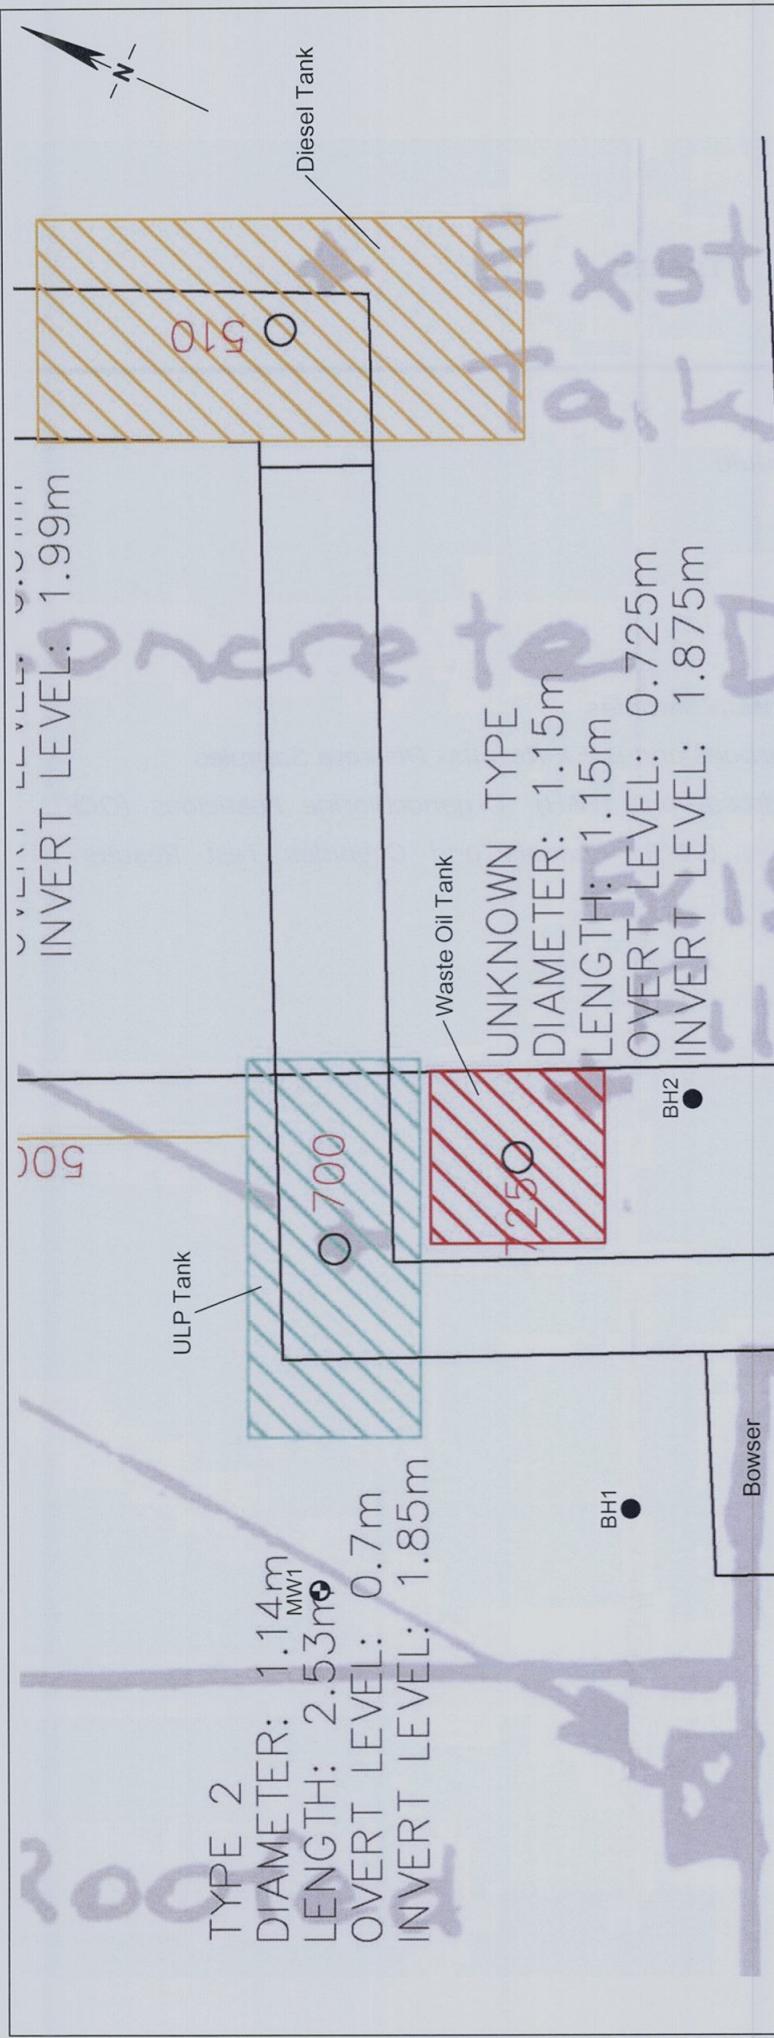
Drawing No: 12593/1-AA1
Job No: 12593/1
Drawn By: MH
Date: 1 December 2011
Checked By: AN
File No: 12593-1
Layers: 0, AA1

Boreholes and Monitoring Well Locations

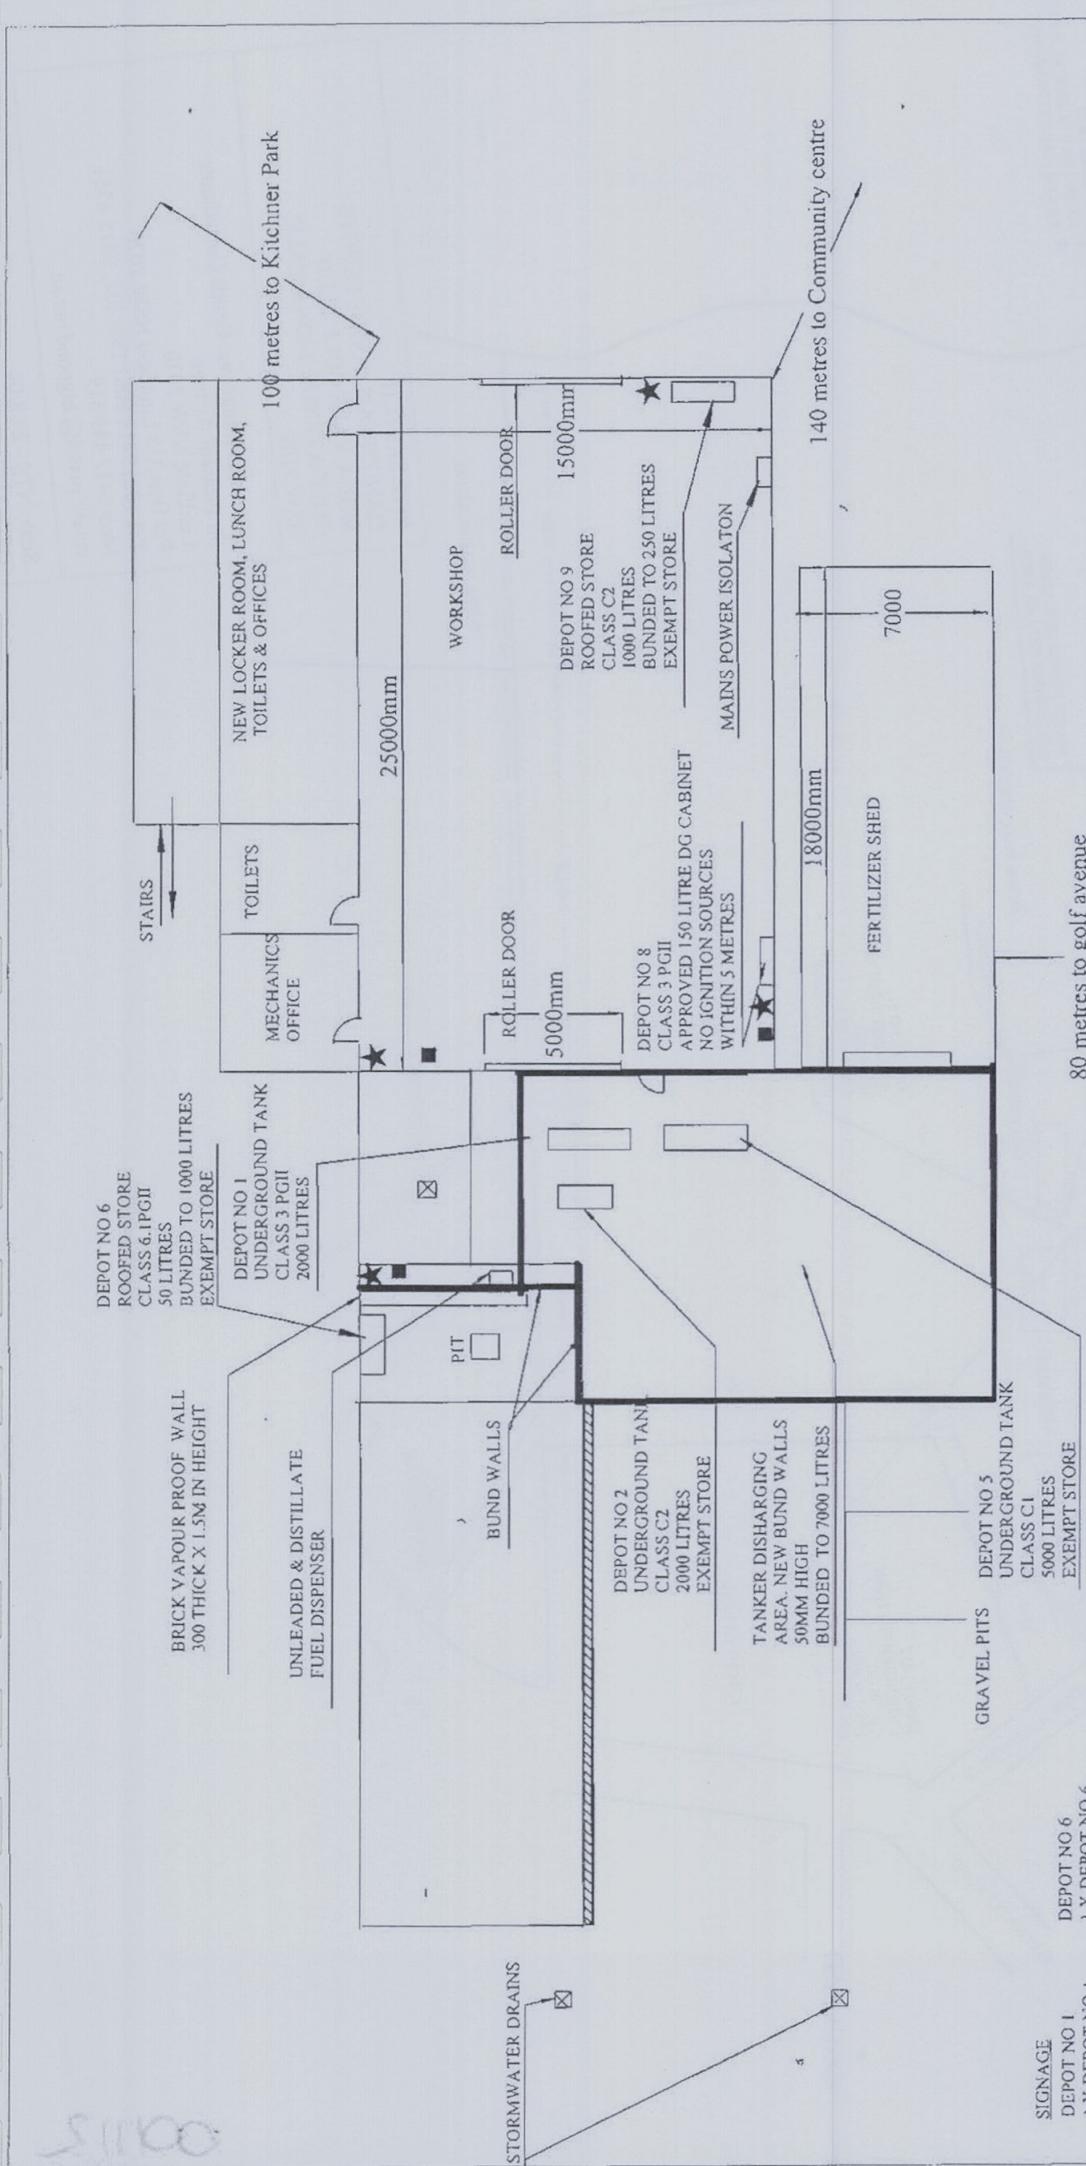
DETAIL A
DANGEROUS GOODS DEPOTS
MONA VALE GOLF CLUB

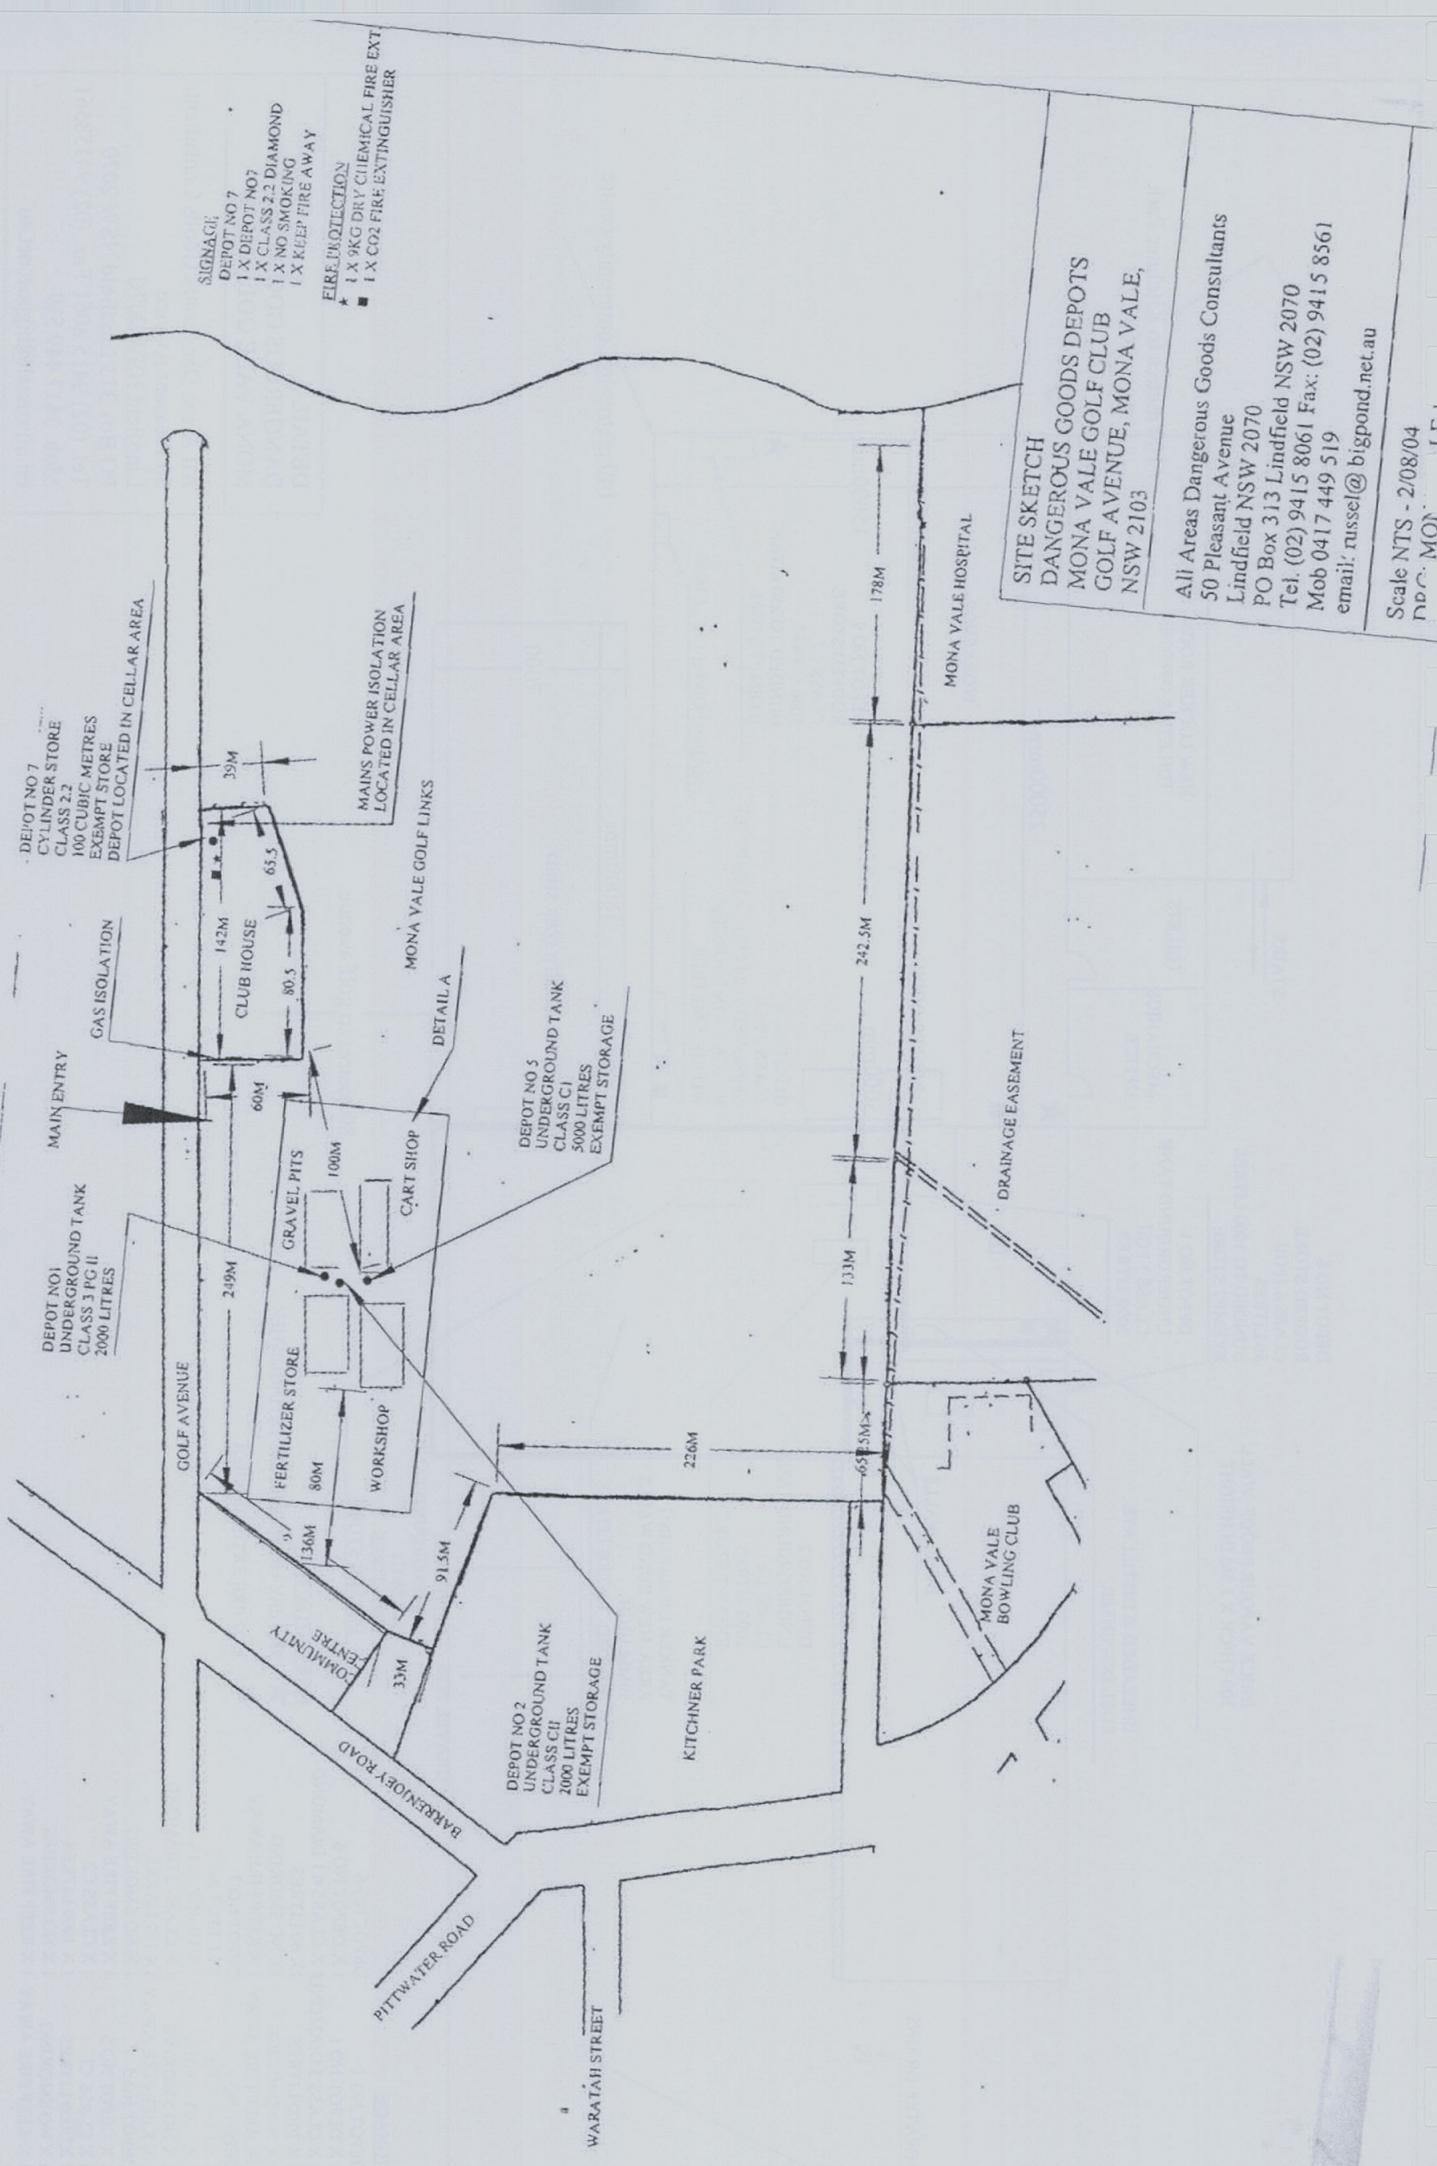
- SIGNAGE:**
- 1 X DEPOT NO 7
 - 1 X DEPOT NO 7
 - 1 X CLASS 2.2 DIAMOND
 - 1 X NO SMOKING
 - 1 X KEEP FIRE AWAY
- FIRE PROTECTION:**
- 1 X 9KG DRY CHEMICAL FIRE EXT.
 - 1 X CO2 FIRE EXTINGUISHER

SITE SKETCH
DANGEROUS GOODS DEPOTS
MONA VALE GOLF CLUB
GOLF AVENUE, MONA VALE,
NSW 2103

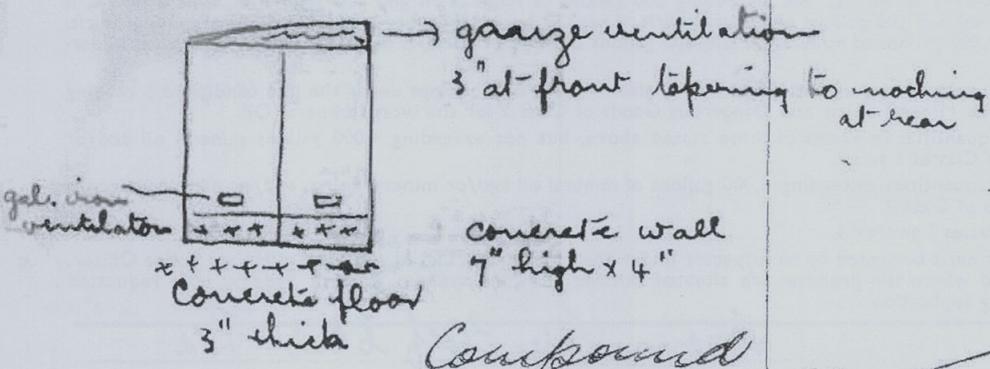
side elevation
 depot. 6' x 6' x 7' high 3x2 hardwood bottom and top plates 3x2 studs and rafters covered gal. iron
 pit. approx. 5' x 5' x 7' high concrete wall approx. 12 cub. feet.

exhausting equipment shed about 70' away
