REPORT ON GEOTECHNICAL INVESTIGATION

PROPOSED NEW RESIDENTIAL DEVELOPMENT

52-54 BRIGHTON STREET, FRESHWATER, NSW

Project No.: 2023-120

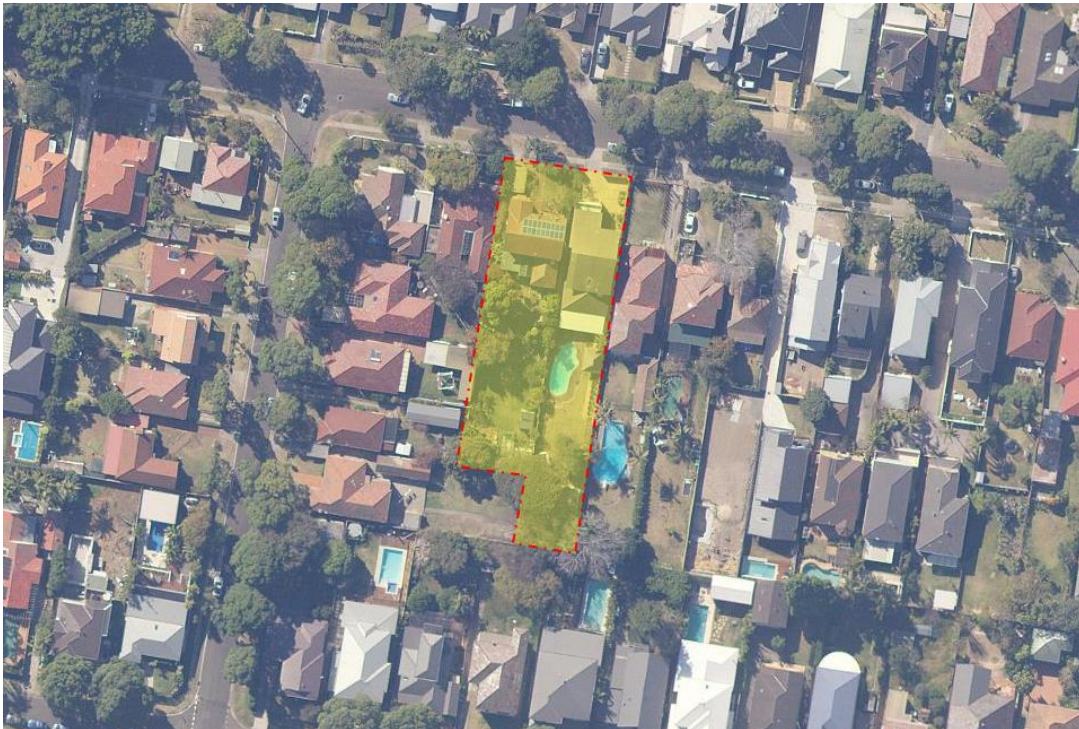
Photograph-1: Aerial photo of site and surrounds (source: SIX Maps, access 16/6/2023)

The site contains two rectangular blocks (Lots 38 DP14450 and Lot A in DP 384323) located on the south side of Brighton Street within generally gently (<3°) northern dipping topography.

The site has a front north/rear south boundary of approximately 28.0m, side west boundary of approximately 67.975m and side east boundary of approximately 83.4m. An aerial photograph of the site and its surrounds as Photograph 1, as sourced from NSW Government SIX Maps spatial data website.

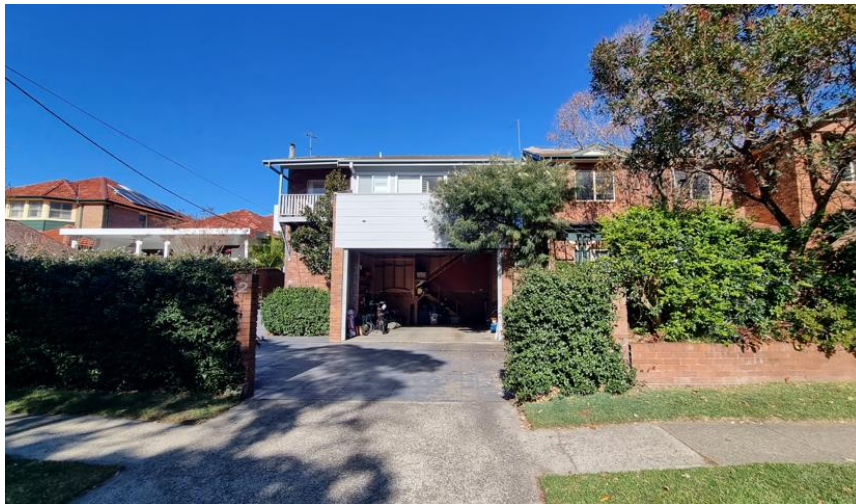
Photograph-2: View of Eastern front of 52 Brighton Street. View looking west from Brighton Street.

The site is situated on the southern side of Brighton Street with gently north-east dipping topography. General views of the site are shown in Photograph 2 to 3 (front) and Photograph 4 to 5 (rear).

- 52 Brighton Street: a two-storey brick building with a detached swimming pool, a pavilion, two one-storey buildings within the rear site area. The main structures appeared in good condition without any sign of significant cracking on the external wall. The remaining area is occupied by concrete-paved driveway, footpath, timber decking, garden beds, tree, and lawns.
- 54 Brighton Street: a two-storey brick building with a detached parking area at the front of the block, a storage building within the rear area. The main structures appeared in fair to good condition. The remaining area is occupied by a concrete-paved driveway, footpath, brick terrace pavement, garden beds, brick stairs, tree, and lawns.

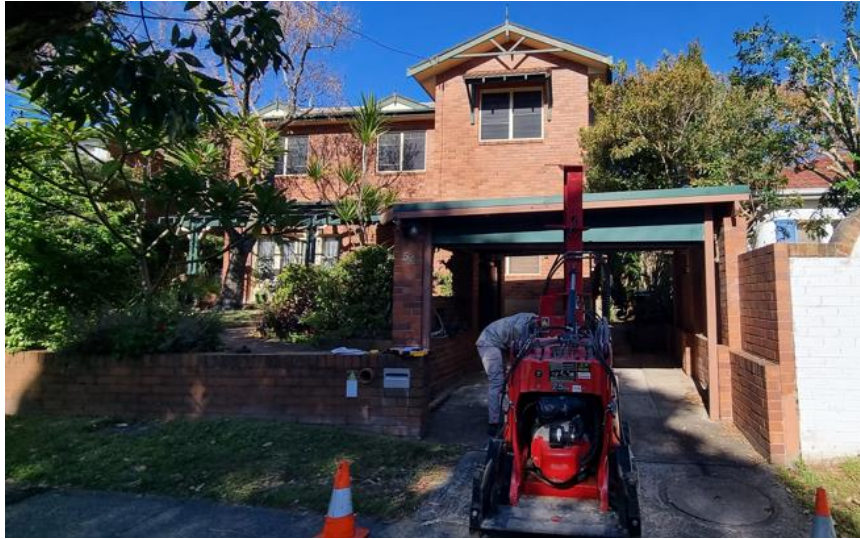
Photograph-3: View of Eastern front of 54 Brighton Street. View looking south from Brighton Street.

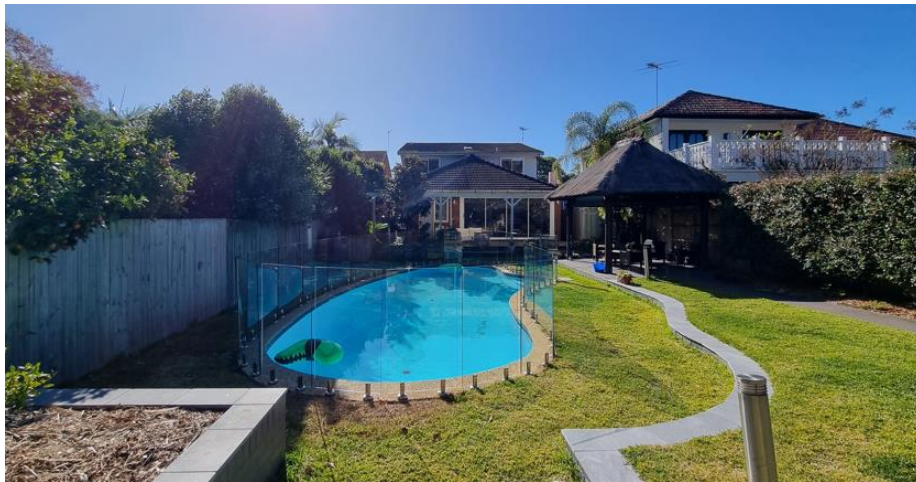
Photograph-4: View of rear area of 52 Brighton Street. View looking north from the rear yard.

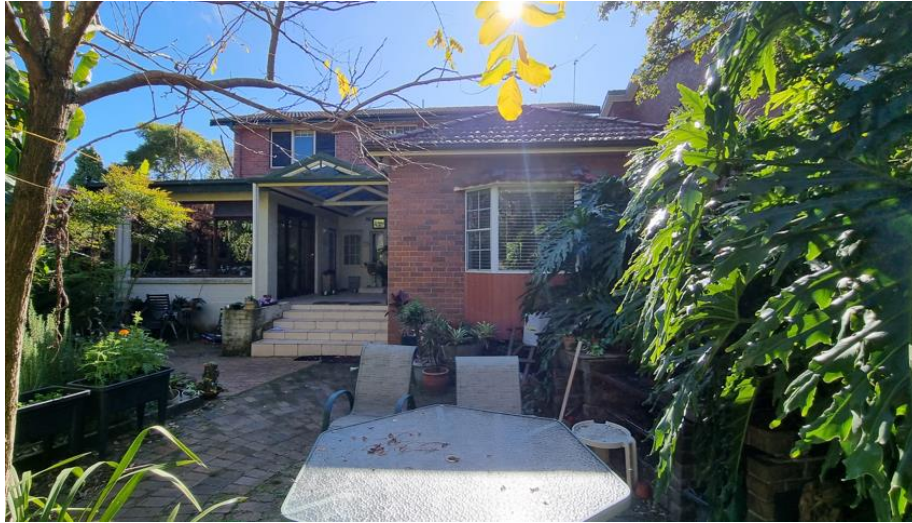
Photograph-5: View of rear side of the main building at 54 Brighton Street. View looking north from the rear yard.

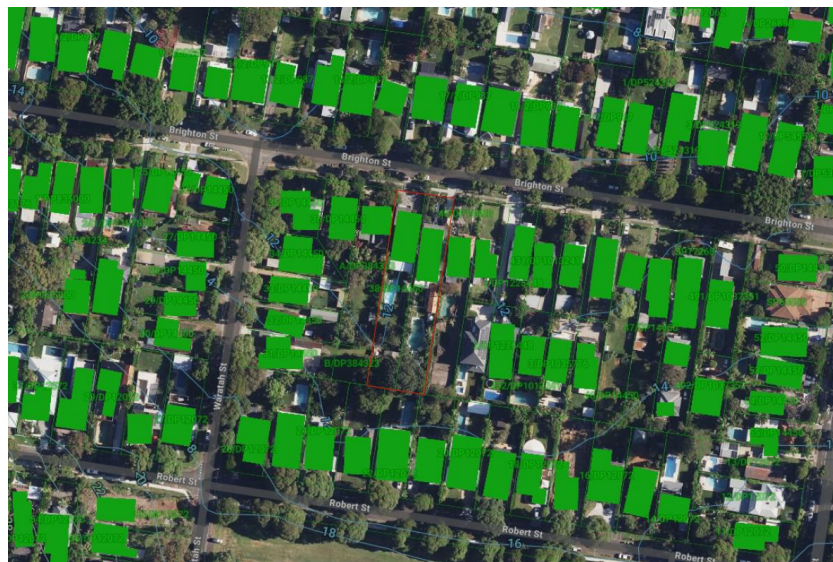
- a) The site is located at middle to bottom portion of a ridge with a generally gently ($<3^\circ$) northern dipping topography, shown in the below plan acquired from Mecone Mosaic.

Plate 1. Aerial photo of site and surrounds (source: Mecone Mosaic, access 4/12/2023)
