Development Application for _____	Name of Applicant _____
Address of site <u>74 LOQUAT VALLEY RD, BAYVIEW</u>

**REPORT TO
PETER RAU**

**ON
GEOTECHNICAL ASSESSMENT
(In Accordance with Pittwater Council Risk
Management Policy)**

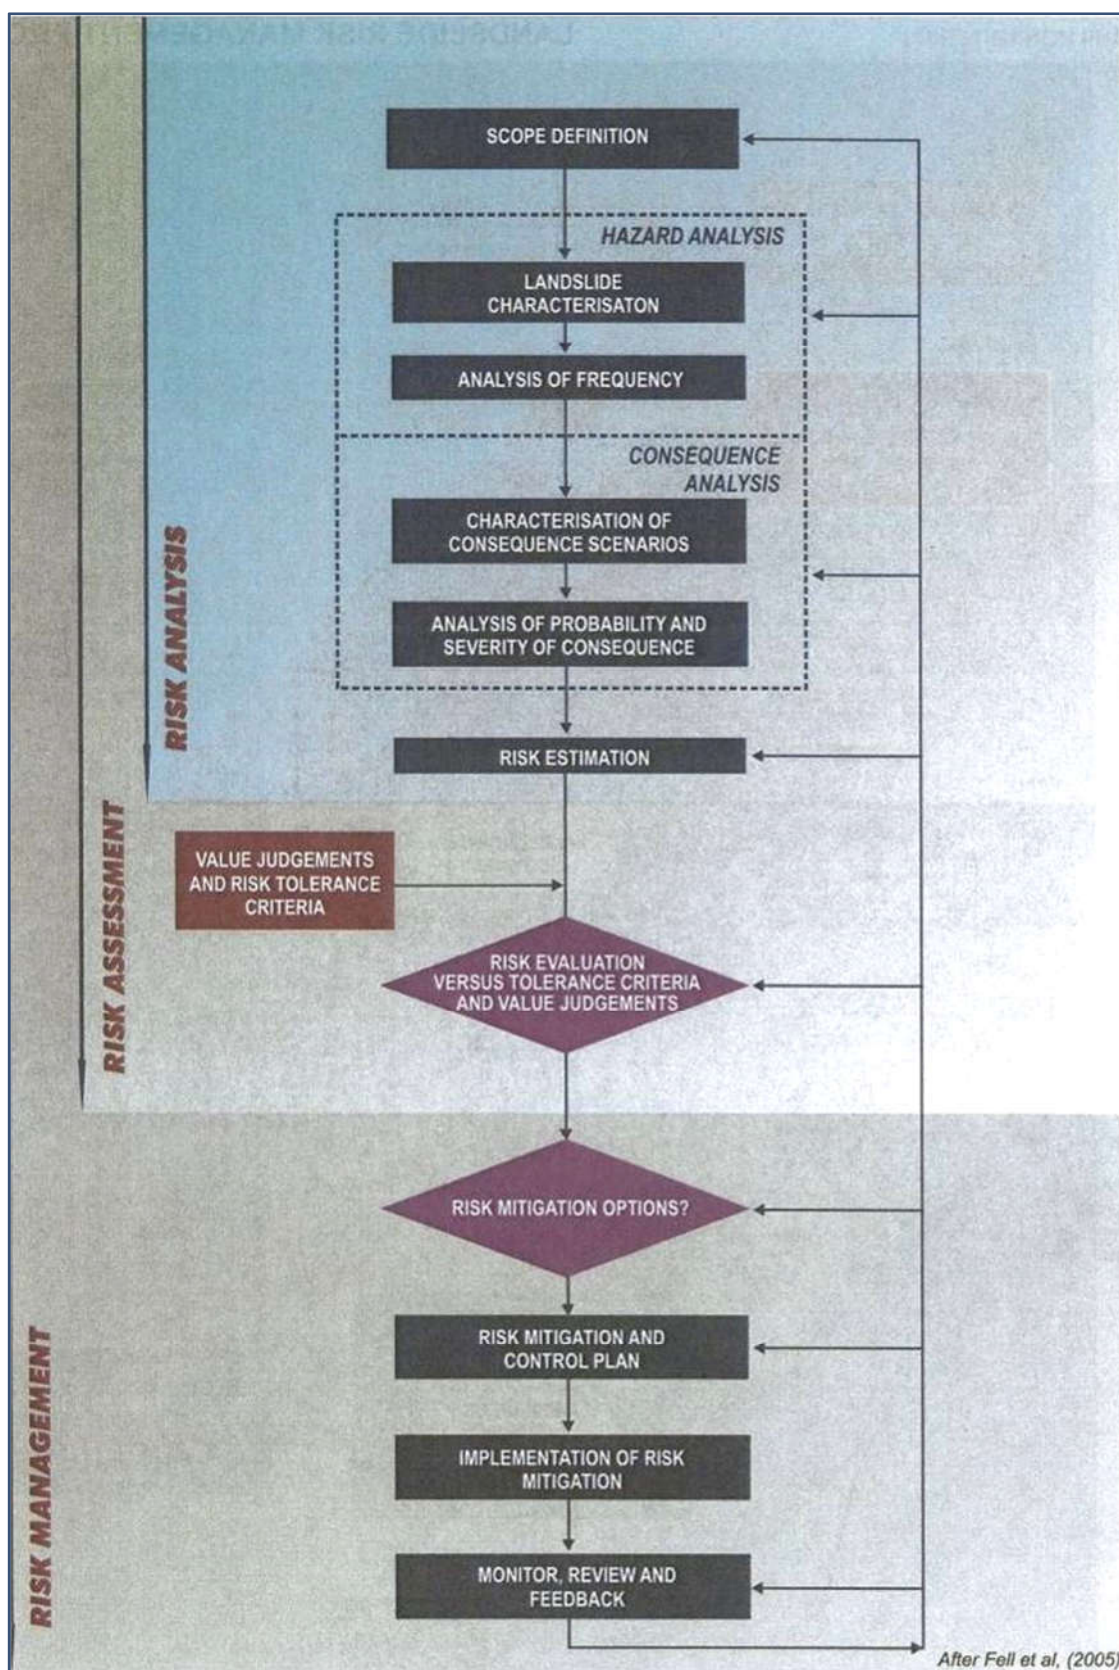
FIGURE A1: Flowchart for Landslide Risk Management.

This figure is an extract from GUIDELINE FOR LANDSLIDE SUSCEPTIBILITY, HAZARD AND RISK ZONING FOR LAND USE PLANNING, as presented in Australian Geomechanics Vol 42, No 1, March 2007, which discusses the matter more fully.
