Acid Sulfate Soil Assessment: Stormwater Harvesting and Irrigation Works Bayview Golf Course, Cabbage Tree Road, Bayview, NSW

P2108485JR02V01 October 2021

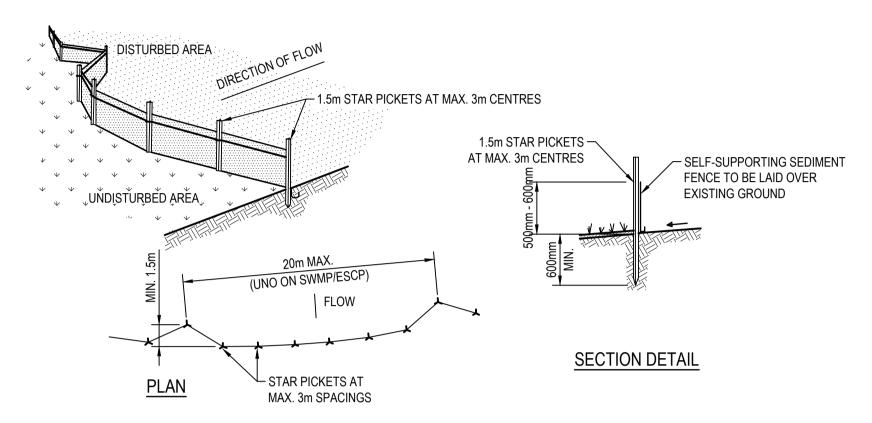
SEDIMENT CONTROL FENCE

- 1. CONSTRUCT SEDIMENT FENCE AS CLOSE AS POSSIBLE TO PARALLEL TO THE CONTOURS
- OF THE SITE.
- 2. DRIVE 1.5m LONG STAR PICKETS INTO GROUND, 3m APART.
- 3. FIX SELF-SUPPORTING SEDIMENT FENCE TO UPSLOPE SIDE OF POSTS WITH WIRE TIES OR AS RECOMMENDED BY SEDIEMNT FENCE MANUFACTURER.
- 4. JOIN SECTIONS OF FABRIC AT A SUPPORT POST WITH A 150mm OVERLAP.
