PALMDEV PTY LTD

Additional Geotechnical Investigation

1112-1116 Barrenjoey Road, Palm Beach NSW

E25203.G04_Rev1
8 August 2024

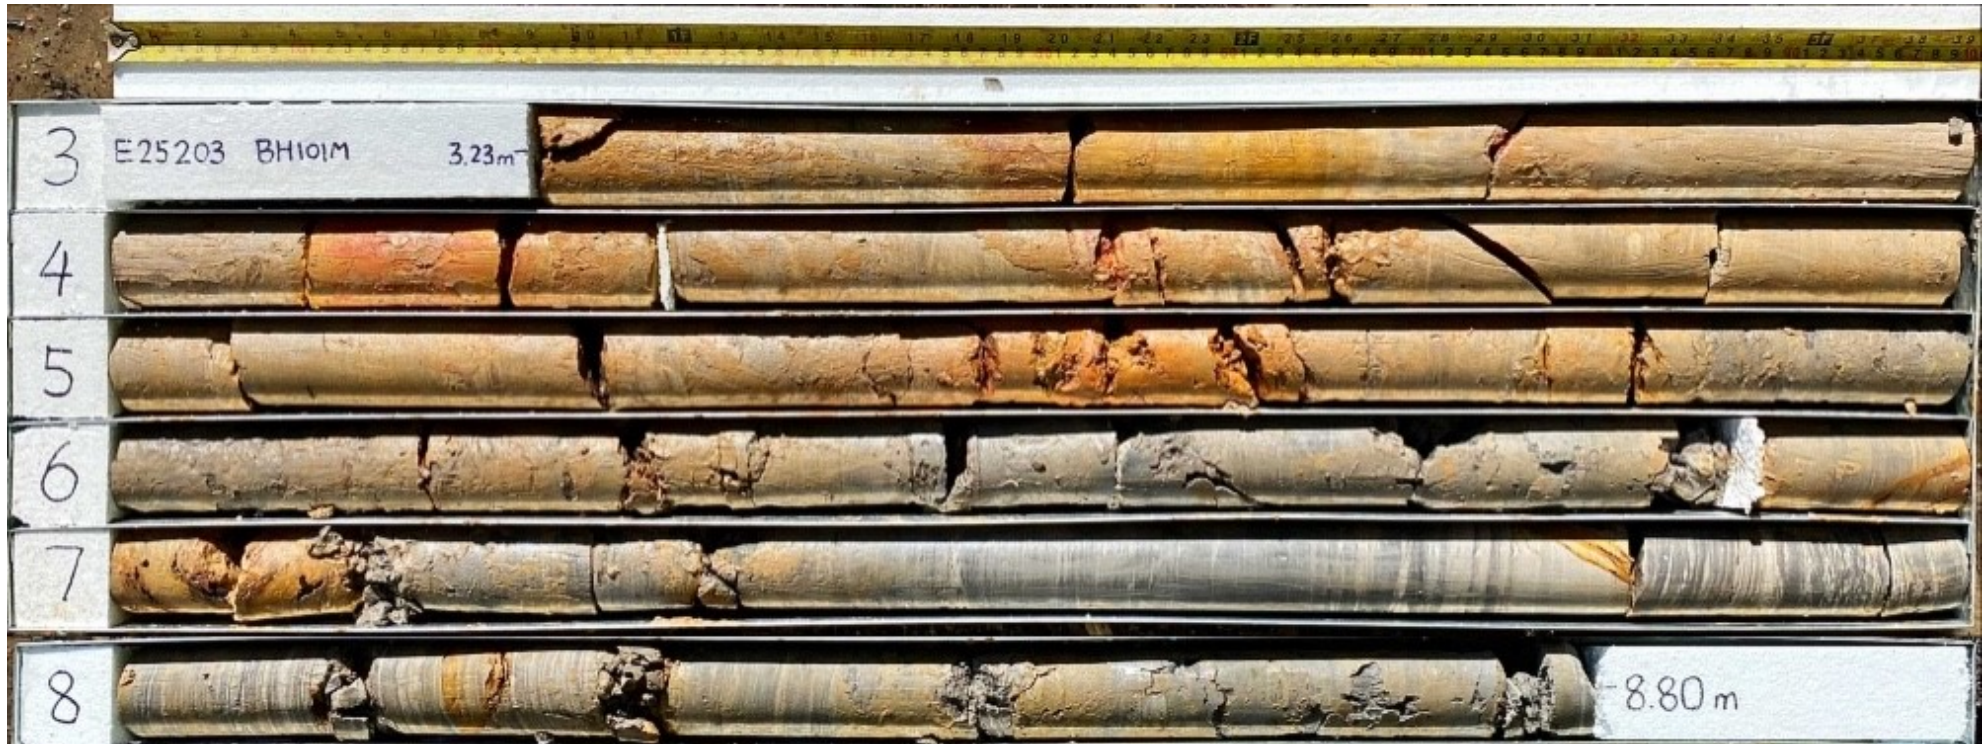
Project	Proposed Development	Depth Range	3.23m to 8.80m BEGL	
Location	1112-1116 Barrenjoey Road, Palm Beach NSW	Contractor	BG Drilling	
Position	Refer to Figure 2	Drill Rig	Christie CE180	
Job No.	E25203.G04	Logged	KX	Date 11 / 06 / 2021
Client	Palmdev Pty Ltd	Surface RL	≈ 2.31 m	
		Inclination	-90°	
		Box	1-2 of 2	
		Checked	SR	Date 14 / 07 / 2021

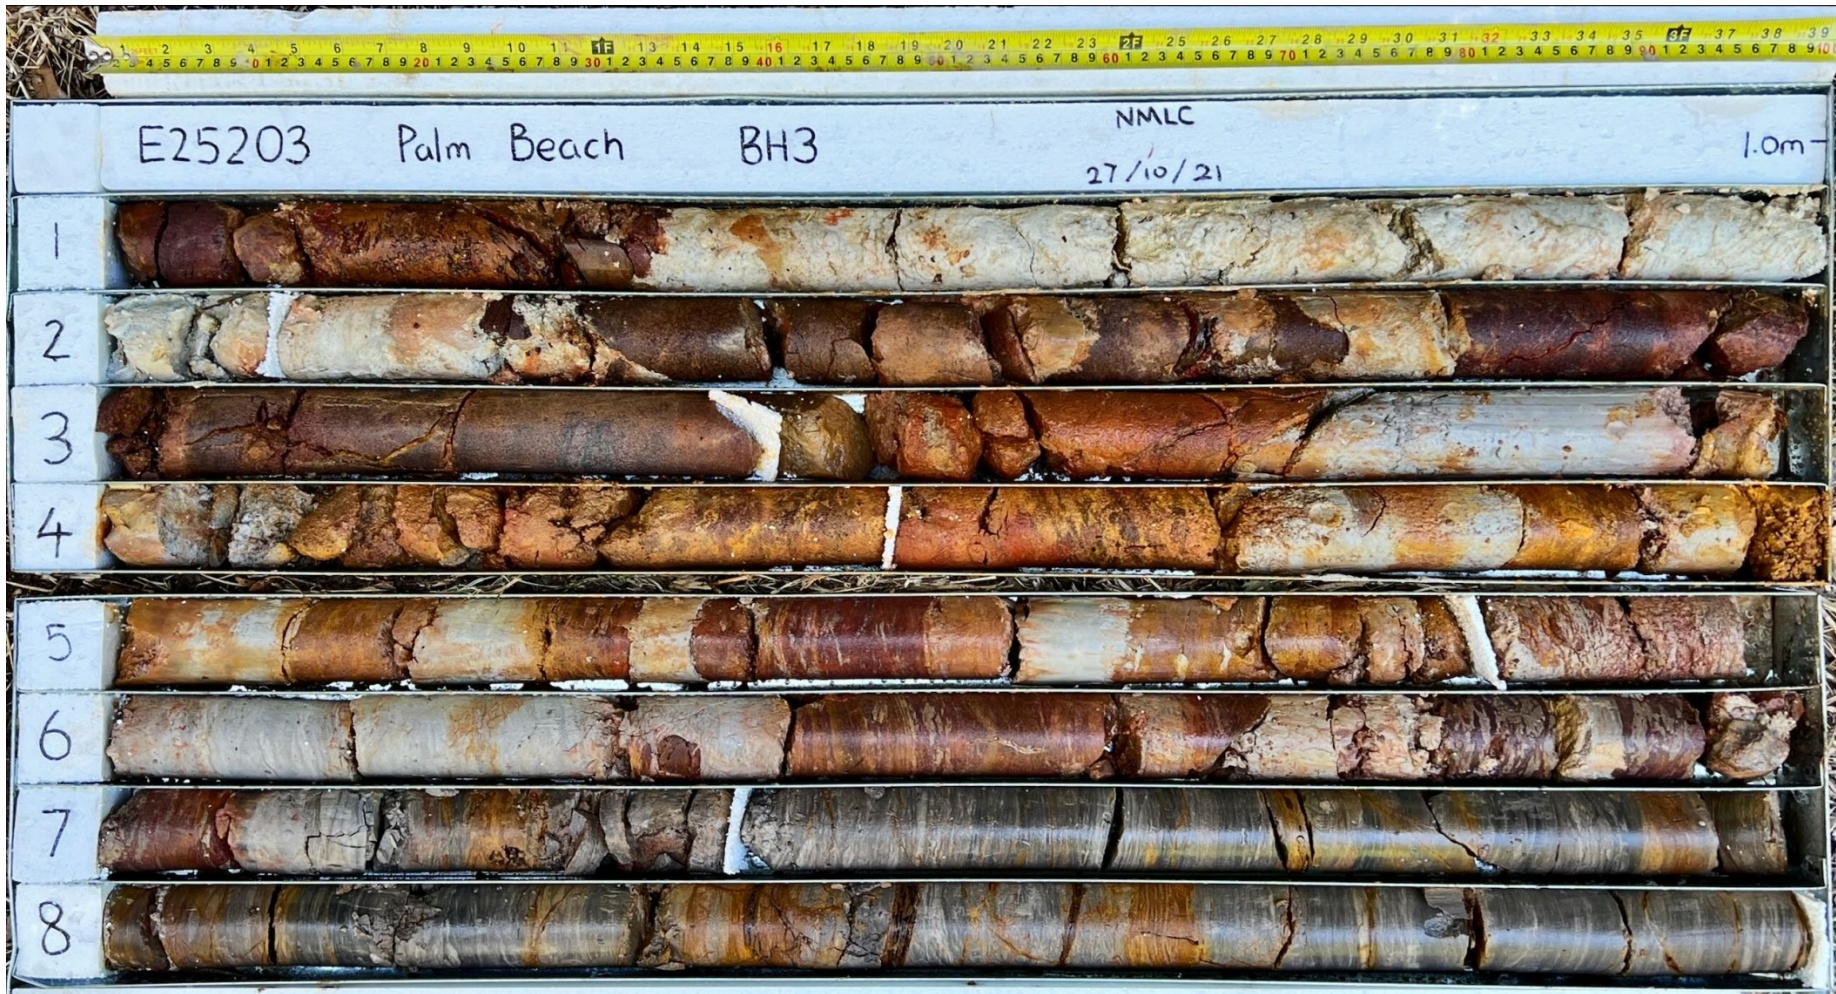
Project	Proposed Development	Depth Range	1.00m to 9.00m BEGL	
Location	1112-1116 Barrenjoey Road, Palm Beach NSW	Contractor	TightSite	
Position	Refer to Figure 2	Drill Rig	Hand Portable	
Job No.	E25203.G04	Logged	KX	Date 27 / 10 / 2021
Client	Palmdev Pty Ltd	Surface RL	≈ 12.0 m	
		Inclination	-90°	
		Box	1-2 of 3	
		Checked	SR	Date 14 / 07 / 2021

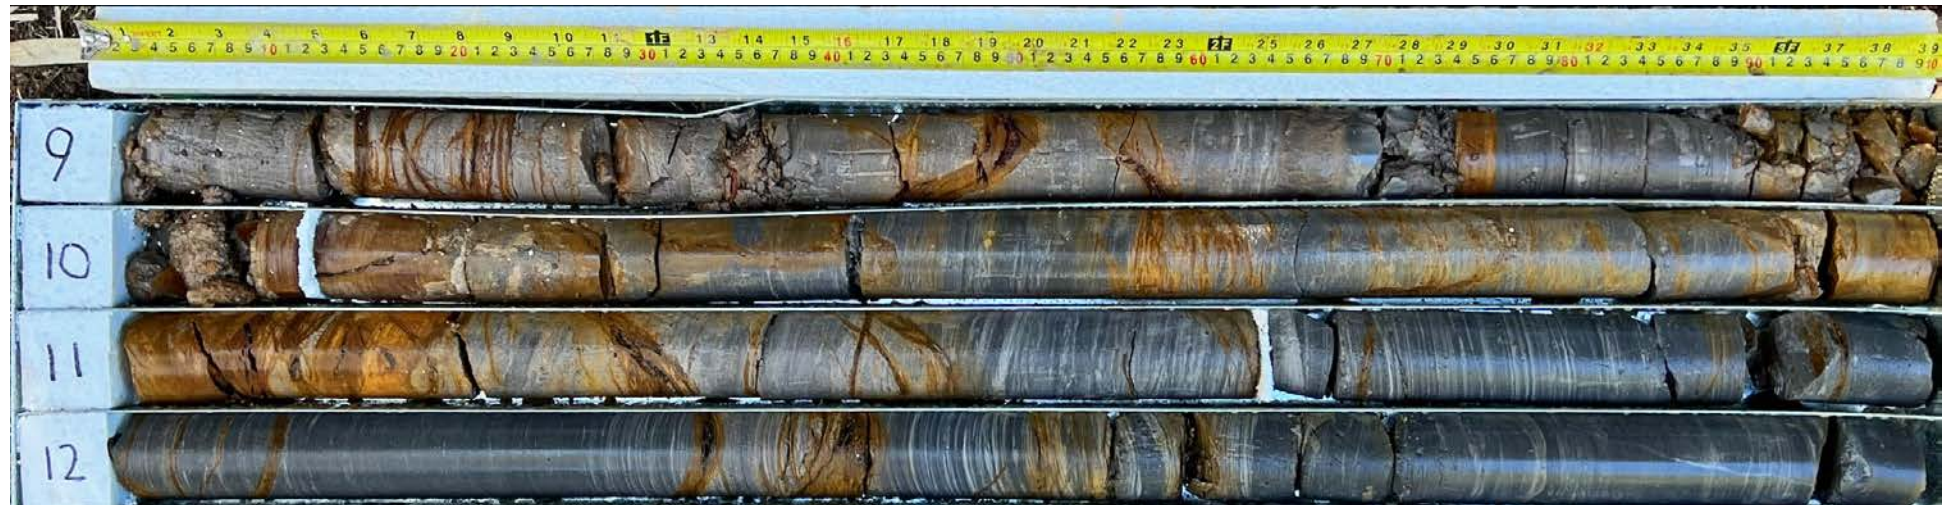
Project	Proposed Development	Depth Range	9.00m to 13.00m BEGL	
Location	1112-1116 Barrenjoey Road, Palm Beach NSW	Contractor	TightSite	
Position	Refer to Figure 2	Drill Rig	Hand Portable	
Job No.	E25203.G04	Logged	KX	Date 27 / 10 / 2021
Client	Palmdev Pty Ltd	Surface RL	≈ 12.0 m	
		Inclination	-90°	
		Box	3 of 3	
		Checked	SR	Date 14 / 07 / 2021

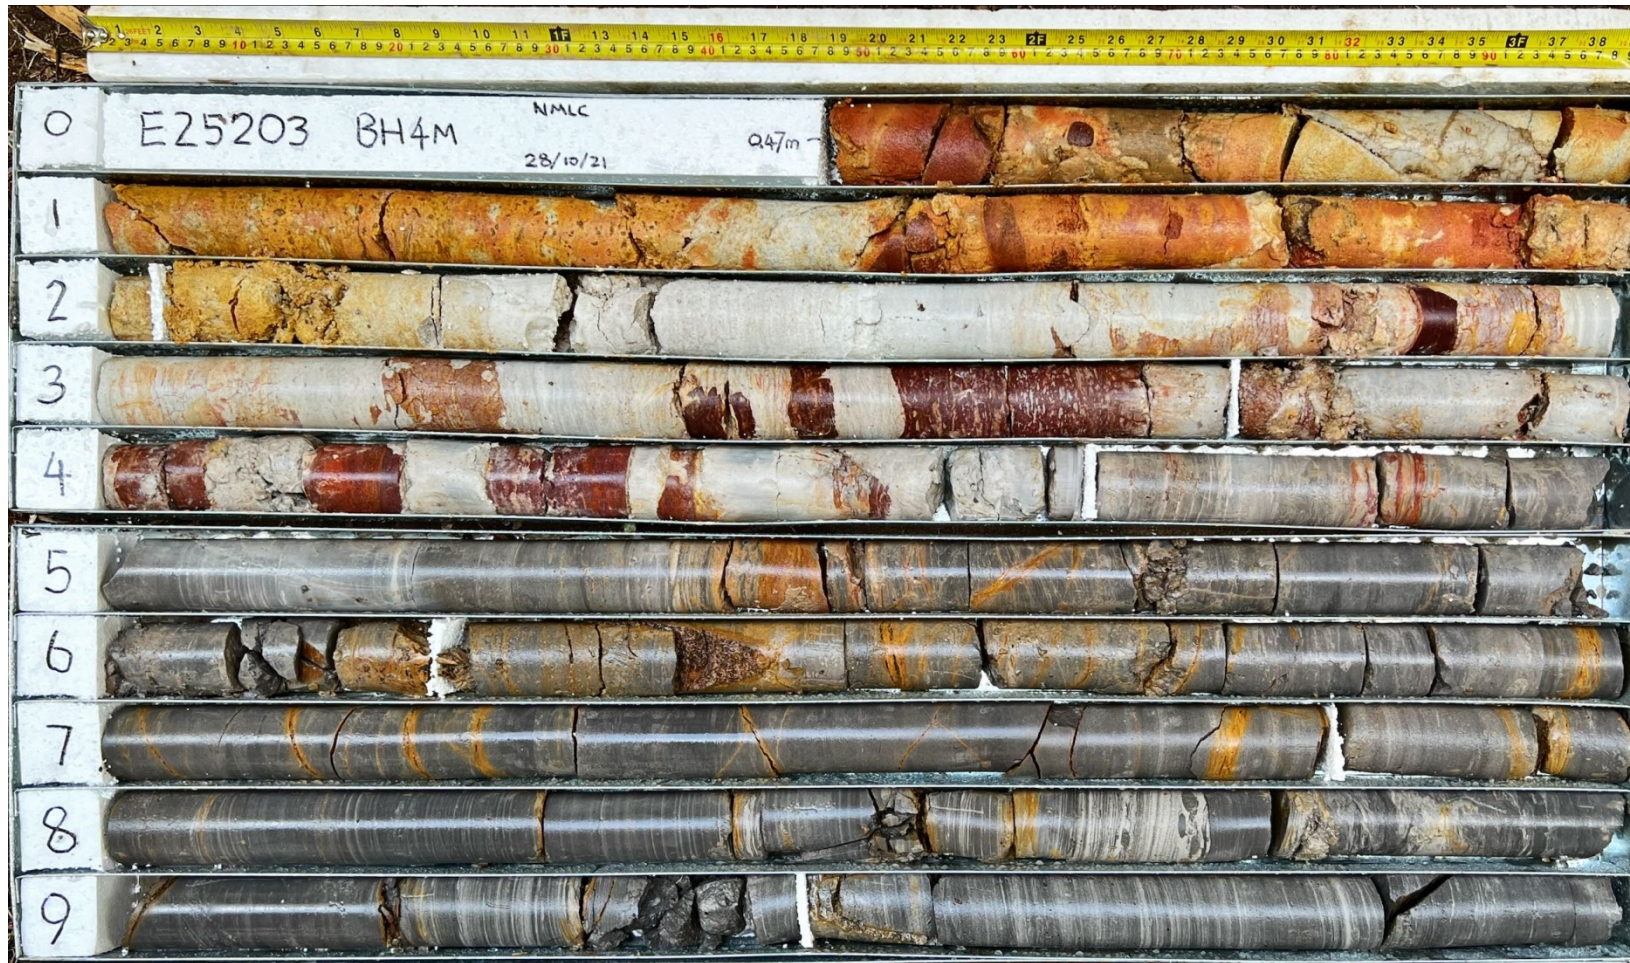
CORE PHOTOGRAPH OF BOREHOLE: BH104M

Project	Proposed Development	Depth Range	0.47m to 10.00m BEGL	
Location	1112-1116 Barrenjoey Road, Palm Beach NSW	Contractor	TightSite	
Position	Refer to Figure 2	Surface RL	≈ 12.0 m	
Job No.	E25203.G04	Inclination	-90°	
Client	Palmdev Pty Ltd	Box	1-2 of 3	
		Drill Rig	Hand Portable	
		Logged	KX	Date 27 / 10 / 2021
		Checked	SR	Date 14 / 07 / 2021

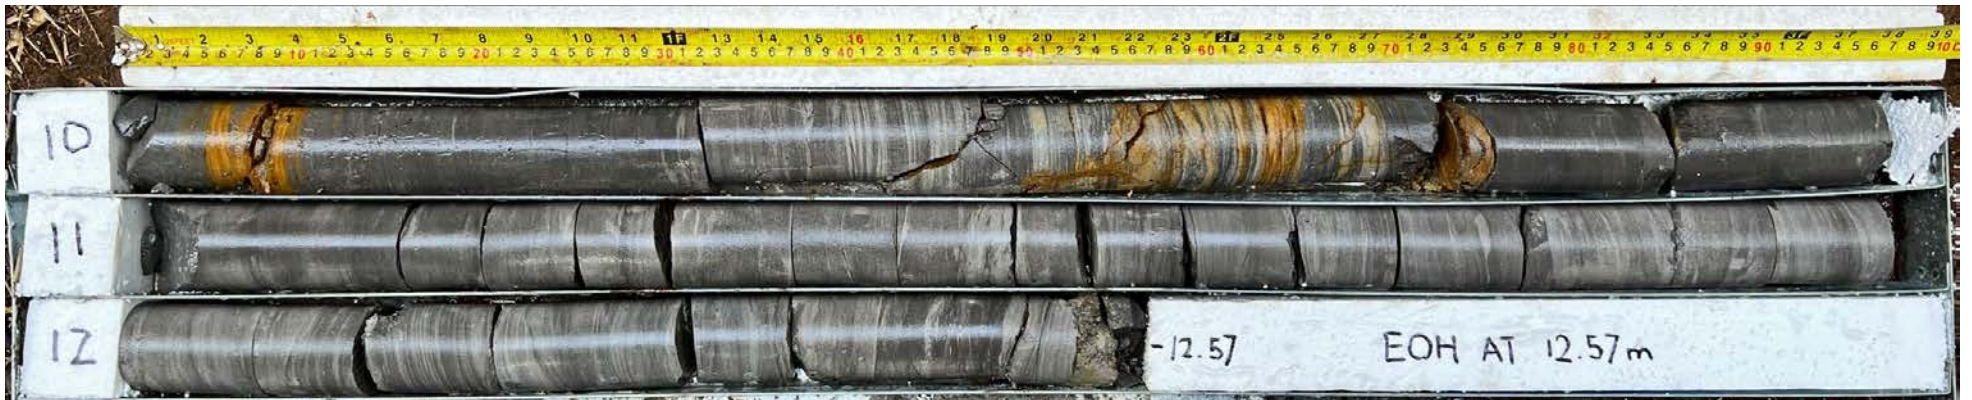
CORE PHOTOGRAPH OF BOREHOLE: BH104M

Project	Proposed Development	Depth Range	10.0m to 12.57m BEGL	
Location	1112-1116 Barrenjoey Road, Palm Beach NSW	Contractor	TightSite	
Position	Refer to Figure 2	Drill Rig	Hand Portable	
Job No.	E25203.G04	Logged	KX	Date 27 / 10 / 2021
Client	Palmdev Pty Ltd	Surface RL	≈ 12.0 m	
		Inclination	-90°	
		Box	3 of 3	
		Checked	SR	Date 14 / 07 / 2021

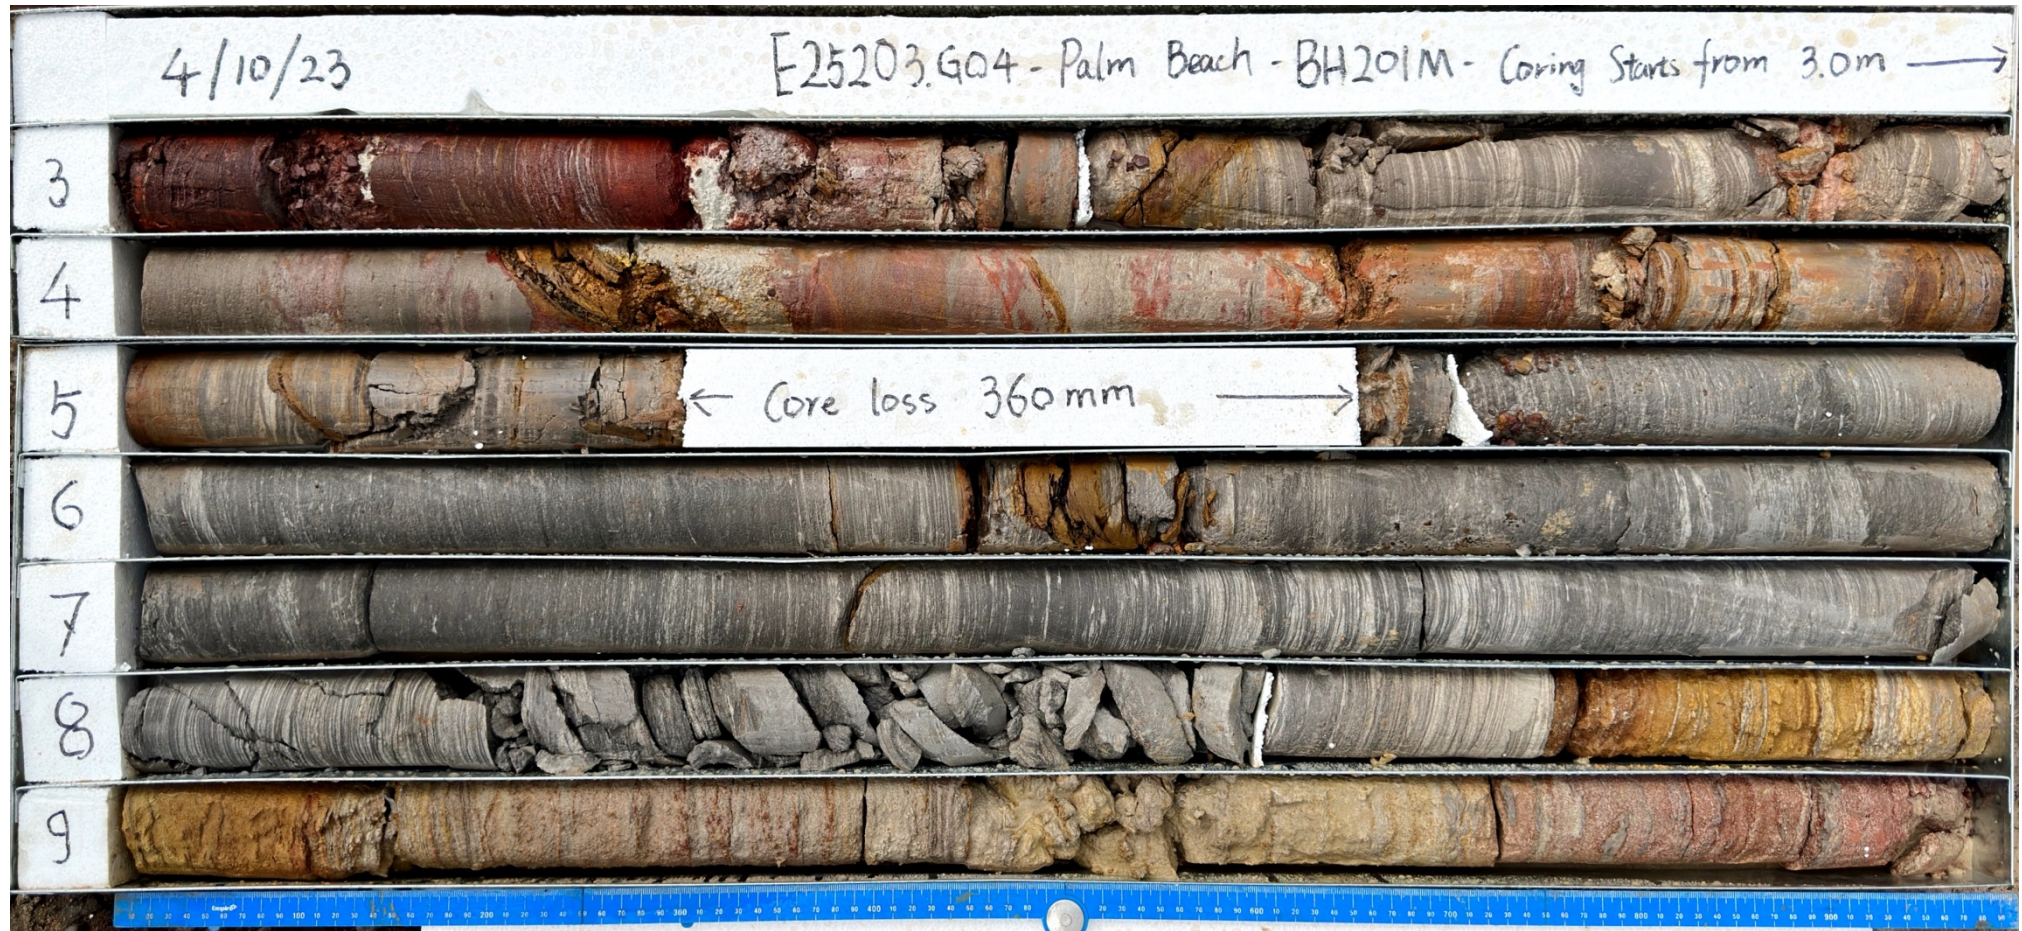
CORE PHOTOGRAPH OF BOREHOLE: BH201M

Project	Proposed Development	Depth Range	3.0m to 10.0m BEGL
Location	1112-1116 Barrenjoey Road, Palm Beach NSW	Contractor	Geosense Drilling
Position	Refer to Figure 2	Drill Rig	Comacchio Geo 205
Job No.	E25203.G04	Surface RL	≈ 1.24 m
Client	Palmdev Pty Ltd	Inclination	-90°
		Box	1,2 of 4
		Logged	LL Date 4 / 10 / 2023
		Checked	SK Date 21 / 11 / 2023

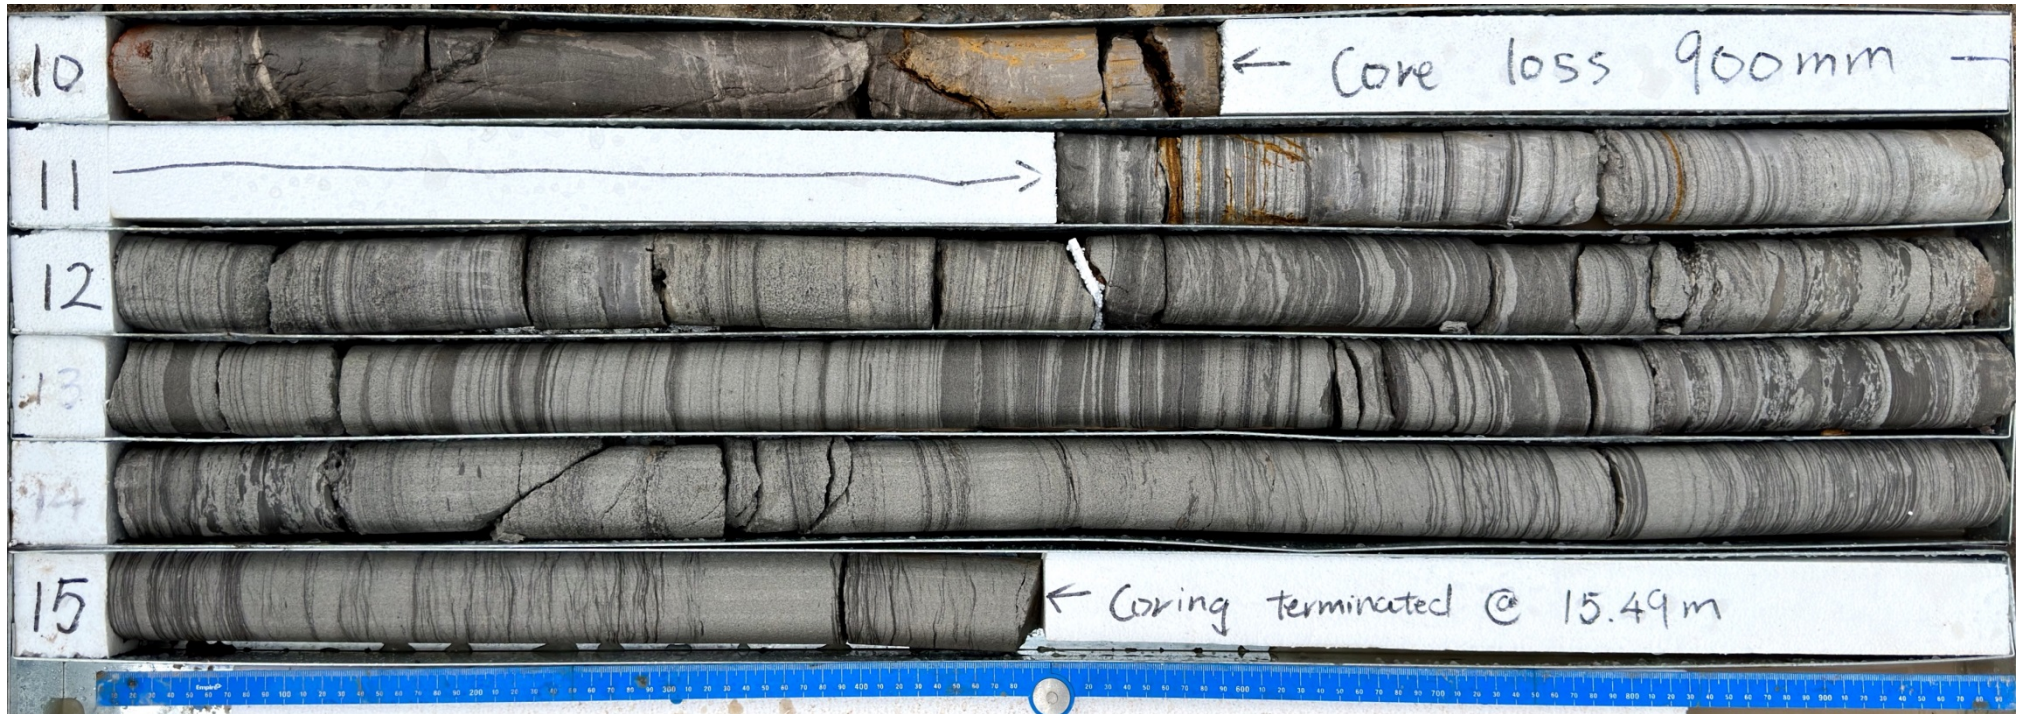
CORE PHOTOGRAPH OF BOREHOLE: BH201M

Project	Proposed Development	Depth Range	10.0m to 15.49m BEGL
Location	1112-1116 Barrenjoey Road, Palm Beach NSW	Contractor	Geosense Drilling
Position	Refer to Figure 2	Drill Rig	Comacchio Geo 205
Job No.	E25203.G04	Logged	LL Date 4 / 10 / 2023
Client	Palmdev Pty Ltd	Inclination	-90°
		Surface RL	≈ 1.24 m
		Box	3,4 of 4
		Checked	SK Date 21 / 11 / 2023

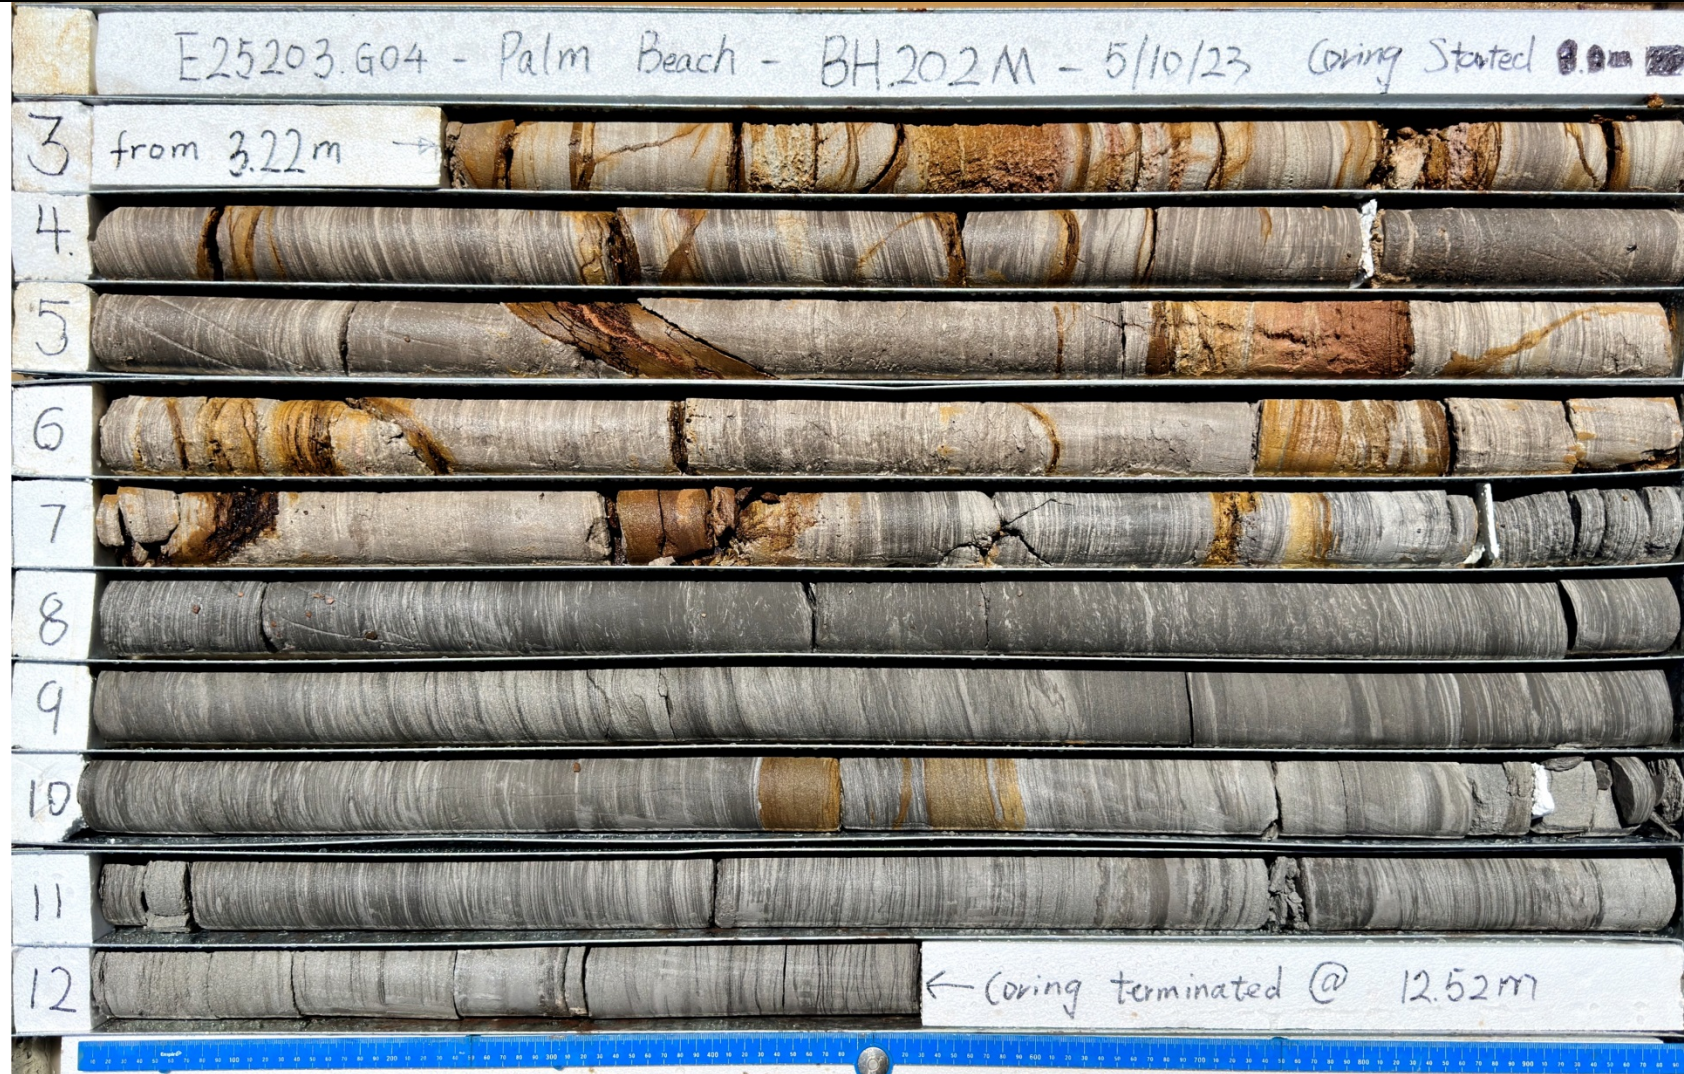
CORE PHOTOGRAPH OF BOREHOLE: BH202M

Project	Proposed Development	Depth Range	3.22m to 12.52m BEGL				
Location	1112-1116 Barrenjoey Road, Palm Beach NSW	Contractor	Geosense Drilling				
Position	Refer to Figure 2	Drill Rig	Comacchio Geo 205				
Job No.	E25203.G04	Surface RL	≈ 2.4 m	Logged	LL	Date	5 / 10 / 2023
Client	Palmdev Pty Ltd	Inclination	-90°	Checked	SK	Date	21 / 11 / 2023
		Box	1,2,3 of 3

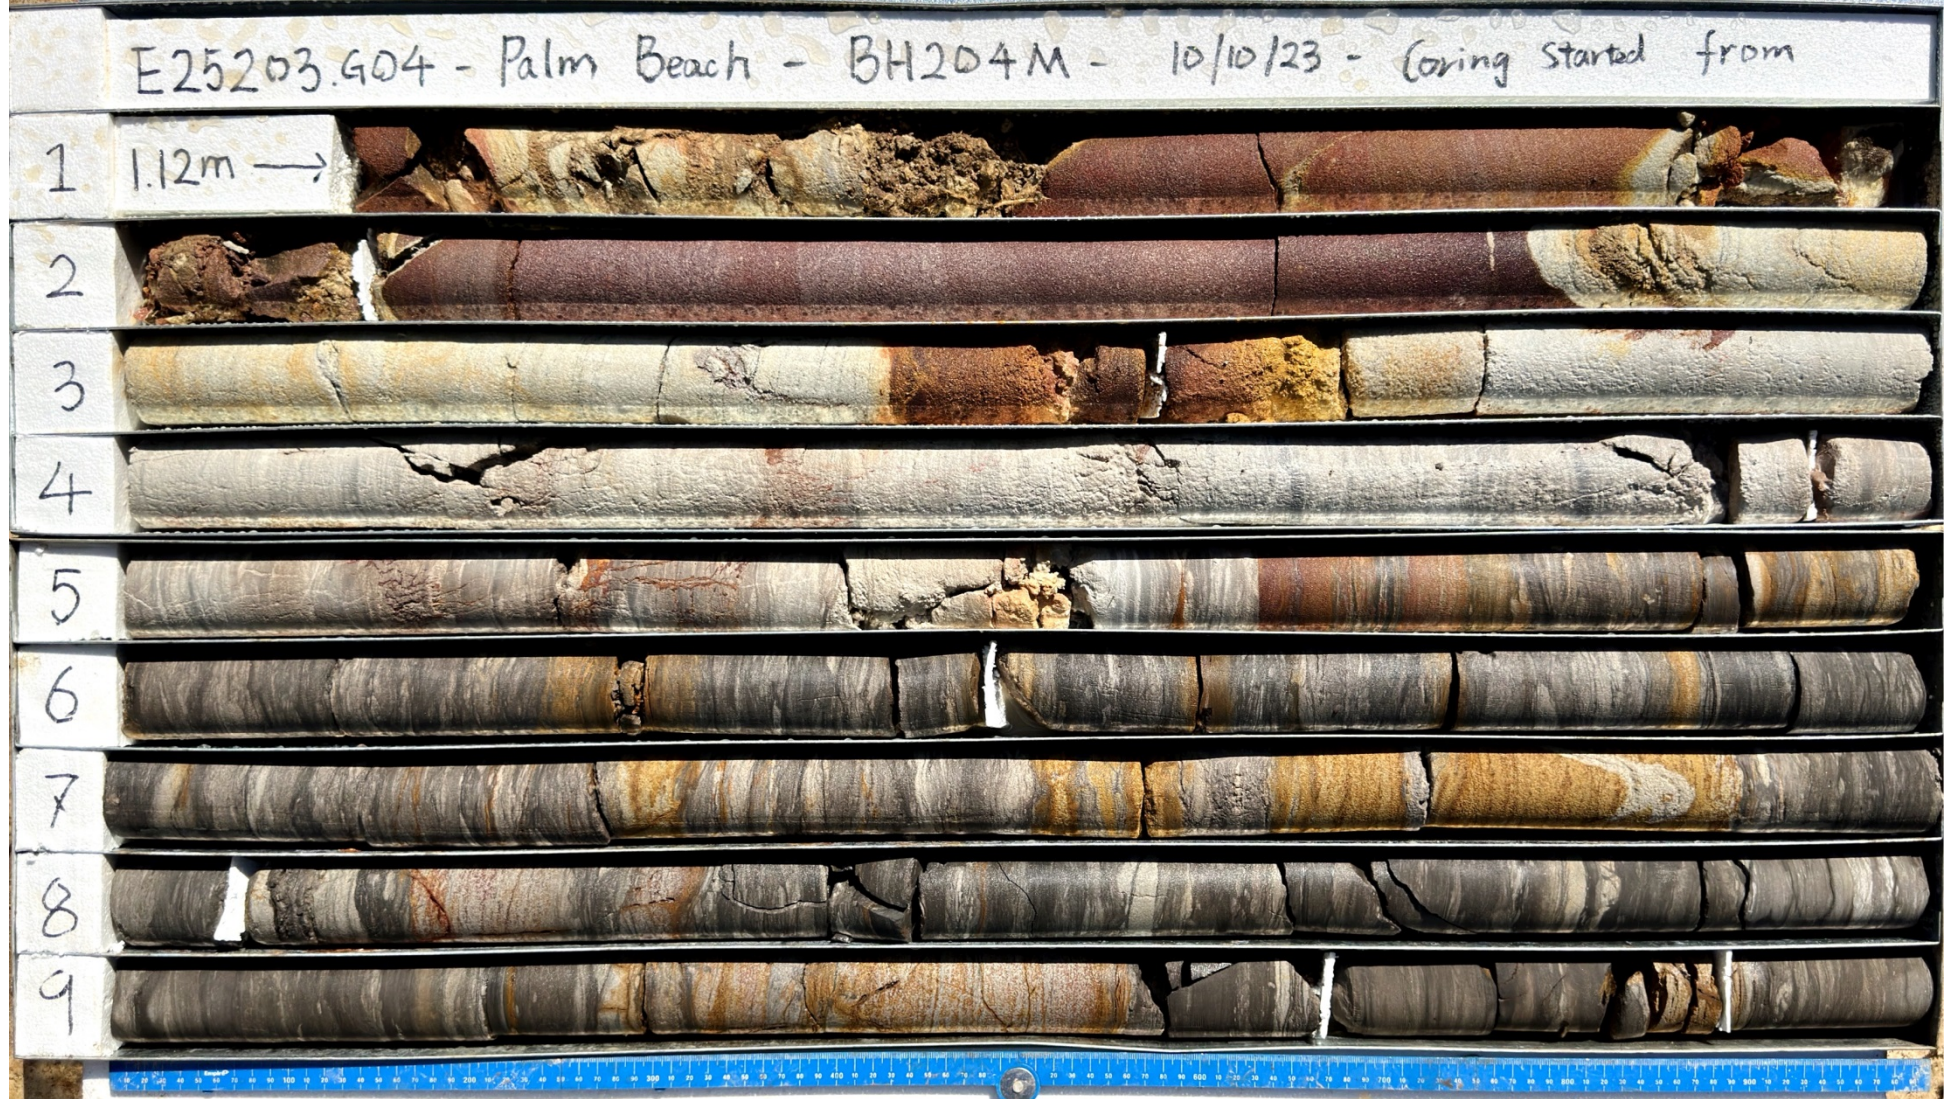
Project	Proposed Development	Depth Range	1.12m to 10.0m BEGL	
Location	1112-1116 Barrenjoey Road, Palm Beach NSW	Contractor	TightSite	
Position	Refer to Figure 2	Drill Rig	Hand Portable	
Job No.	E25203.G04	Surface RL	≈ 12.92 m	Logged
Client	Palmdev Pty Ltd	Inclination	-90°	Date
		Box	1,2 of 3	Date
				10 / 10 / 2023
				21 / 11 / 2023
