Arboricultural Impact Appraisal and Method Statement – Revision A

5 Skyline Place
Frenchs Forest, NSW

Prepared for
Platino Properties

05 March 2024

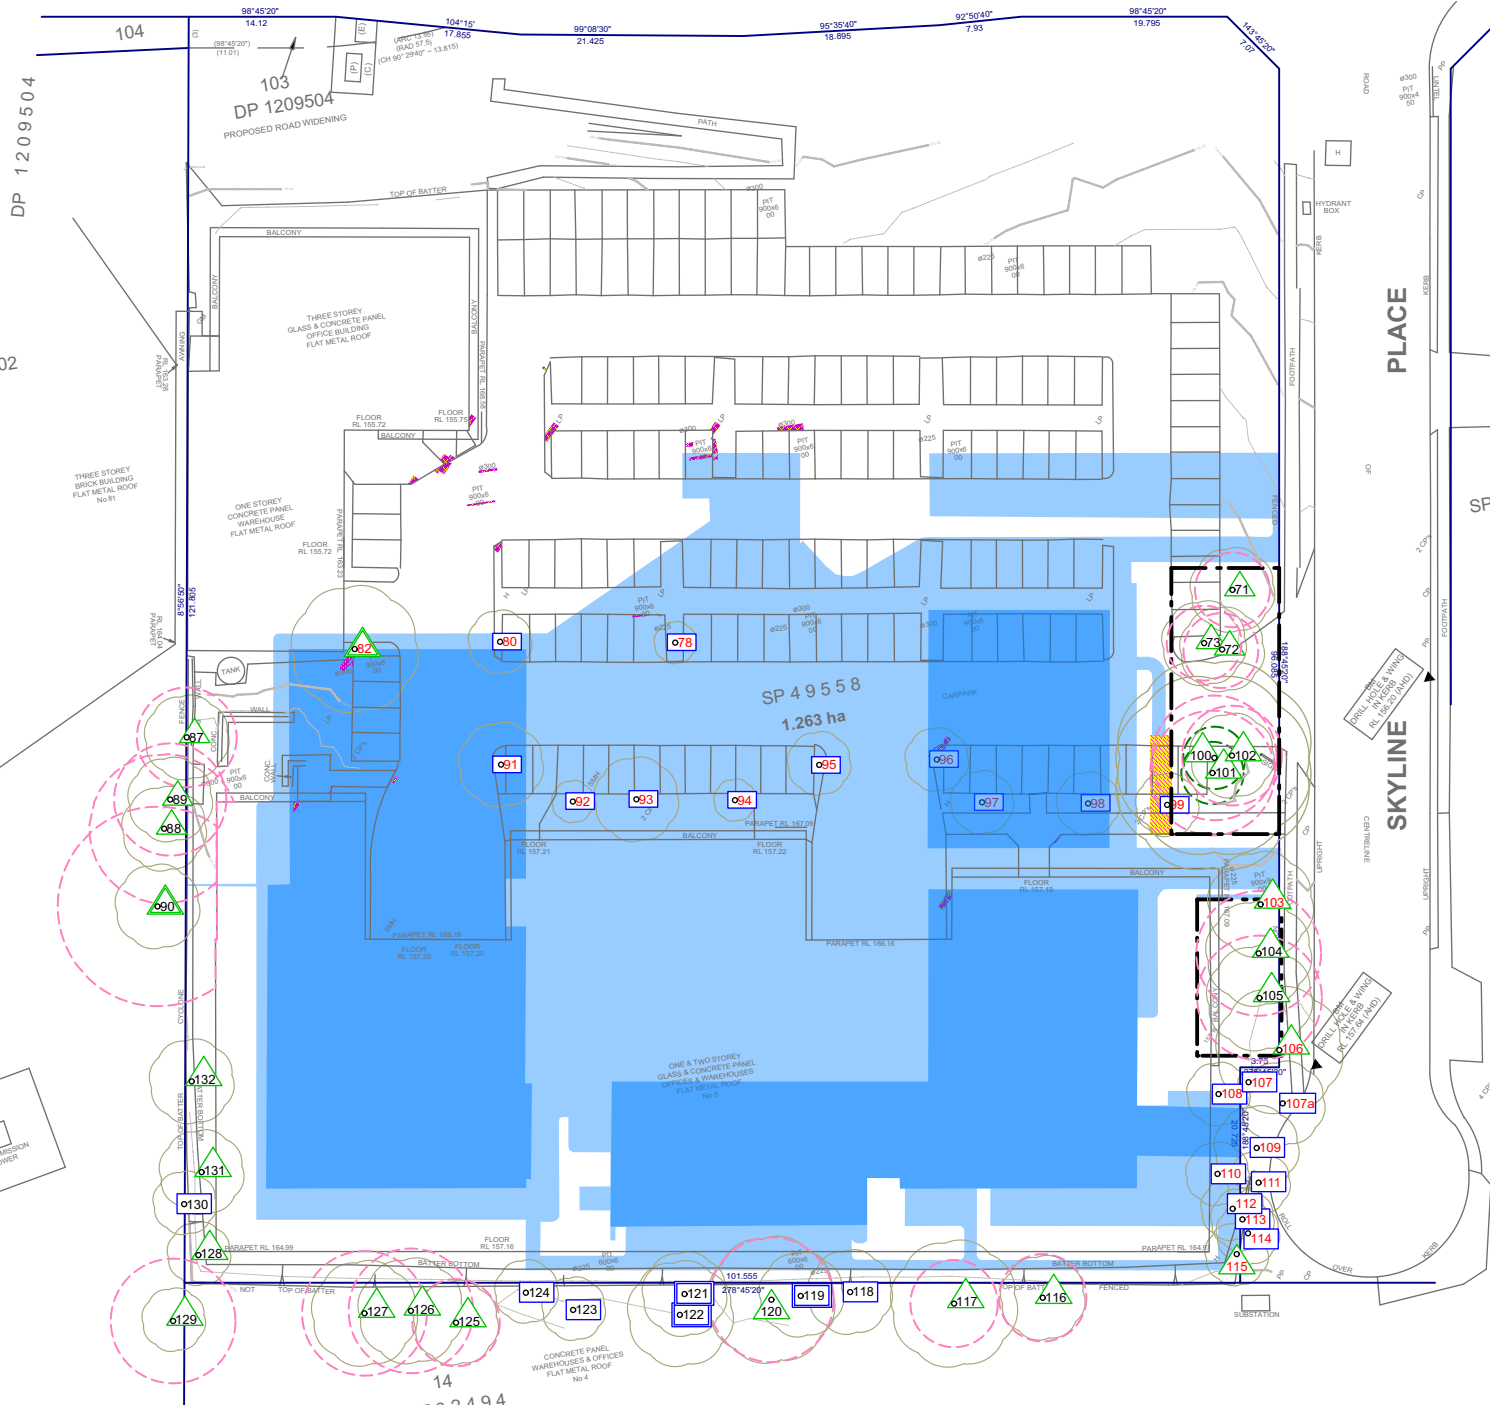
DATE 05/03/2024 DWG # REV
SCALE @ A1 1:400 **TMP01-A**
DRAWN AS

- 2.2.4 **Identification and location of the trees:** I have illustrated the locations of the significant trees on the Tree Management Plan (Plan TMP01) included as Appendix 8. This plan is for illustrative purposes only and it should not be used for directly scaling measurements.

- 2.2.6 **Plan updates:** During my site visit, I noted four trees (Trees 89, 90, 129 and 130) that were not shown on the land survey. I have illustrated their approximate locations on plan TMP01 but these positions have not been accurately surveyed. I do not consider that this has affected the conclusions of this report but if their locations are considered important, they should be accurately surveyed. Additionally, a number of trees were no longer present on site and have been removed from the plan.

4.2.1 **Protection fencing:** Tree protection fencing must comply with AS4970 (section 4.3) recommendations. An illustrative guide is included as Appendix 4. The approximate location of the barriers and the TPZs is illustrated on plan TMP01. The precise location of the fencing must be agreed with the project Arborist before any development activity starts.

4.2.2 **Ground protection:** Any TPZs outside the protective fencing must be covered in ground protection based on AS4970 recommendations until there is no risk of damage from the demolition and construction activity. An illustrative specification for this ground protection is included as Appendix 5. On this site, it must be installed near Trees 72, 73, 100, 101, 102, 104 and 105 as illustrated on plan TMP01 before any demolition and construction starts.

This guidance should always be read in conjunction with the Tree Management Plan (TMP01) illustrating the areas where specific precautions are necessary. Each area where precautions are required is explained on the plan as identified on the legend. All protective measures should be installed according to the prevailing site conditions and agreed as satisfactory by the Project Arborist before any demolition or construction work starts.
