## DRAFT AQUATIC ECOLOGY ASSESSMENT

### PROPOSED JETTY, RAMP, PONTOON & MOORING PEN

#### 149 RIVERVIEW ROAD AVALON

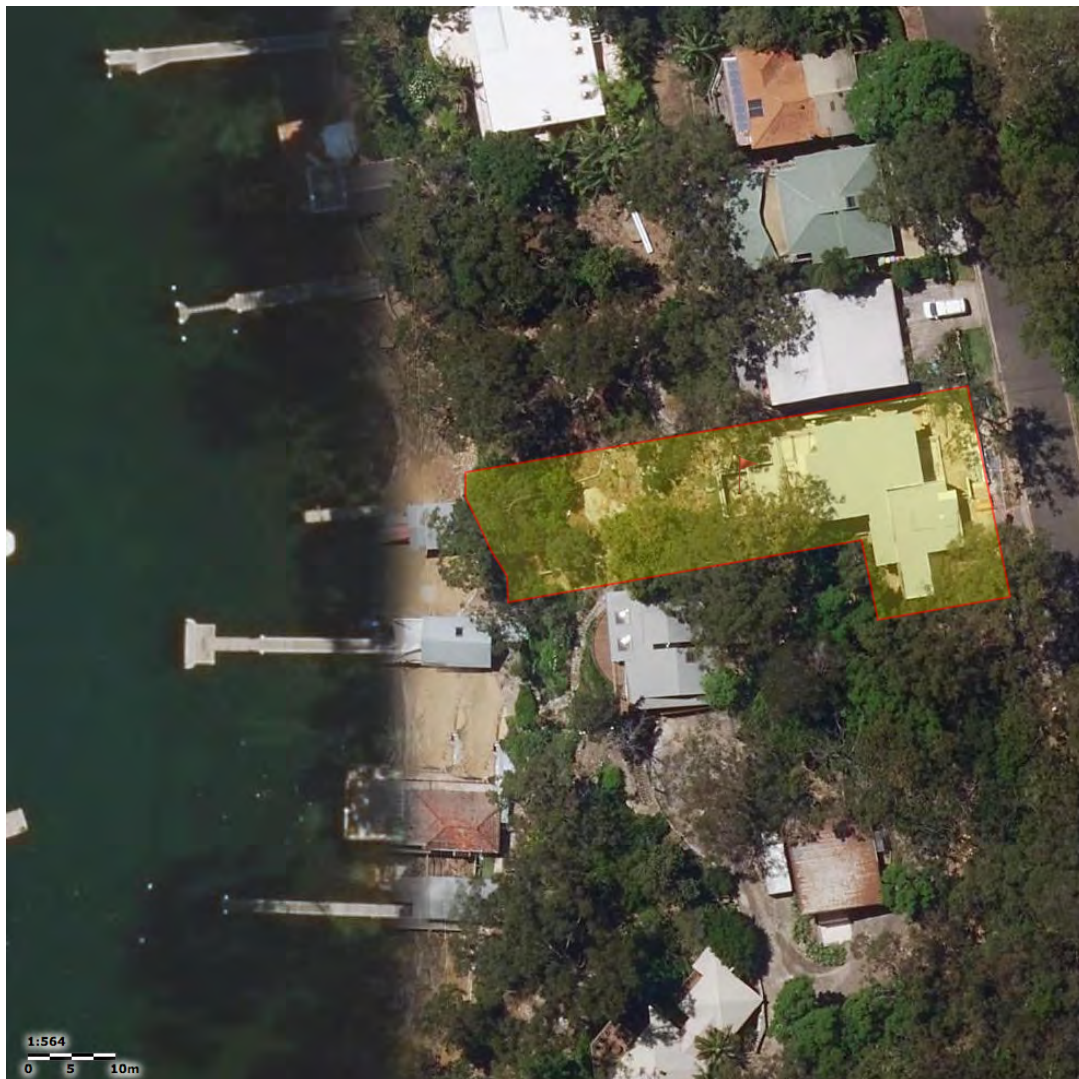
Figure 1 Location of existing boatshed, stub jetty and slipway at 149 Riverview Road Avalon in relation to adjacent marine facilities

Figure 1 provides an aerial view showing similar marine facilities around the site. Figure 2 shows the existing facility looking towards shore. Figures 3 and 4 provide views of the jetty from the south and north respectively, showing the preponderance of rock reef outcrops around the Facility.

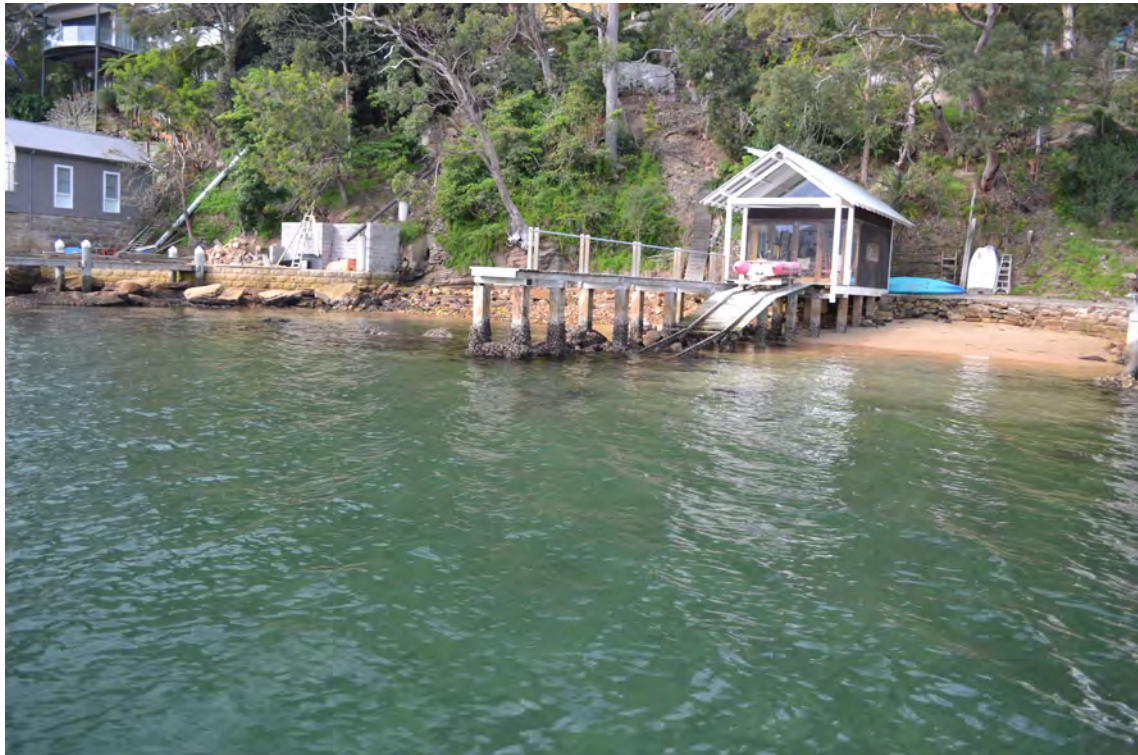
Figure 2 Existing jetty, slipway and boat shed facility looking to shore. Note sandstone seawalls on shoreline and rocky reefs to the north of the jetty.

- There is a mixed riparian rock and sandy beach either side of the existing boatshed and jetty (Figures 2 to 4) and there is a natural intertidal rock and rubble reef offshore as indicated in Figure 5.

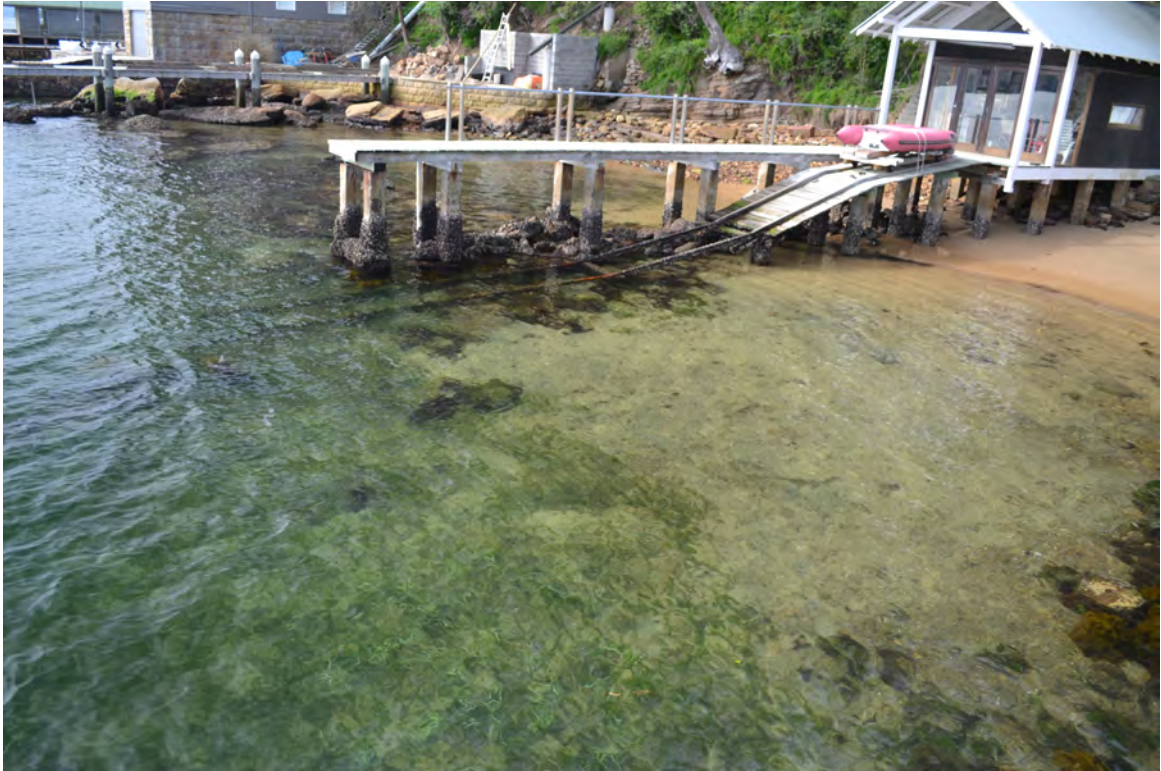
Figure 3 View north to the existing facility. There is sandy beach on the south side of the facility and rocky shore and reef extending out into subtidal waters on the north side. Note also the *Zostera* seagrass bed offshore from the sandy beach and from the existing jetty.

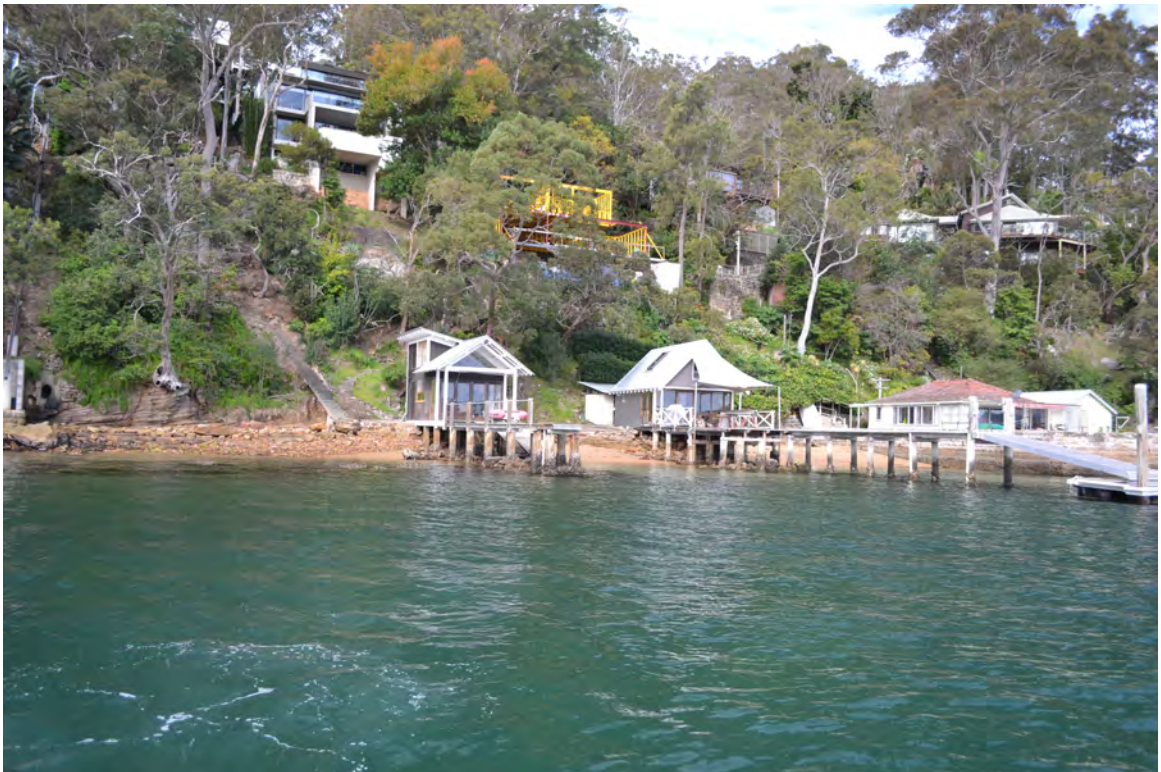
Figure 4 View of proximity of existing facilities at Nos 149 and 147 (south) Riverview Rd.

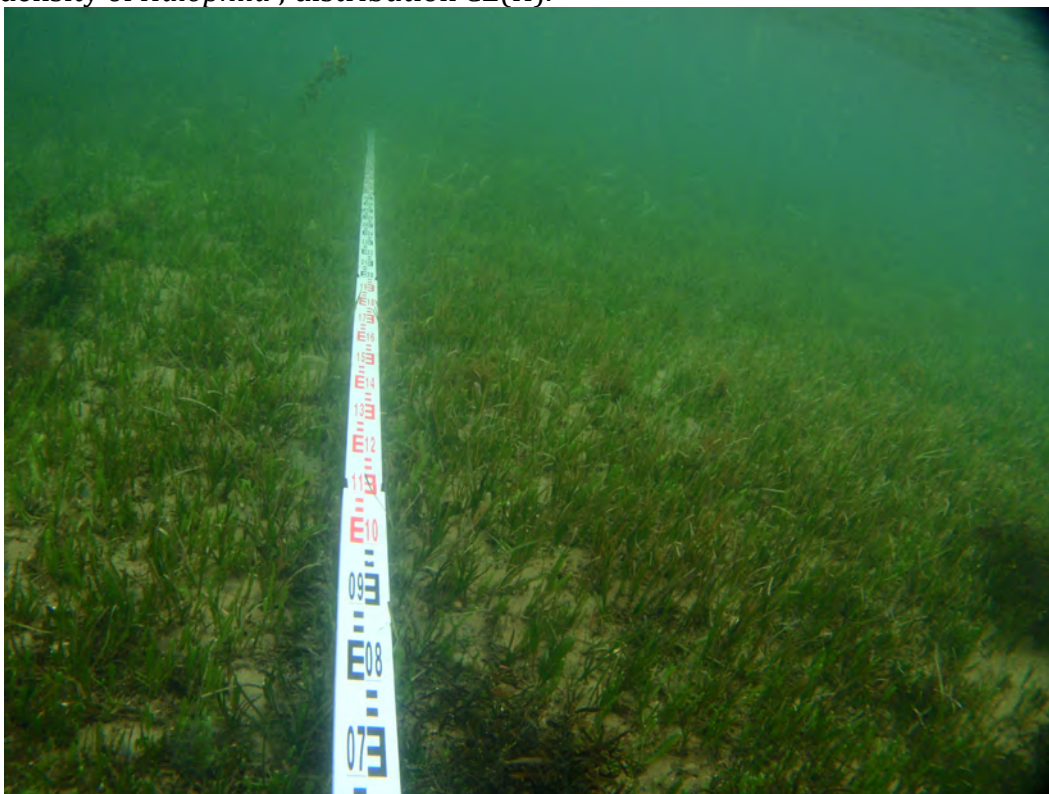
Figure A2: 0.5 to 5m offshore looking west. CZ(H) in the foreground to 3m and mixed *Caulerpa* and *Zostera* with low density *Posidonia* to 5m (ZCP) see also Figures A3 through to .

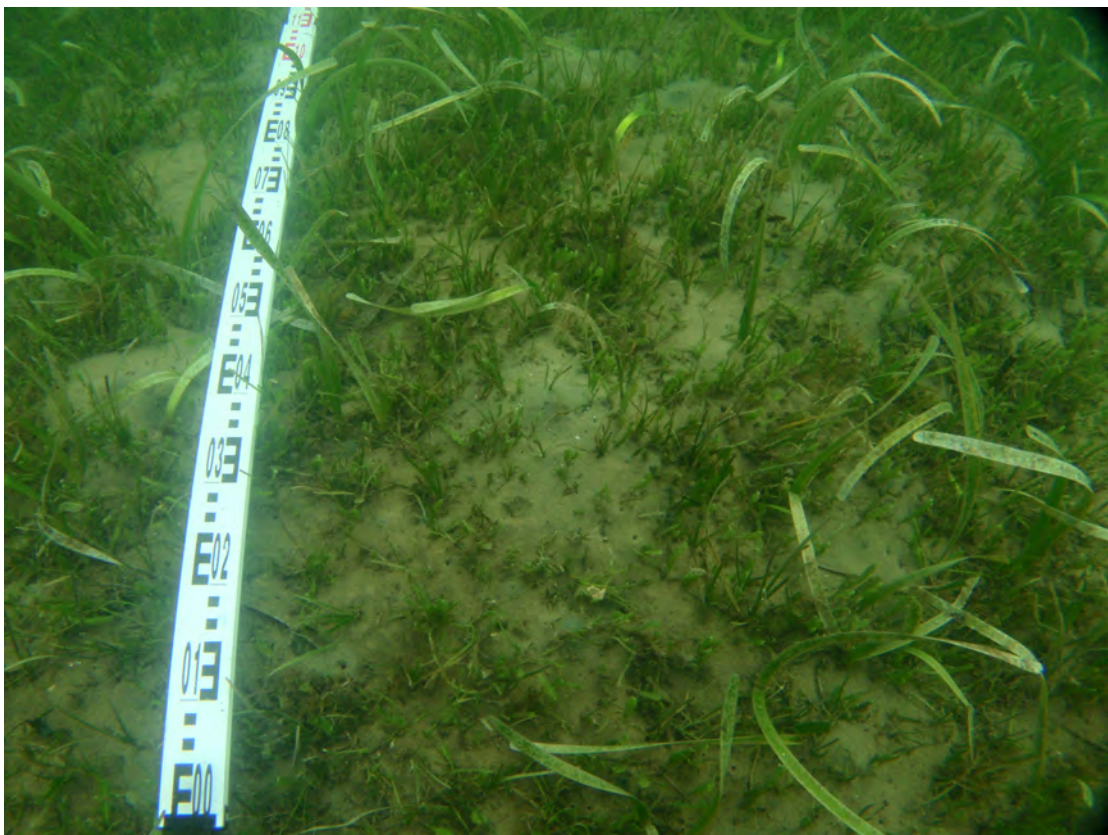
Figure A4: 5m to 6m looking west, ZCP as per Figure A3.

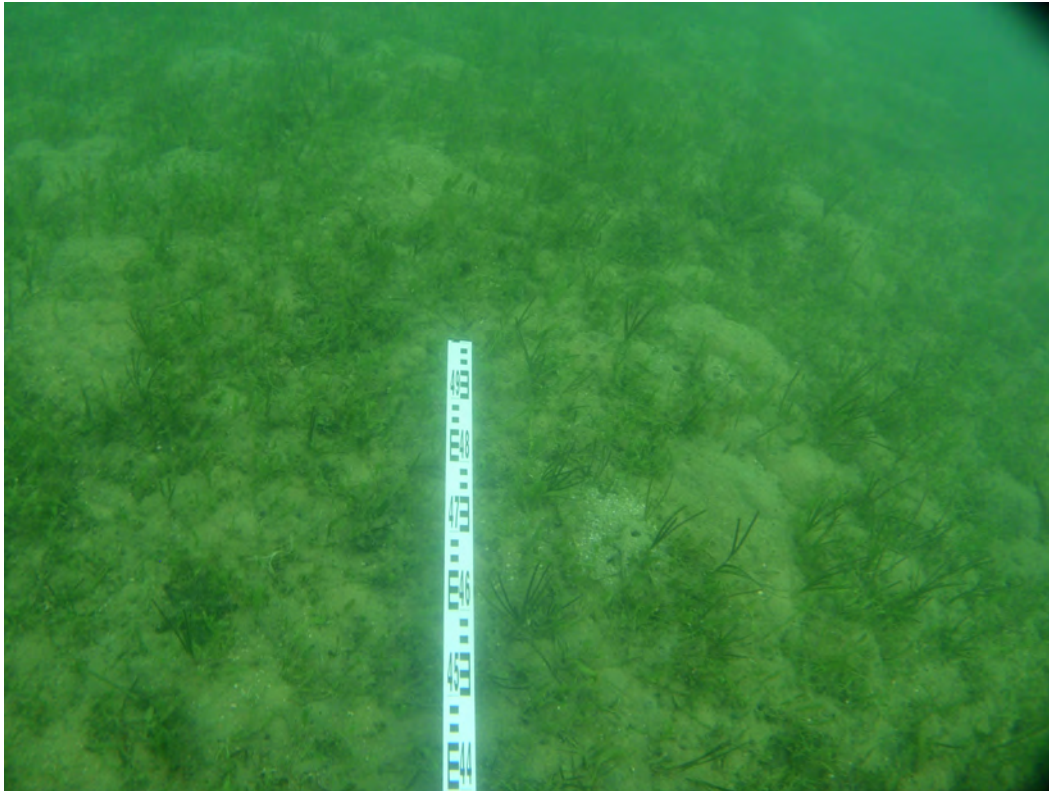
Figure A13: From 19.4m looking west beyond the 20m mark. There was no more *Posidonia* after 19m offshore and the low density *Zostera* extended some 3m to 4 m further offshore. The seabed was bare sediment in waters beyond that point.

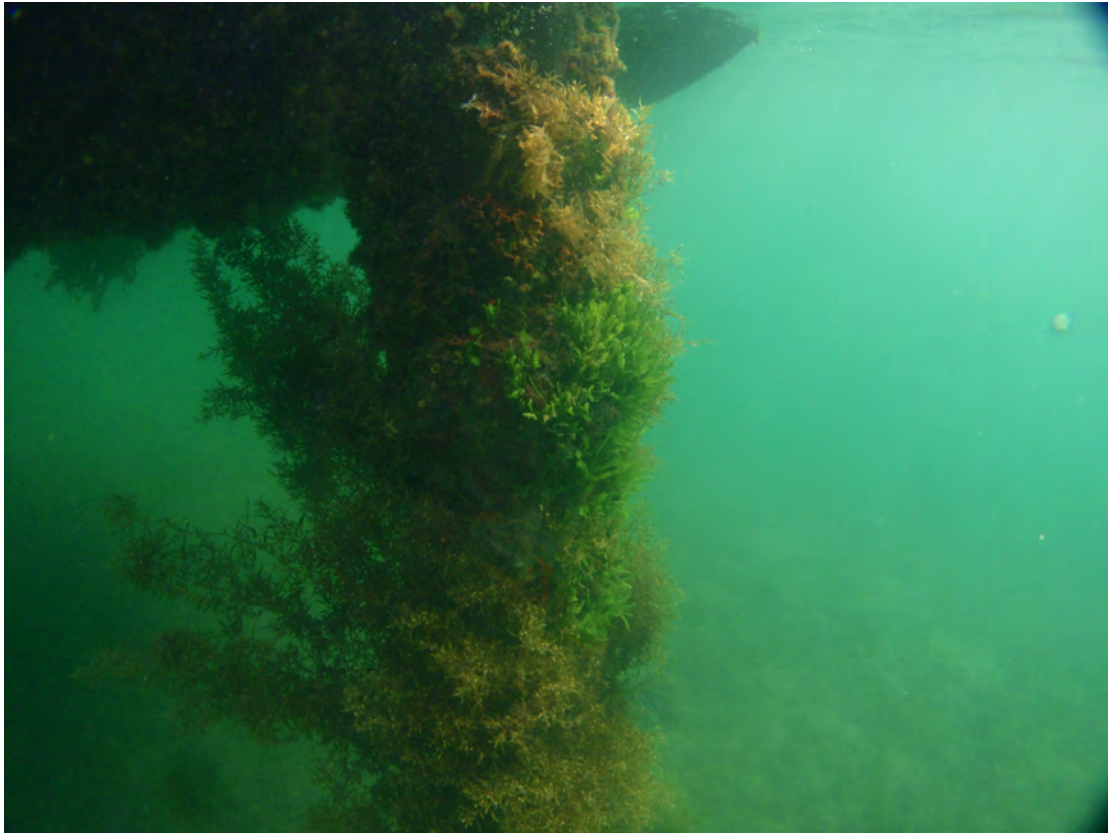
Figure A15: Mixed brown and red algae and green *Caulerpa* growth on outer jetty pile at No 149 Riverview Road.

- The seabed beyond the 23m mark was bare silty sand sediment.
- Jetty support piles and the wetted edges plus undersides of pontoons in the locality (at Nos 147 and 149) supported a diverse cover of algae and encrusting fauna (see Figures A14 to A16 in Appendix B).

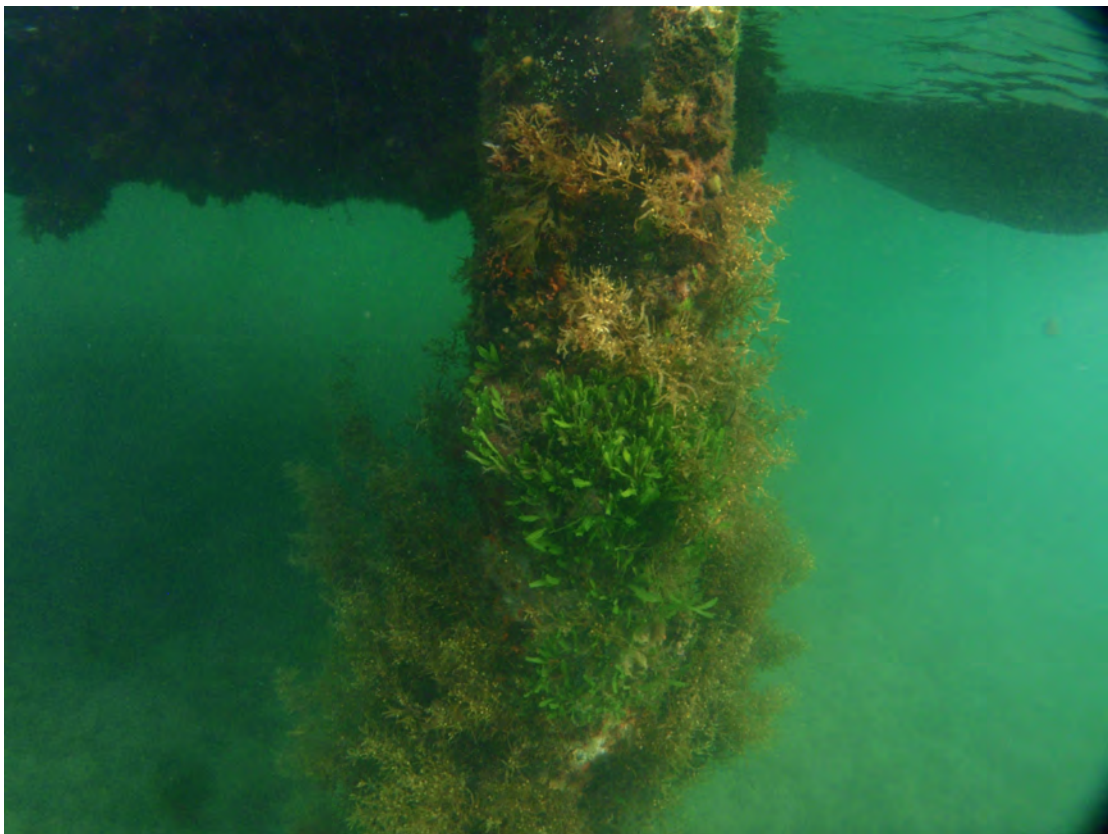
Figure A16. Similar attached algae, *Caulerpa* and encrusting fauna growth on outer pontoon locator pile for jetty at No 147
