GEOTECHNICAL ASSESSMENT REPORT

PROPOSED ALTERATIONS AND ADDITIONS

24 DE LAURET AVENUE, NEWPORT, NSW

Project No.: 2023-173

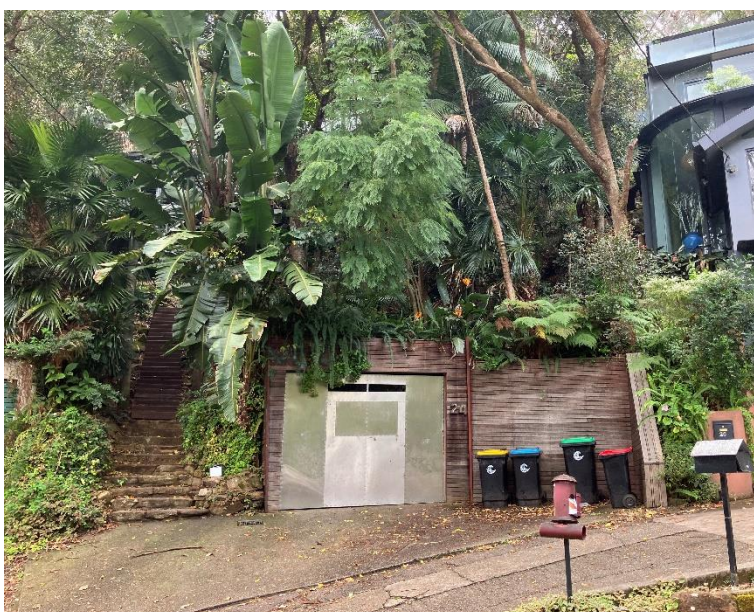
Photograph 1: View of the front of the site, looking broadly north from the roadway

A timber garage structure is situated adjacent to the front boundary with a set of stairs extending up into the site through a steep south to south west dipping, relatively densely vegetated slope. The garage is anticipated to have been excavated up to 2.50m below pre-development ground levels. Photograph 1 below provides a view of the front of the site from the roadway.

Multiple sandstone boulders were observed within the front garden of the site with all appearing to be relatively embedded below ground levels and none exhibiting any signs of impending instability.

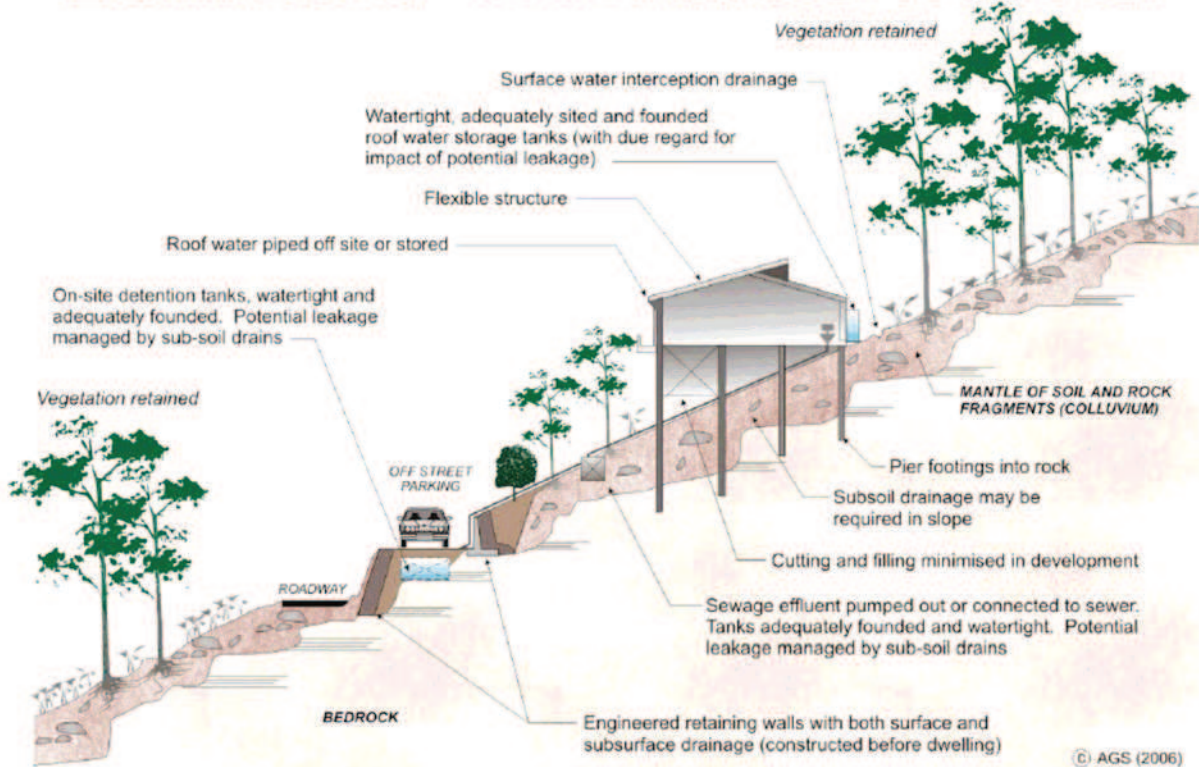
EXAMPLES OF **GOOD** HILLSIDE PRACTICE

ADVICE		GOOD ENGINEERING PRACTICE	POOR ENGINEERING PRACTICE
GEOTECHNICAL ASSESSMENT		Obtain advice from a qualified, experienced geotechnical practitioner at early stage of planning and before site works.	Prepare detailed plan and start site works before geotechnical advice.
PLANNING			
SITE PLANNING		Having obtained geotechnical advice, plan the development with the risk arising from the identified hazards and consequences in mind.	Plan development without regard for the Risk.
DESIGN AND CONSTRUCTION			
HOUSE DESIGN		Use flexible structures which incorporate properly designed brickwork, timber or steel frames, timber or panel cladding. Consider use of split levels. Use decks for recreational areas where appropriate.	Floor plans which require extensive cutting and filling. Movement intolerant structures.
SITE CLEARING		Retain natural vegetation wherever practicable.	Indiscriminately clear the site.

ROCK OUTCROPS & BOULDERS		Remove or stabilise boulders which may have unacceptable risk. Support rock faces where necessary.	Disturb or undercut detached blocks or boulders.
RETAINING WALLS		Engineer design to resist applied soil and water forces. Found on rock where practicable. Provide subsurface drainage within wall backfill and surface drainage on slope above. Construct wall as soon as possible after cut/fill operation.	Construct a structurally inadequate wall such as sandstone flagging, brick or unreinforced blockwork. Lack of subsurface drains and weepholes.
FOOTINGS		Found within rock where practicable. Use rows of piers or strip footings oriented up and down slope. Design for lateral creep pressures if necessary. Backfill footing excavations to exclude ingress of surface water.	Found on topsoil, loose fill, detached boulders or undercut cliffs.
SWIMMING POOLS		Engineer designed. Support on piers to rock where practicable. Provide with under-drainage and gravity drain outlet where practicable. Design for high soil pressures which may develop on uphill side whilst there may be little or no lateral support on downhill side.

DRAINAGE			
SURFACE		Provide at tops of cut and fill slopes. Discharge to street drainage or natural water courses. Provide general falls to prevent blockage by siltation and incorporate silt traps. Line to minimise infiltration and make flexible where possible. Special structures to dissipate energy at changes of slope and/or direction.	Discharge at top of fills and cuts. Allow water to pond on bench areas.
SUBSURFACE		Provide filter around subsurface drain. Provide drain behind retaining walls. Use flexible pipelines with access for maintenance. Prevent inflow of surface water.	Discharge roof runoff into absorption trenches.
SEPTIC & SULLAGE		Usually requires pump-out or mains sewer systems; absorption trenches may be possible in some areas if risk is acceptable. Storage tanks should be water-tight and adequately founded.	Discharge sullage directly onto and into slopes. Use absorption trenches without consideration of landslide risk.
