# Point Polaris Forestway Shopping Centre SYDGE217641

26 October 2018

# **Forestway Shopping Centre**

Prepared for Point Polaris

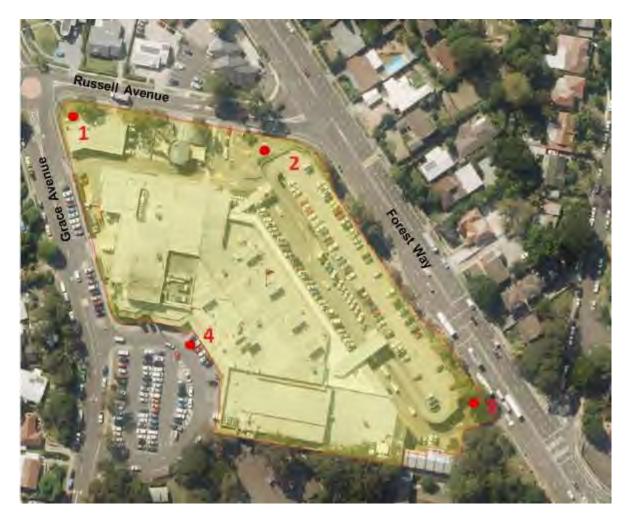
Figure 1 - Site Location Plan

The site location plan is shown in Figure 1. It is located within the existing Forestway shopping centre at the corner of Forest way and Russell avenue, Frenchs forest. The site is bounded by Forest way to the east, Grace avenue to the west and Russell avenue to the North. It is relatively flat, situated on a local high plateau. To the west of the site, beyond Grace avenue the ground slopes steeply (between  $15^{\circ}$  to  $20^{\circ}$ ) west towards Lane Cove river. The southern section of the site, comprising the residential area, has a gentle (<5°) slope to the south, towards Warringah road.

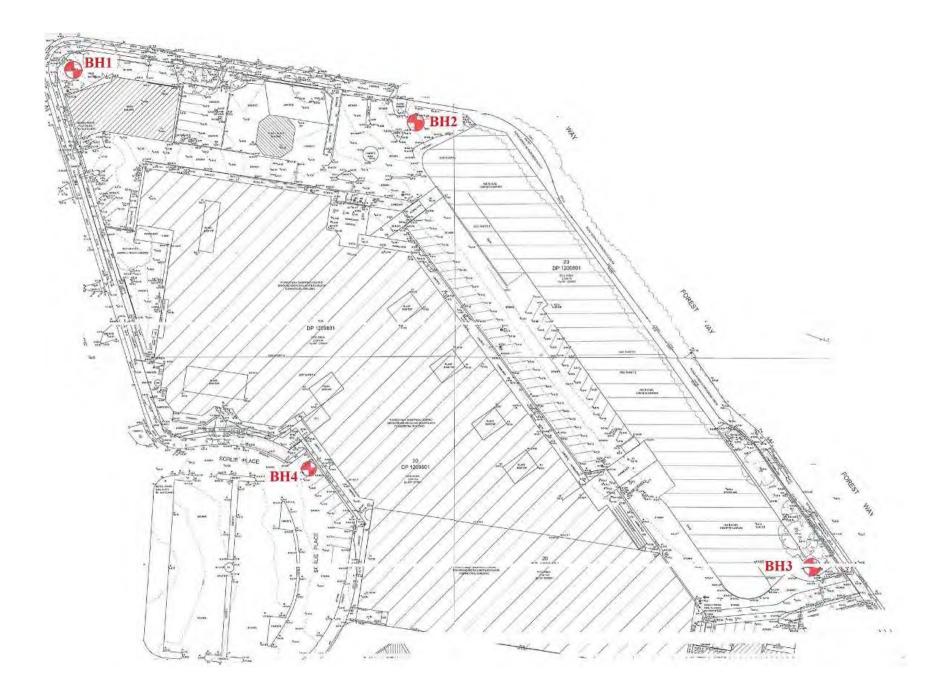
Appendix A - Borehole Location Plan

The fieldwork was carried out from 26 July to 30 July 2018 and comprised the drilling of four boreholes numbered BH1 to BH4. The borehole locations, as shown on the attached borehole location plan in Appendix A, were nominated by the client and determined on site by Coffey after the clearance of underground services at the drilling locations.

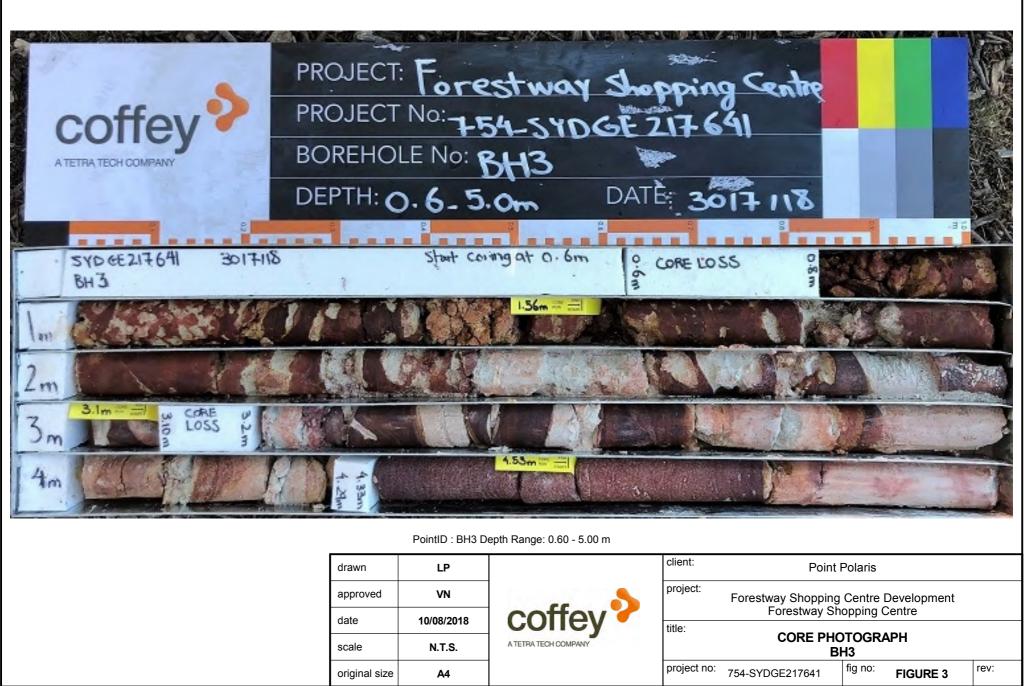
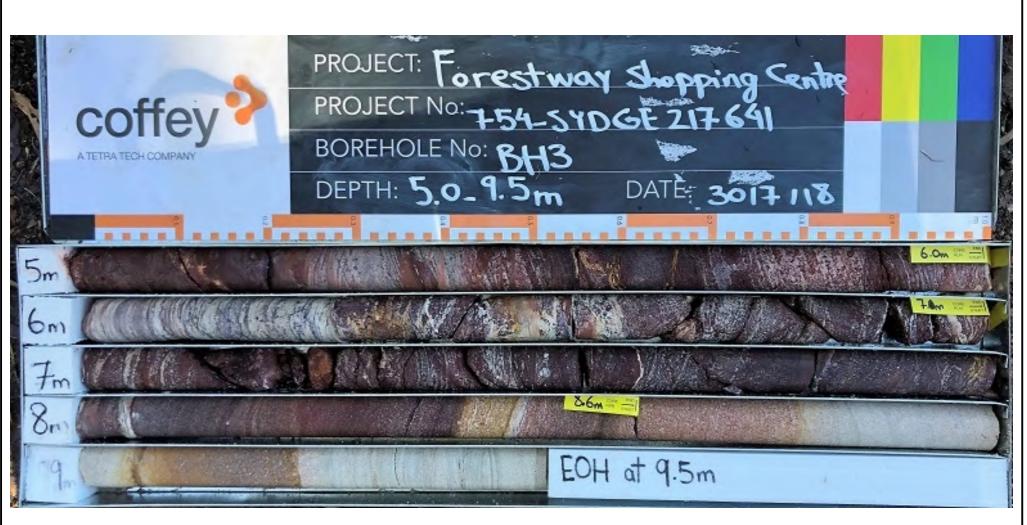
PointID : BH3 Depth Range: 5.00 - 9.50 m

For detailed descriptions of the materials and sub-surface conditions encountered at each borehole, reference should be made to the boreholes logs and core photographs presented within Appendix B.
