# DAVIES GEOTECHNICAL

10 February 2016

15-062.A

re: **GEOTECHNICAL ASSESSMENT / LANDSLIP RISK ISSUES  
PROPOSED RESIDENTIAL DEVELOPMENT- COMBINED SUBDIVISION & DA  
NO.14 (LOTS 502 & 503 DP218045) YEATS AVE KILLARNEY HEIGHTS NSW**

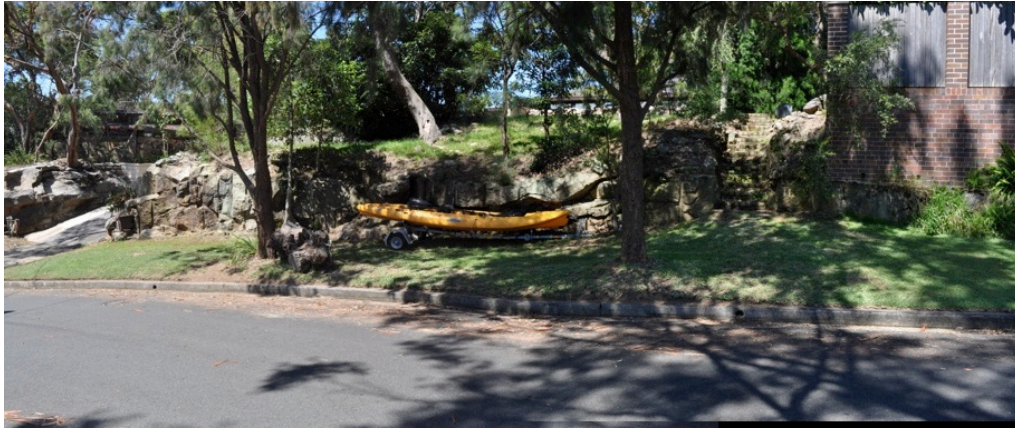
<b>Project No:</b>	15-062	<b>Scale:</b>	NTS	SITE PHOTOGRAPHS 19/1/16 NO. 14 YEATS AVE KILLARNEY HEIGHTS NSW (Mr & Mrs A Toohey)	<b>Figure 3A</b>
<b>Drawn:</b>	wnd	<b>Date:</b>	10 Feb 16

Yeats Ave is formed in a rock cutting across the frontage of No.14, which exposes sandstone bedrock. The cutting on the frontage is some 2m or so maximum height (refer photograph in Figure 3A). From the top of the road cutting, the land rises at a gentle to moderate grade ( $8^{\circ} - 10^{\circ}$ ) to the east to the rear of the property, which borders on a public reserve.

Frontage of Lot 502. Driveway to No. 14 on left, brick wall on frontage of No. 92 on right.

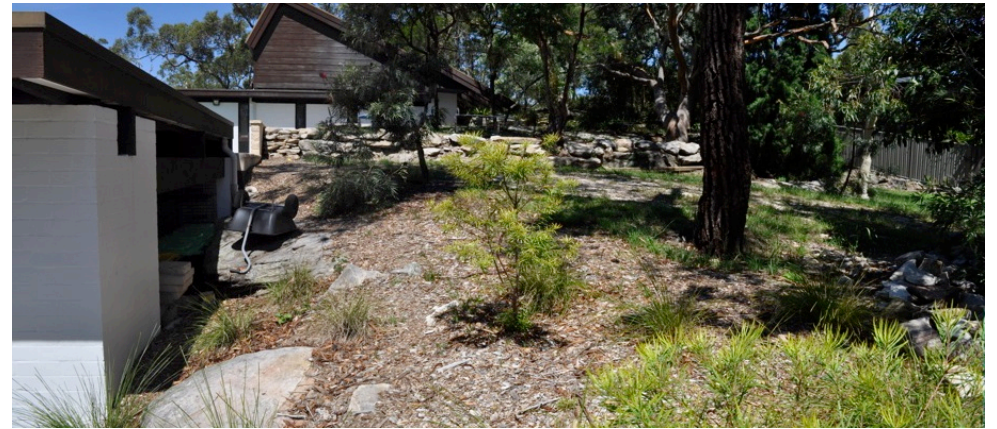
View east along proposed boundary between Lots 502 & 503. No. 14 carport in left foreground.

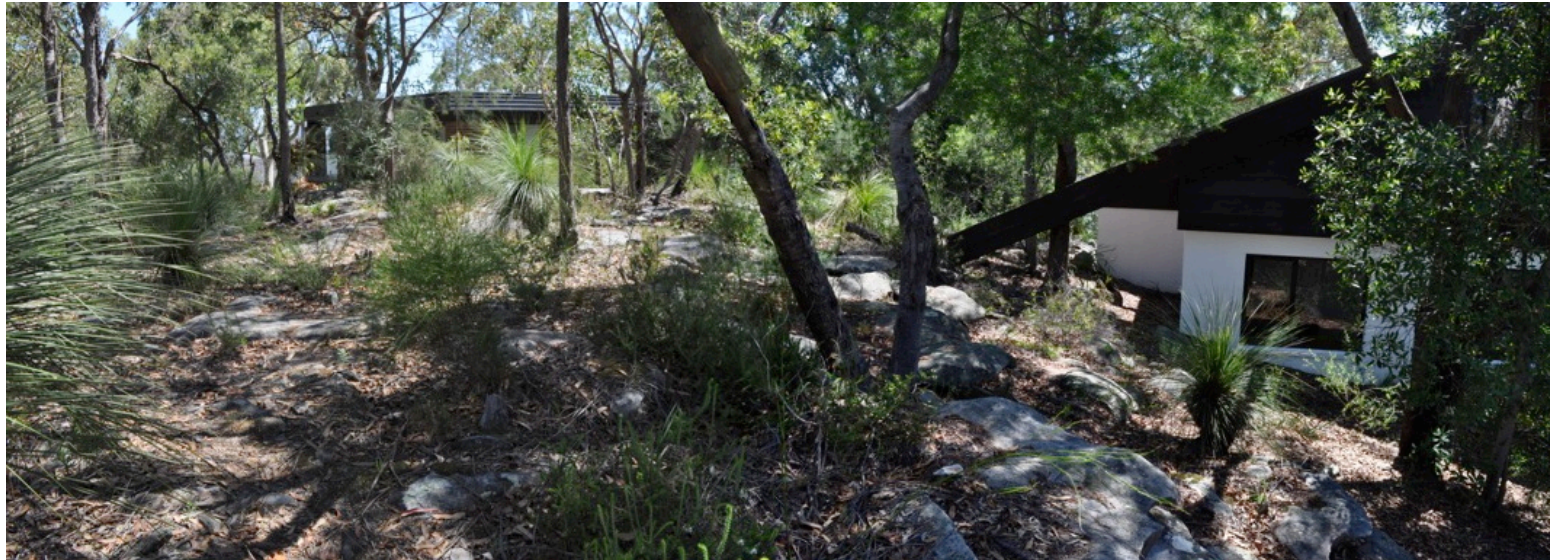
View to SW across rear of Lot 502. Dwelling on No. 92 in left background. Dwelling at rear corner of No. 14 in right foreground.

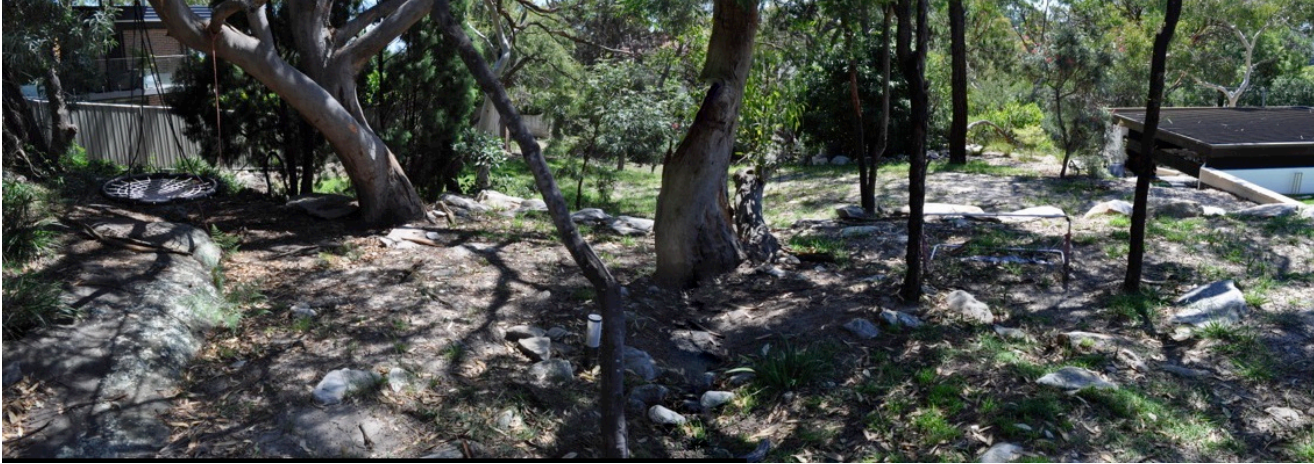
<b>Project No:</b>	15-062	<b>Scale:</b>	NTS	SITE PHOTOGRAPHS 19/1/16 NO.14 YEATS AVE KILLARNEY HEIGHTS NSW (Mr & Mrs A Toohey)	<b>Figure 3B</b>
<b>Drawn:</b>	wnd	<b>Date:</b>	10 Feb 16

View from rear of Lot 502, looking towards front. No.14 carport on right.

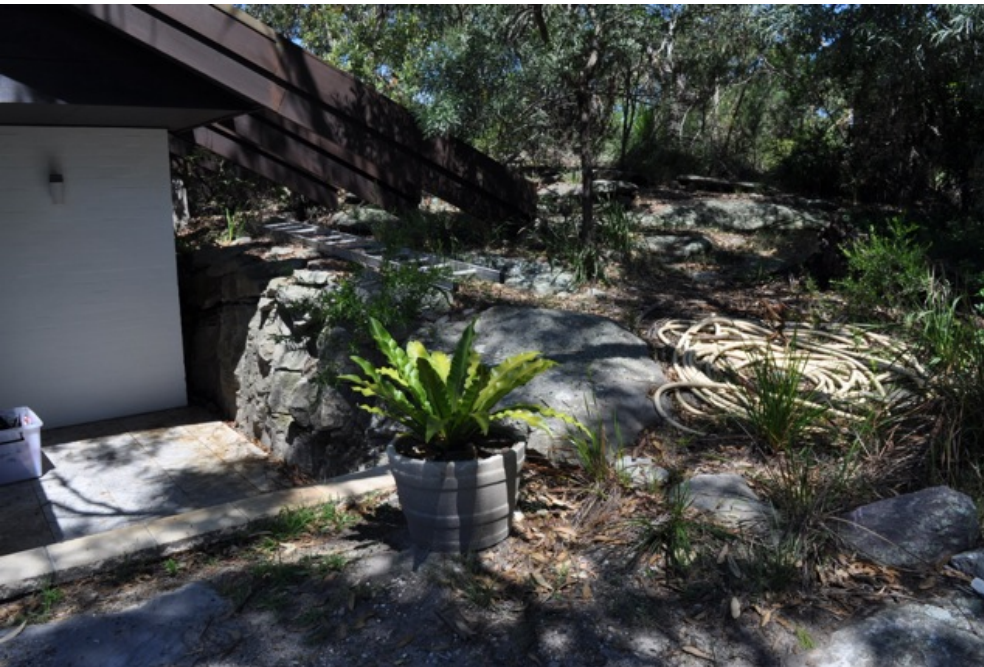
The existing development is partly benched into the slope at the south-eastern rear corner to about 1.4m depth and at the front carport to about 1.2m depth. Sandstone bedrock is exposed in the excavated faces.

Rear of dwelling on No.14 cut into sandstone bedrock. Lot 502 to the right.
